EAST HERTS COUNCIL HERITAGE AT RISK REGISTER

Updated July 2021

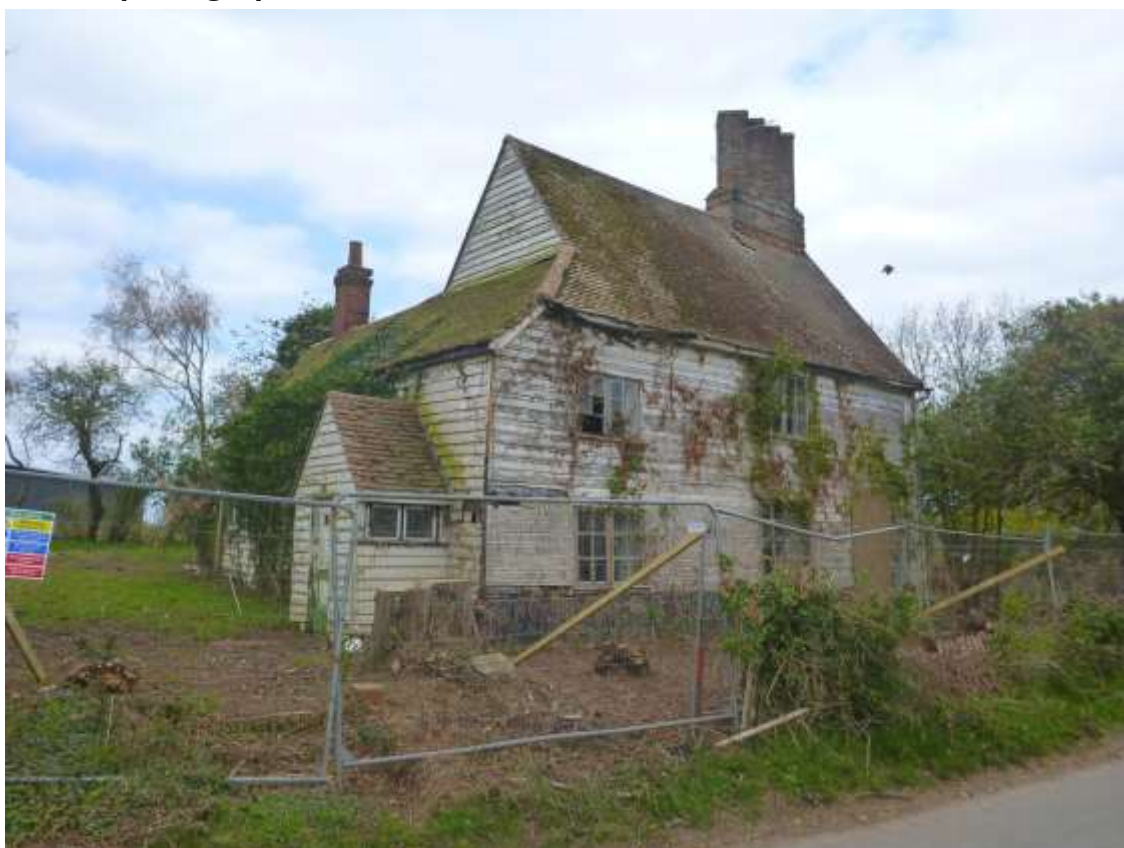
Description: Grade II. House. W part late medieval, C16th lower NW wing, C17th main range replacing medieval hall, but E half demolished. Timber frame over a brick plinth, weather-boarded. Stucco on N and E side walls. Steep red tile roofs. L-shaped house facing S with main range of two storeys and attics with large central chimney and lobby entry. Gabled porch to new entrance into SW room. Two flush 2-light casement windows on front to each floor and 4-panel door with small hood. Very large red brick chimney with four diagonal shafts joined in-line axially over a moulded base.

Latest update: Deterioration has accelerated, but some minor works have been undertaken by owner to make it weathertight. Application 3/17/2823/LBC was granted for refurbishment works and a small rear extension.

- General renovation to be habitable
- Assessment of damp / rot throughout
- Repair / replace weatherboarding, roof and guttering, windows and doors

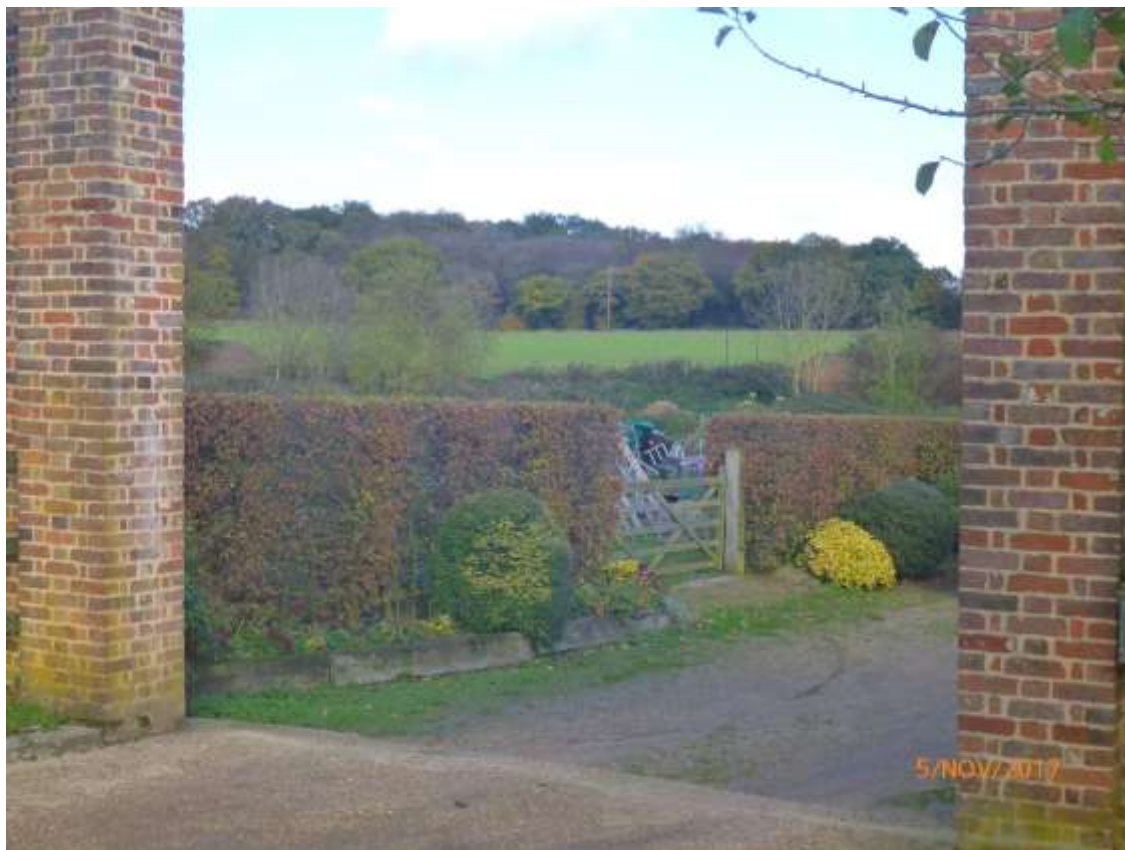
Description: Grade II. Former kitchen garden wall dating from about 1785. Part of the garden wall has collapsed. Cottage and the rest of the garden wall are in good condition. Owner advised us that many works had been carried out to other sections of walling and that restoration of this element was a future project.

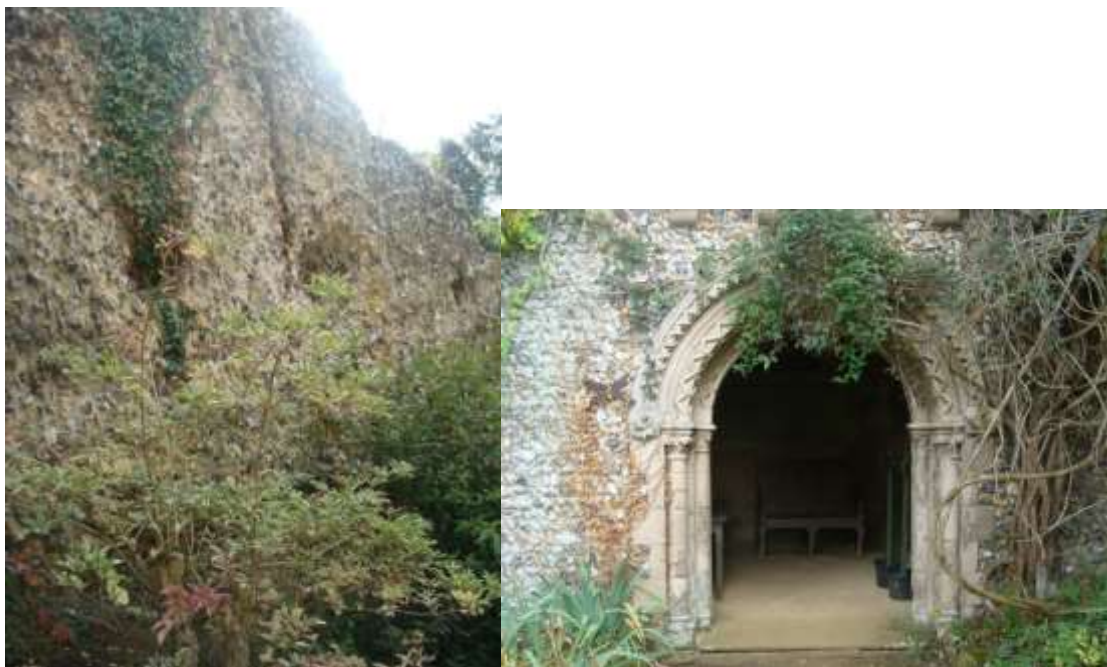
Description: Grade II Summerhouse and adjoining curtain wall. Mid-C19th by James Pulham for the Proctor family. Left photo shows significant split in flint wall.

Works required: Overall objective – secure consolidation and safety of ruin and prevent ongoing deterioration. Remove vegetation. Obtain specialist advice regarding consolidation and safety.

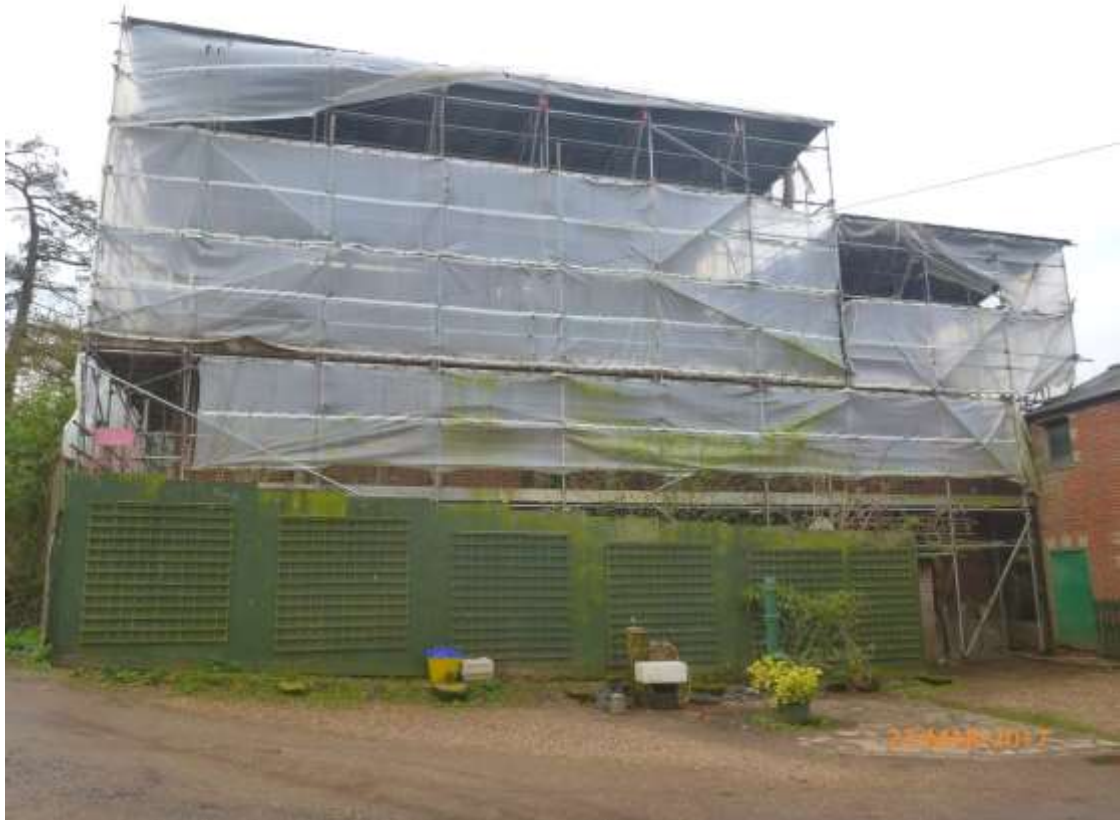
Description: Grade II. Mid-C19th Farmhouse. Red brick with white brick dressings to windows and door, red tile roof. Two storeys, symmetrical, five sash windows (now boarded). On opposite side of yard mid-C19th 10-bay aisled barn.

Latest update: Scaffolding erected around building with temporary roof. No change to condition. Will eventually be repaired as part of S106 for Bishop's Stortford North development. Needs to be monitored.

- General renovation to be habitable
- Assessment of damp / rot throughout
- Repairs to roof covering, possible replacement of all roof
- Repair / replace doors and windows

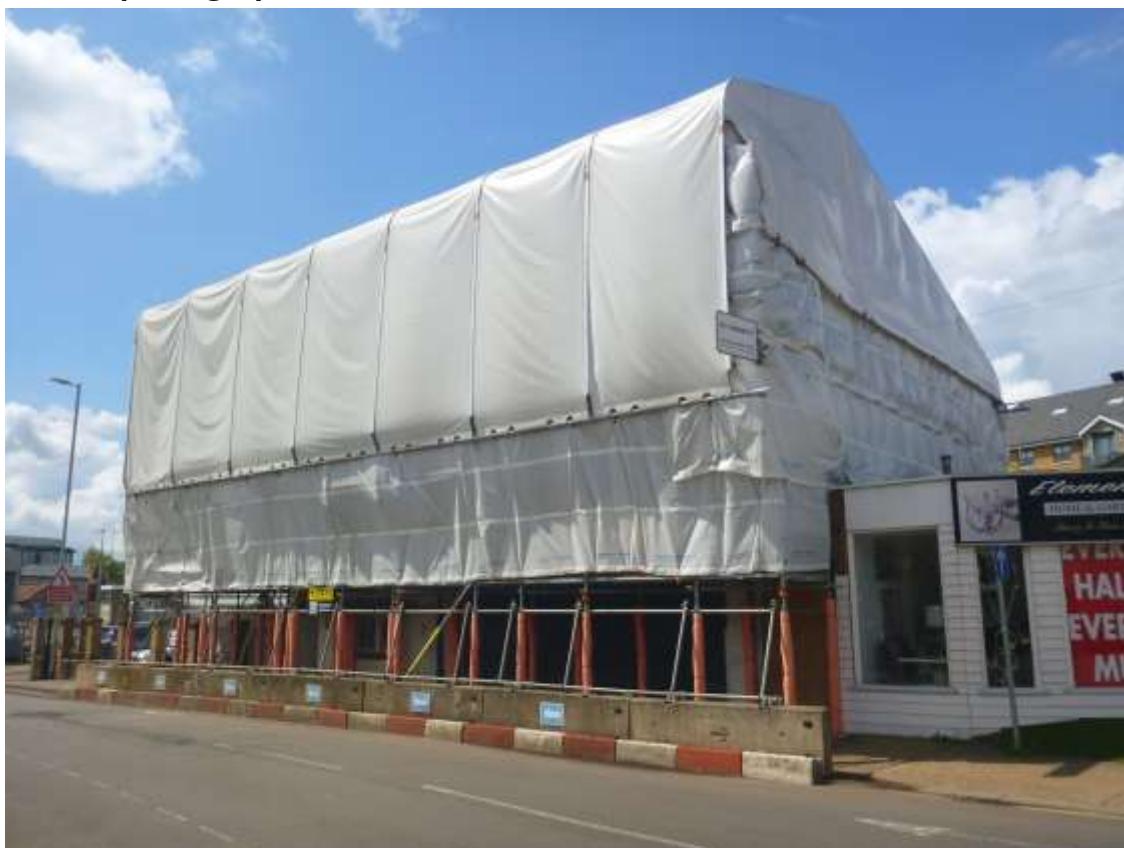
Description: Grade II. C17 timber frame, plaster and painted brick front, old red tile roof. Two and a half storeys. Central third storey overhanging sack hoist on curved brackets. Two pargetted roses on soffit and other C17 pargetted armorial motifs on walls. C19 sash windows. Modern shop front to north. Parallel timber frame pitched roof block at rear.

Latest update: Works to repair the building throughout were granted consent by 3/16/1262/LBC. Repair works commenced in 2017 but have stopped whilst uncovered issues are assessed by a Structural Engineer. We have been in contact with the agents and hope that work will restart soon.

- General renovations to be habitable
- Assessment of damp/rot throughout
- Repairs to roof and rainwater goods
- Repairs or replacement of windows and doors

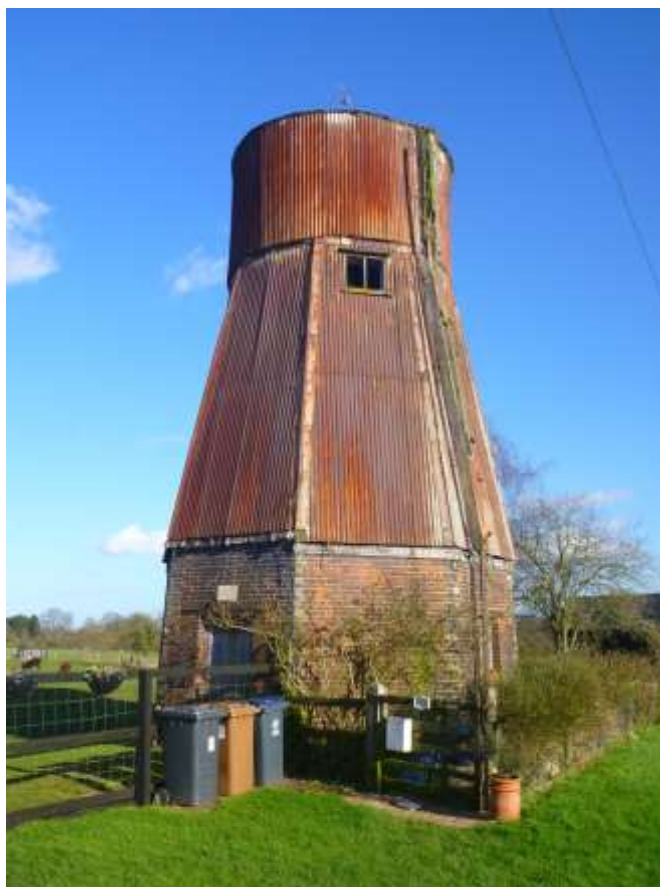
Description: Grade II. Windmill. Dated 1826 by plaque over door 'Erected by Wm Halden 1826'. Octagonal red brick base surmounted by timber smock, clad in corrugated iron, supporting a water tank. Interior denuded of all fittings, vertical softwood panelling intact on first and second floor.

- Needs to be made watertight or complete restoration
- Assessment of damp / rot throughout
- Assessment of roof structure
- Repair / replace roof covering
- Repair / replace doors and windows
- Remove vegetation to tower

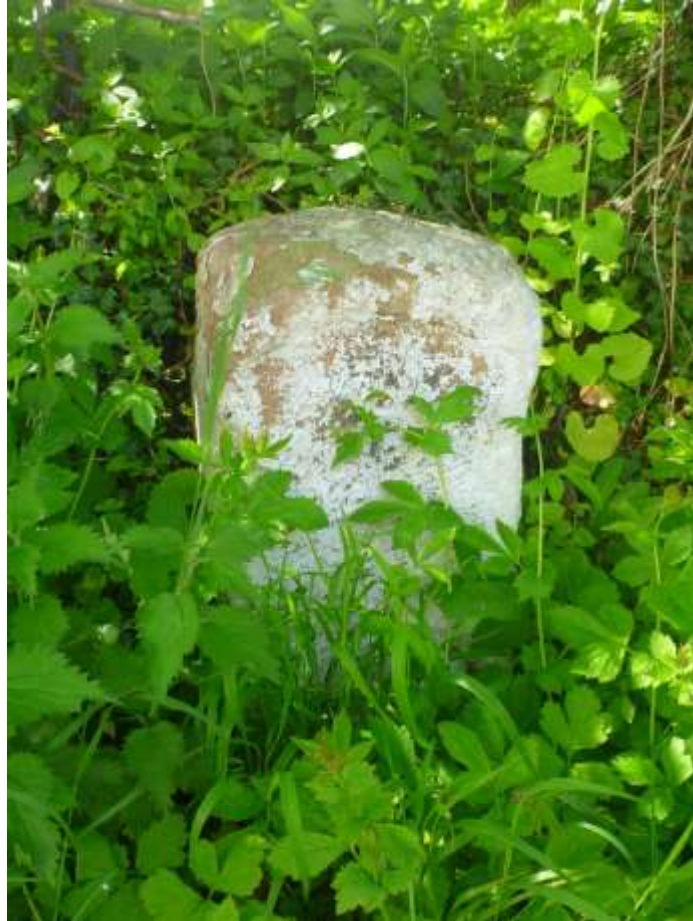
Description: Grade II. Milestone. Circa 1742 for Wadesmill Turnpike Trust. The face was covered by iron lettered plate c.1804 probably to design of McAdam which is now missing. A square stone pillar about 50cm tall, which had a large front plate of iron with a segmental curved top and raised edge-bead. Inscription formerly read: "LONDON 32 BUNTINGFORD 1 ROYSTON 6". The first and second words were raised in segmental arcs.

Latest update: HCC now actively involved in commissioning repairs. Works planned to be undertaken soon.

- General restoration
- Cleaning and re-painting of stone
- Replacement of plate

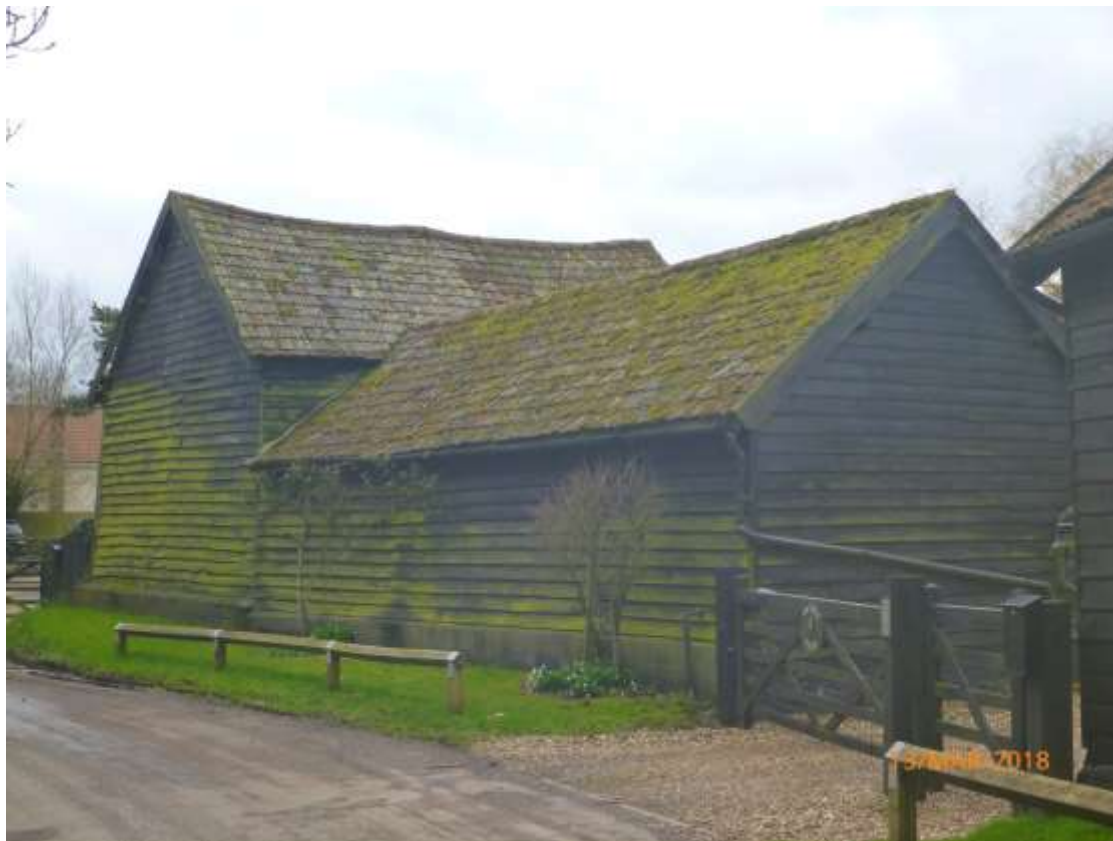
Description: Farm buildings. C18/19th. Post and truss construction. Timber frame on a brick rendered sill, weatherboarding to the exterior. Doorway face into farmyard. Pantile gabled roofs. Three buildings attached to one another, L-shaped next to roadside with a third part attached at the rear. Owned by Cheynes Farmhouse.

- Total renovation, or to be made watertight
- Assessment of damp / rot to timber frame and roof structure
- Repair / replace brick base
- Repair / replace timber weatherboarding
- Repair / replace roof covering
- Repair / replace doors

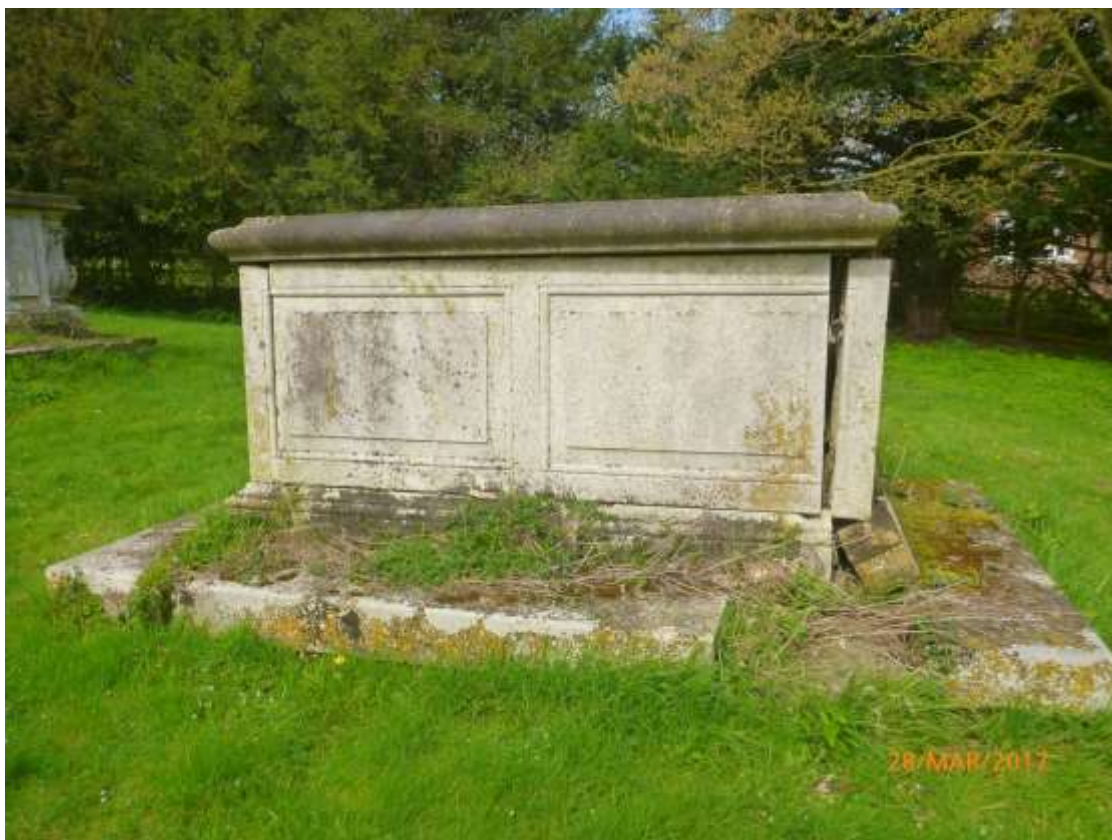
Description: Grade II. Tomb. Late C17th. Stone rectangular tomb chest with moulded plinth and boldly moulded slab. Tomb of Turvin family, owners of Terlings 1683-1847.

Latest update: Extensive vegetation has helpfully been removed, but the structural condition of the tomb needs to be addressed.

- Contact Gilston Parish Council and the Rector of St Mary's Church
- General restoration
- Re-assess the condition of the tomb

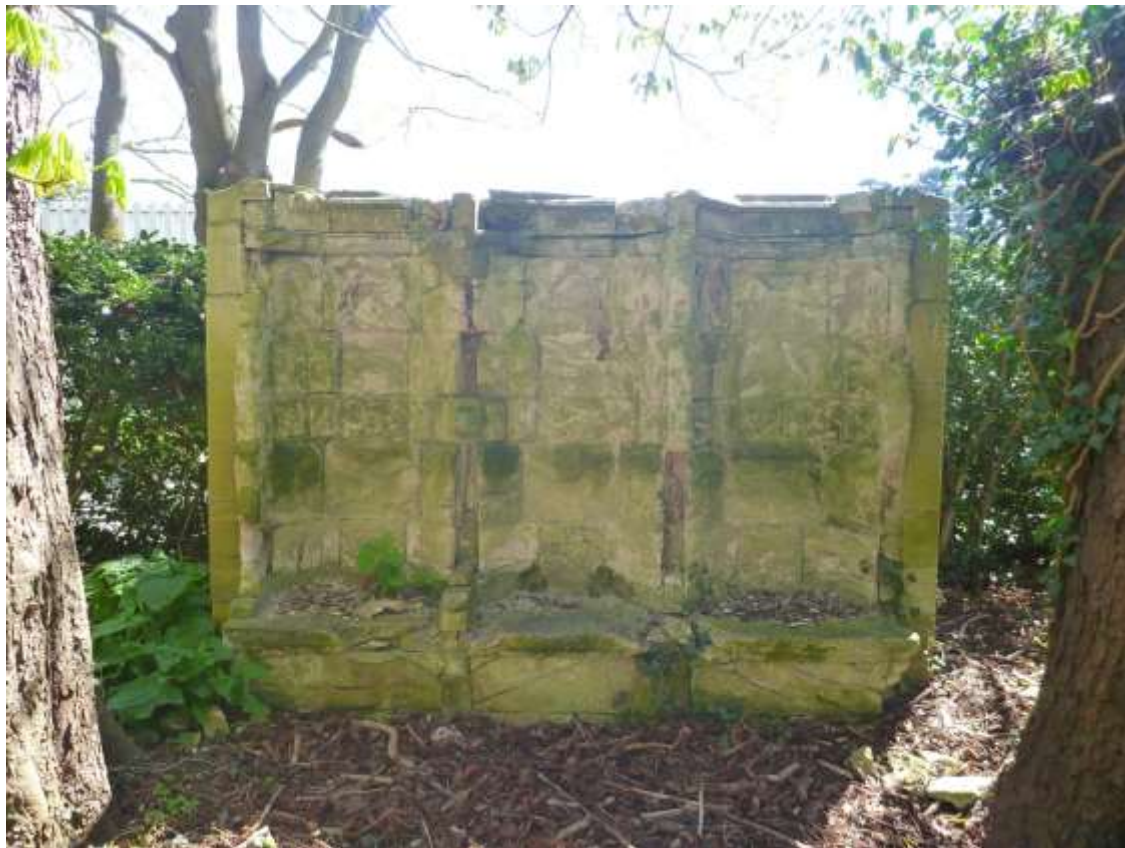
Description: Grade II. Sedilia (seats for clergy). C14th. Decorated Gothic style, triple stall, with stone seats, and three recessed bays, subdivided with attached colonnettes. Canted backs panelled with trefoil arches in blind tracery, roll moulded cornice. Badly eroded. Removed from church during restoration and rebuilding in 1891. Loss of historic C14th fabric of great concern.

- General restoration to consolidate
- Repair to stone and joints
- Long-term protection from erosion (possibly return to church or provide a shelter)

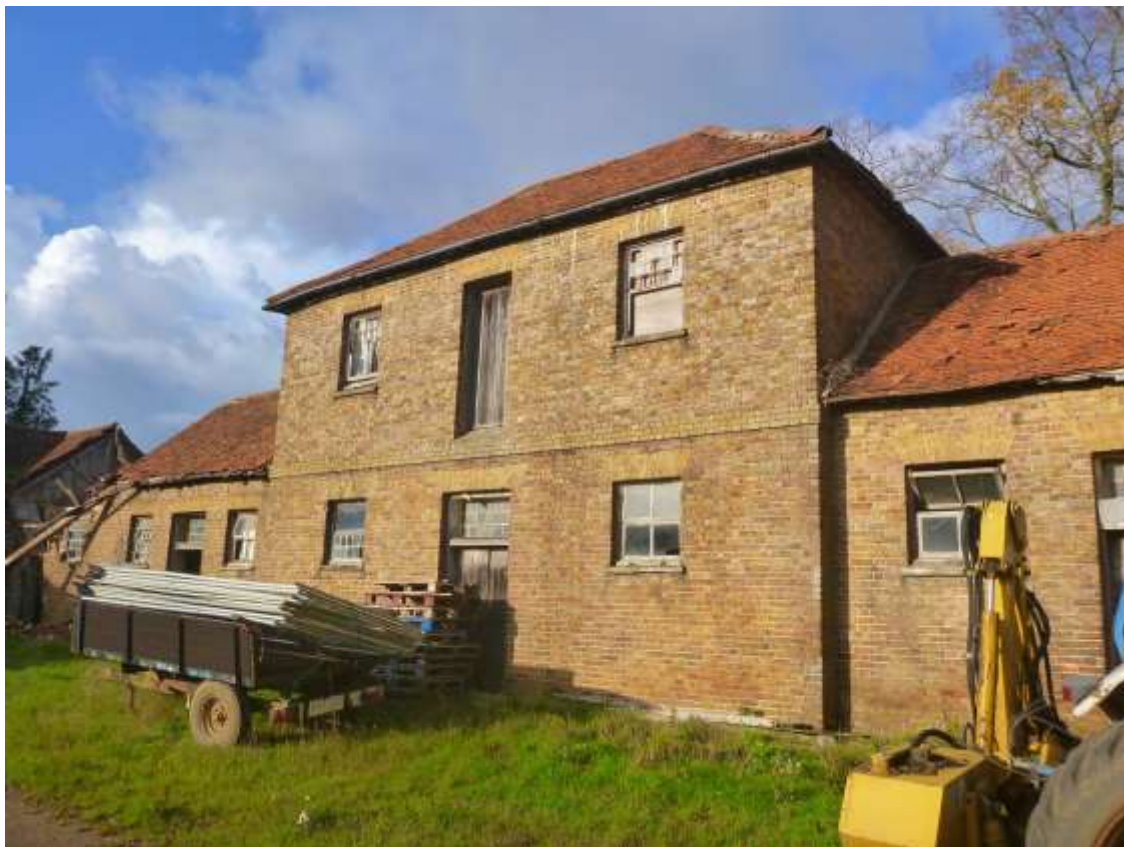
Description: Grade II. Central granary and stables attached to separately listed further stables. Early C19th. Brick stable range with hipped red tile roof. Four boarded stable doors with multi-light fanlights under a yellow brick gauged arch. Flanked by small high-set windows, each under a yellow brick gauged arch. Each window has a wooden frame with 10/10 or 2/2 panes. Granary with brick band at mid-height. Central doorway under a yellow brick gauged arch to ground and first floor. Each flanked by 2/2 window to ground floor and 15/10 window to first floor.

Latest update: Large collapse of roof structure above single-storey element occurred autumn 2019. We met with the agents of the owners to secure urgent repairs but none have been completed so far.

- General renovation, or to be made watertight
- Assessment of damp / rot to roof structure
- Repair / replace roof covering
- Repair / replace doors and windows

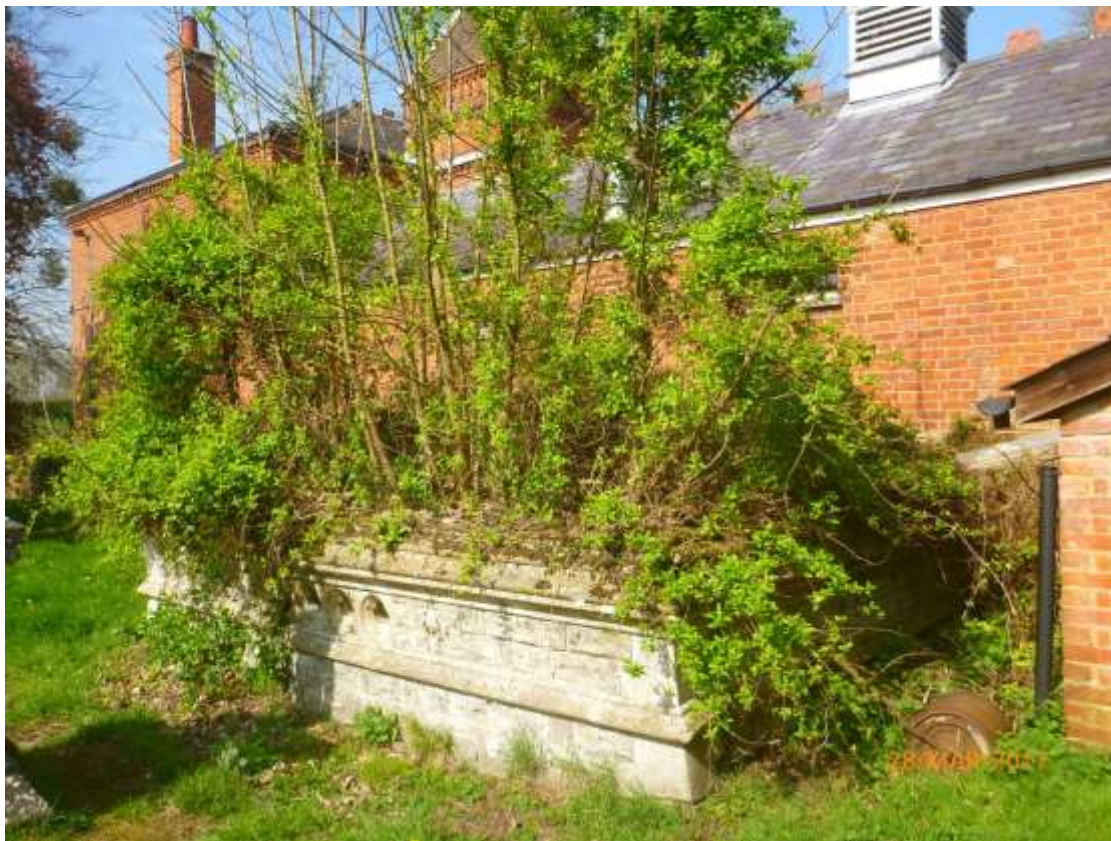
Description: Grade II. Monument. 1881. White limestone, hard plaster mouldings to surrounding wall. Rectangular Gothic tomb chest within a stone walled enclosure. Random squared rubble walls, freestone quoins, base topped by a heavy ogee base moulding. Row of five trefoil pierced stones in the middle of long side. Heavy series of plaster capping mouldings. Upper part with foliate recumbent cross carved in high relief. Lombardic lettered inscription to Walter family. Significant vegetative growth needs to be removed.

- Contact Hunsdon Parish Council and the Rector of St Dunstan's Church
- Assess stability and damage by tree stump
- General restoration
- Removal of vegetation

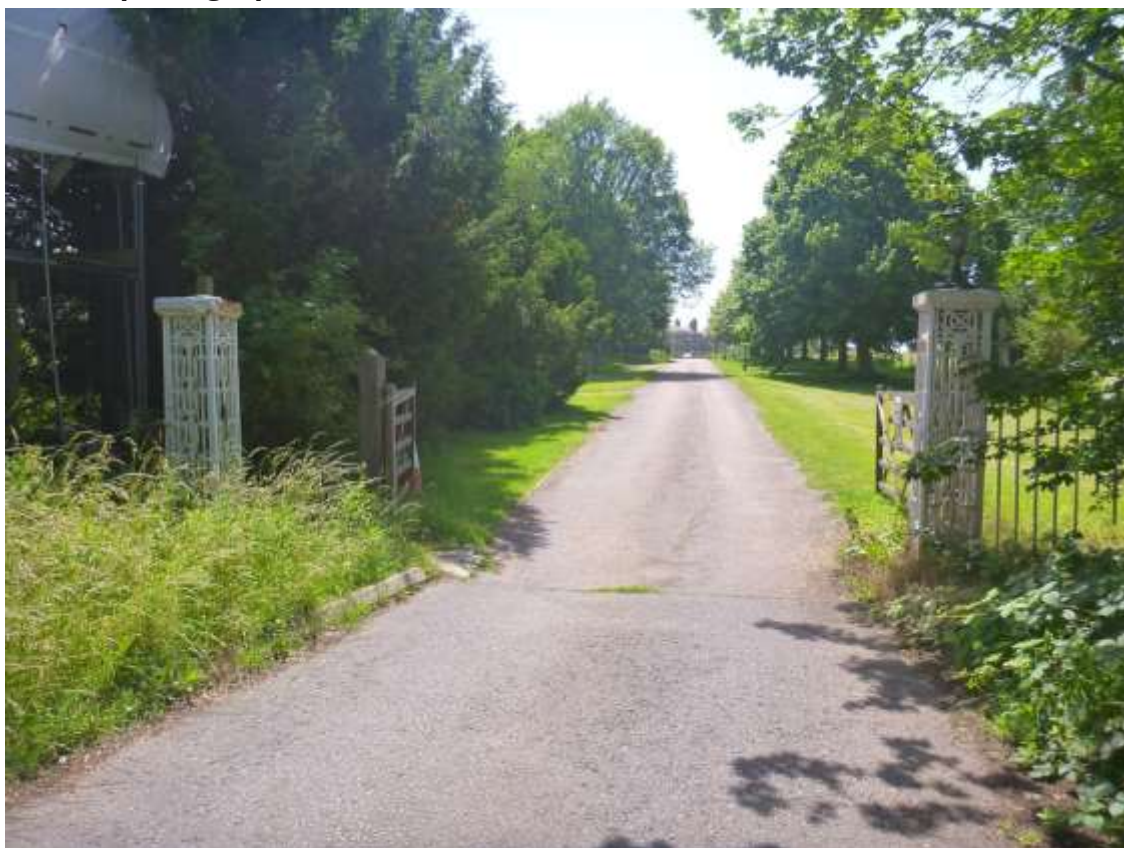
Description: Grade II. Gates and gate piers. Early C19th. Neo-classical cast iron gates and piers at entrance to North Drive at Briggens. Tall openwork cast iron piers in the form of tapered square pylons on ball feet, a saltire with superimposed oval at top and bottom, stylized anthemion ornament up each face within a margin of rosettes, all topped by deep flat square caps. Similar side railings sweep down to lower terminal piers of cast iron of similar design to the higher piers. Gates have been removed.

- General repairs to piers and side railings
- Repair and reinstatement or Replacement of gates and pier
- Replacement of railings

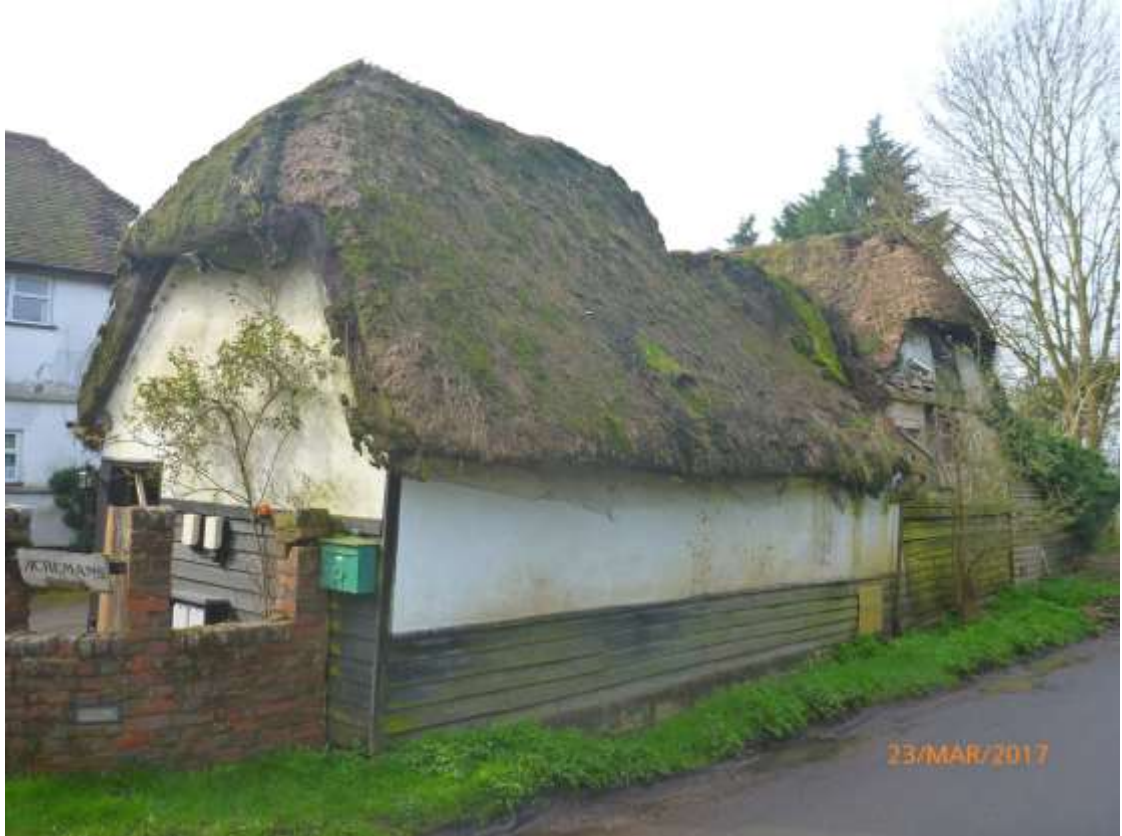
Description: Grade II. Farm buildings. Later C17th. L-shaped range, thatched, timber framed, on roadside. T-plan barn with longer part N-S and projection on W. Lower stables extend to E along roadside and at S end. Red brick bases in English bond, plastered walls with weather-boarded aprons to all. Barn has ventilation holes under eaves, closed by battens. Wind-vane with stork. Steep thatched roofs half-hipped at ends. All doors open to yard on SE. Owned by Acremans.

Latest update: Vehicle strike in 2021 has caused extensive damage. We are awaiting structural advice.

- General renovation
- Assessment of damp / rot to timber frame and roof structure
- Repair / replace weatherboarding and external plaster
- Replace thatched roof
- Repair / replace door

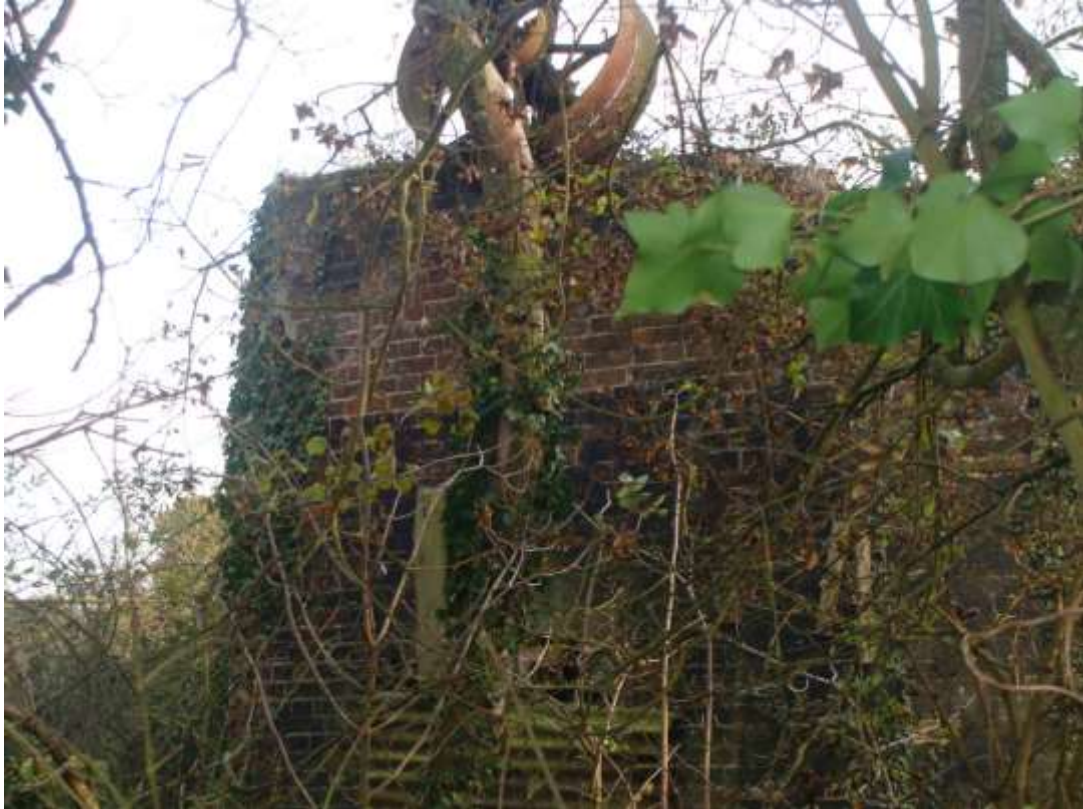
Description: Grade II Windmill tower. Upper part destroyed by fire in 1981. Mid-C18th. Formerly a tall 2 storeys, red brick and octagonal tower. In use up to 1930s. Used to represent a striking industrial monument of considerable historic and technological interest. Now only stump remains.

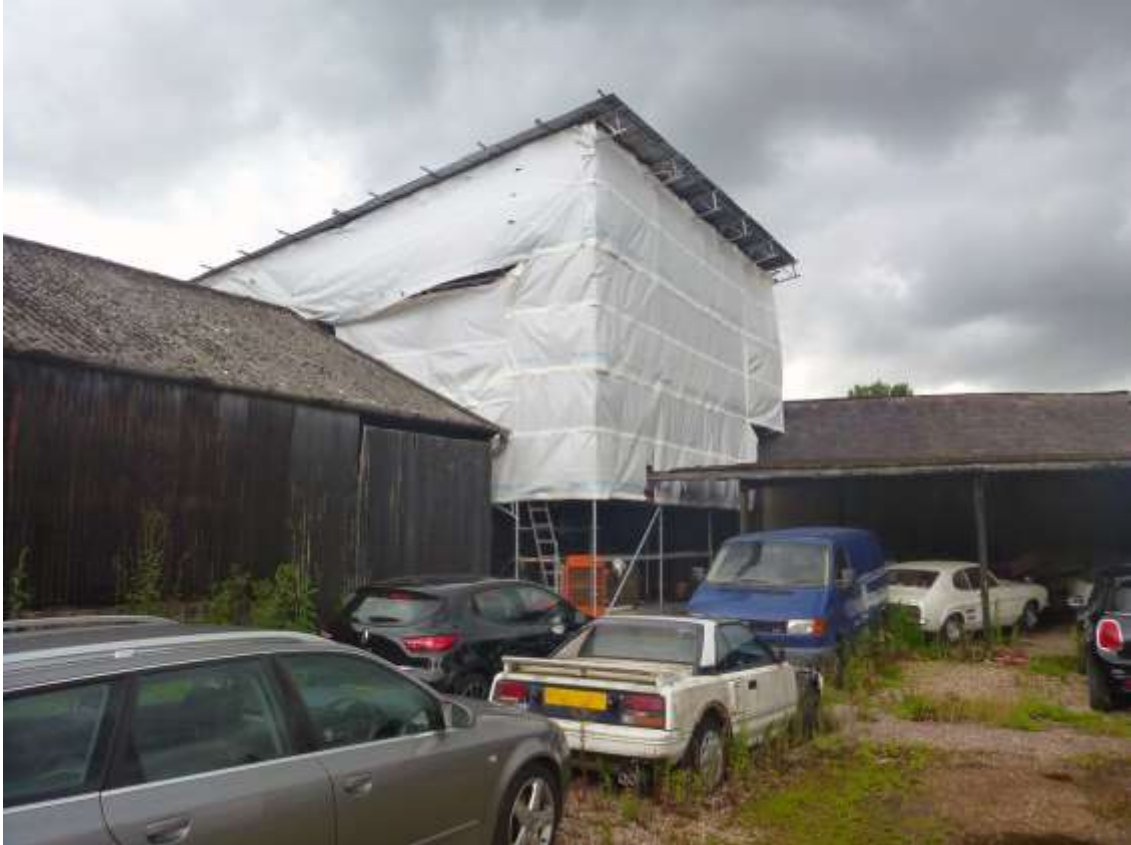
Description: Grade II Stable. C17th. Timber-frame stable with steep pitched roof. Part of a courtyard group. LB description advises it is an 'unusual survival'. Now in an advanced stage of deterioration but capable of restoration.

Works required: Overall objective to repair and restore building consistent with retaining its existing small scale and form. Assess structural stability and undertake appropriate restoration, including re-roofing with historically appropriate material. Other former agricultural buildings on site have been converted to commercial uses.

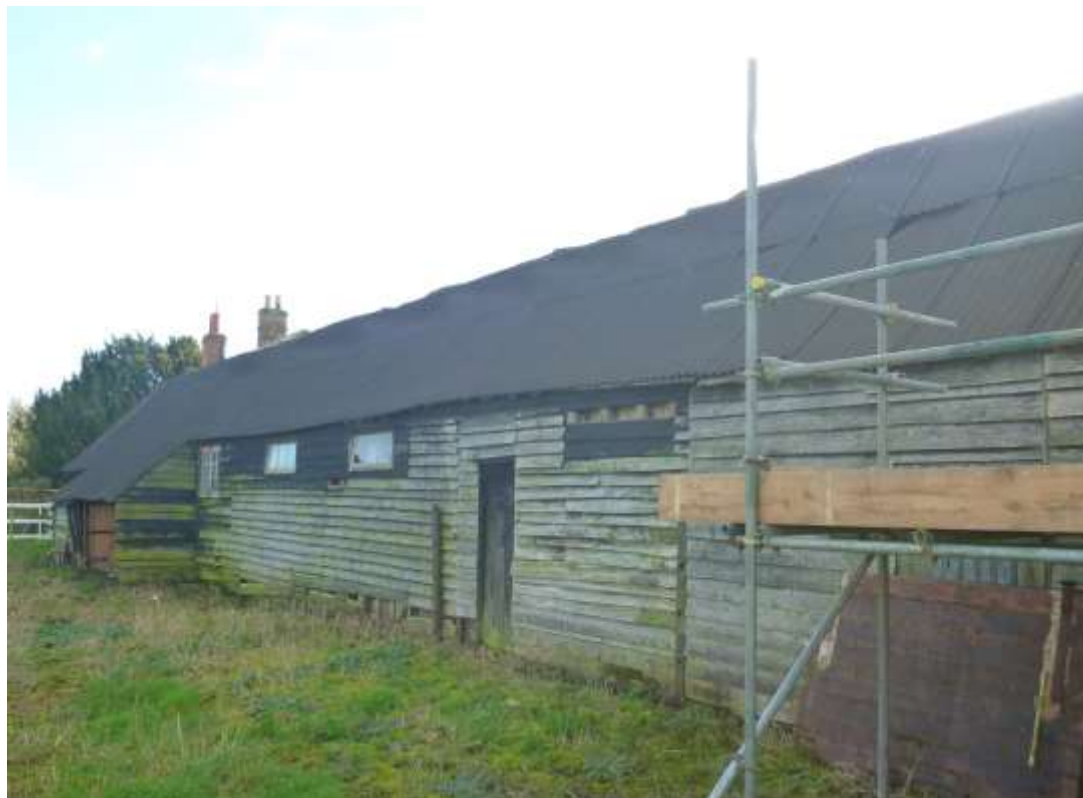
Description: Grade II C19th timber-framed and weather-boarded with corrugated iron roof. All elements in poor condition; roof appears to leak in places; some weatherboarding missing. Used for accommodation of 100 Shire horses in late-C19th when owner of this time had a Hackney carriage enterprise.
