EAST HERTS COUNCIL HERITAGE AT RISK REGISTER

Updated October 2025

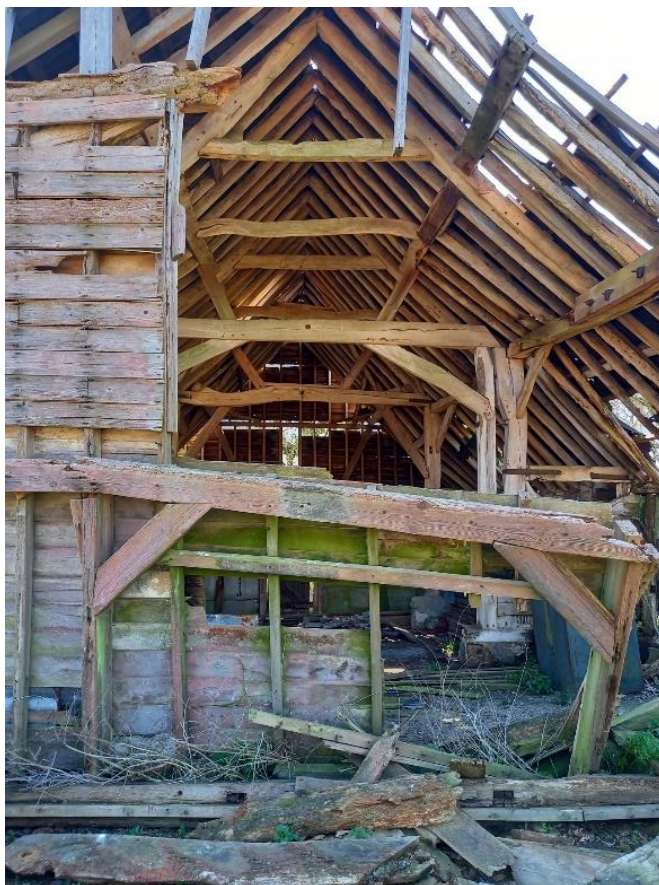
Date of photograph: 02/04/2025

Description: Grade II. C17 or earlier timber-framed, weatherboarded with corrugated asbestos roof, all on a brick plinth. Three bays remain of what was an eight-bay barn. Double aisled. One gabled entrance remains in the most northerly bay.

- Prop structure / repair frame with new framing where necessary
- Replace missing roof sheeting / replace rood covering
- Repair / replace weatherboarding
- Record building
- Long-term use needs to be found to ensure full repair and future maintenance

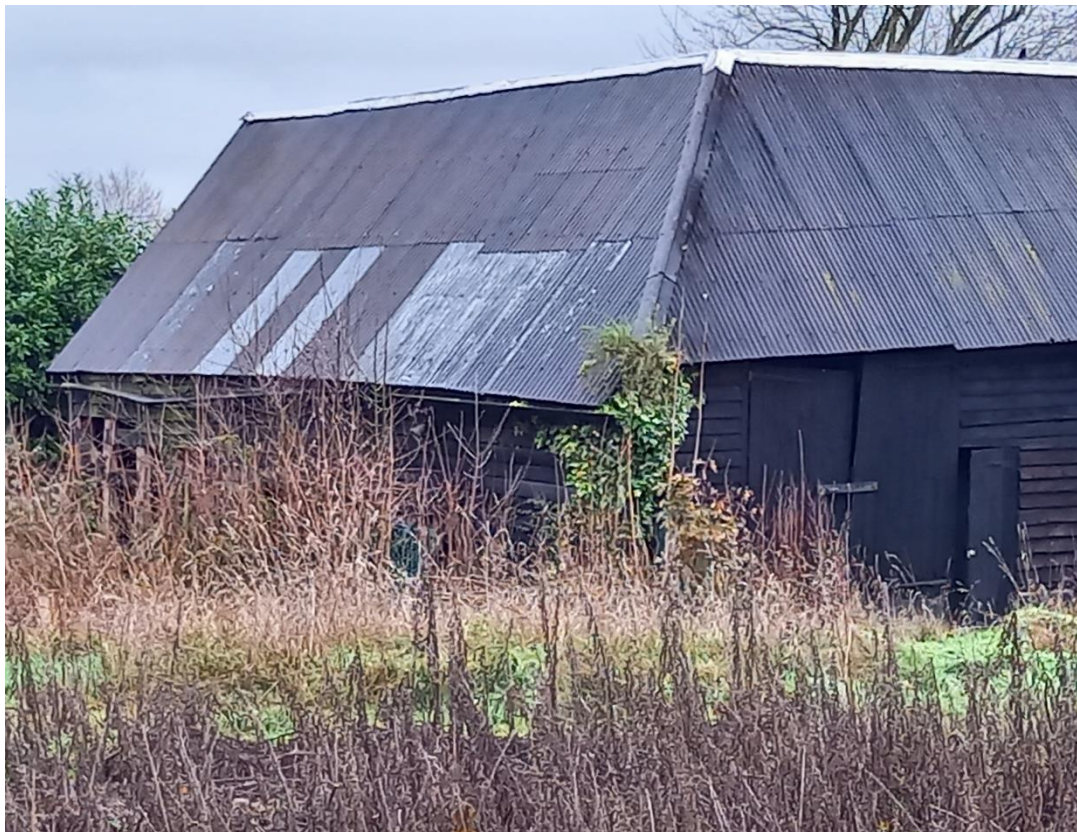
Description: Grade II. C17, extended in C19. Timber frame on brick sill, dark weatherboarded (some with edge roll) with steep pitched roof now of black corrugated iron. A tall single bay barn facing W with later rear outshut and lower contemporary building against W side with entrance in W gable, extended to rear in C19 and re-roofed in line with barn. Taller barn has jowled posts, curved braces to tie beam, clasped-purlin roof with collar beam truss with inclined queen-struts. Holes for wattle infill in wall-plate of barn and W building. Pidgeon holes and small porch over gable doors to barn.

- General renovation
- Assessment of damp / rot throughout
- Repair / replace weatherboarding
- Repair / replace doors

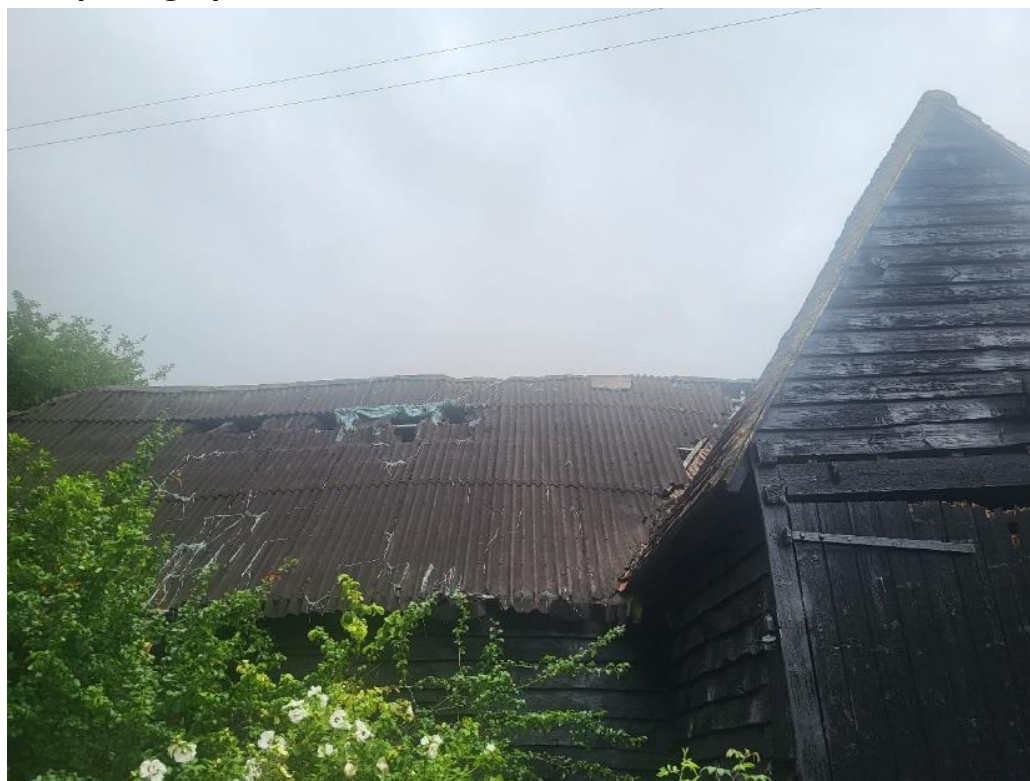
Description: Grade II Barn and two stables in one range. Early C17. Timber framed dark weatherboarded. Steep pitched roofs. Barn has old red tiles to gabled front porch but corrugated iron elsewhere (half-hip at South). Short stable at North end of barn also roofed in corrugated iron. Long stable at North thatched with hipped North end. A tall six-bay barn facing East with gabled front porch with double-doors and small winnowing door in rear wall of same bay. Jowled posts with straight braces to cambered tie-beams. Inclined queen-posts to clasped purlin roof. Some re-used timbers. An impressive group of old farm buildings.

Works required: The roof covering has holes in it and is not watertight on the main barn and adjacent two storey element. Single-storey stable roof is watertight, but thatch mentioned in description has some years ago been changed to corrugated metal. The timber frame especially in the main barn is in poor condition, showing signs of buckling above plinth/sole plate level, but has been propped internally with scaffolding.

Latest update: New addition. Owner to investigate feasibility of the replacing the degraded corrugated roofing with an alternative temporary roof covering as well as exploring feasibility of longer term works to the roof and the frame.

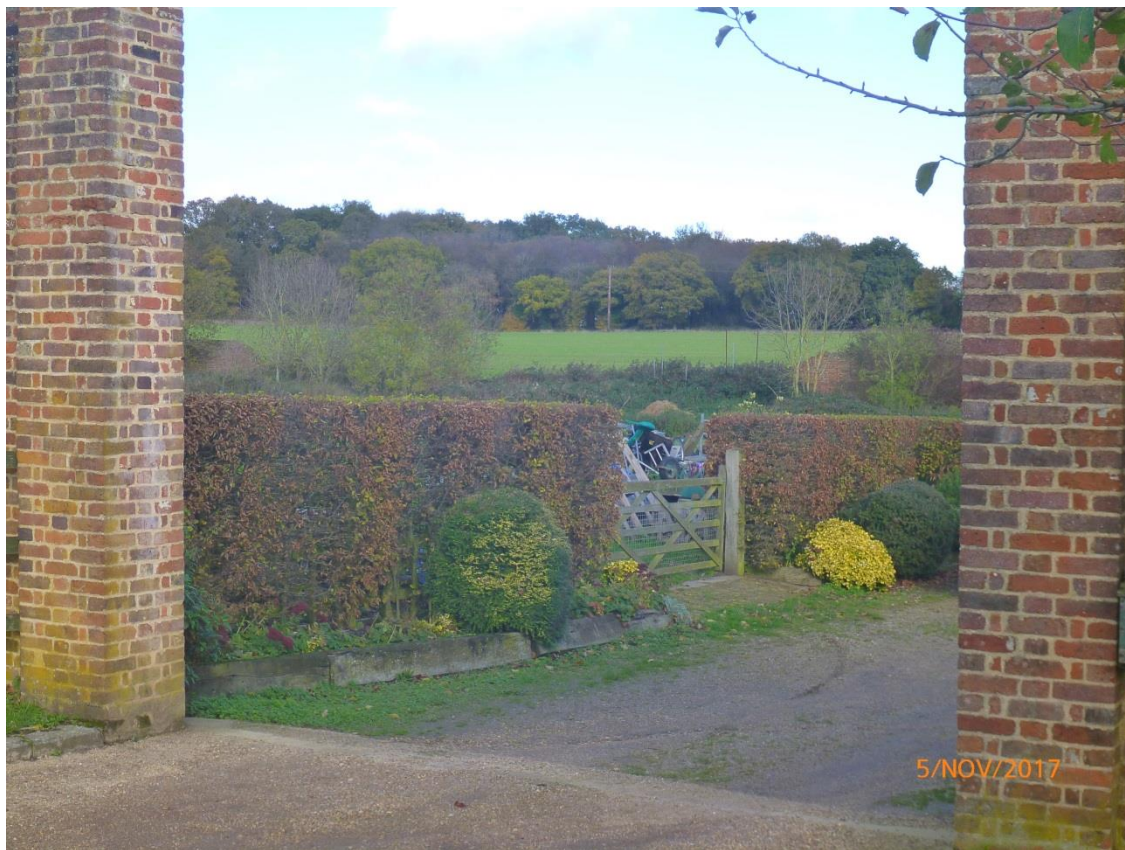
Description: Grade II. Former kitchen garden wall dating from about 1785. Part of the garden wall has collapsed. Cottage and the rest of the garden wall are in good condition. Owner advised us that many works had been carried out to other sections of walling and that restoration of this element was a future project.

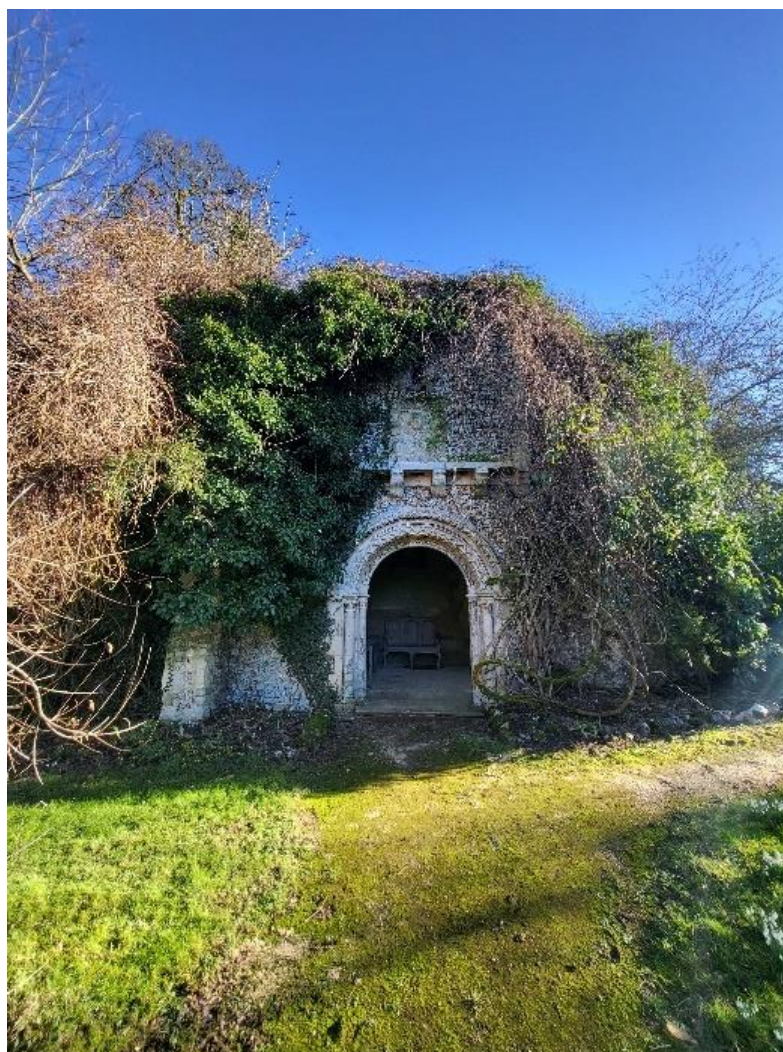
Description: Grade II Summerhouse and adjoining curtain wall. Mid-C19th by James Pulham for the Proctor family.

Works required: Overall objective – secure consolidation and safety of ruin and prevent ongoing deterioration. Significant split in flint wall needs repairs. Remove vegetation. Obtain specialist advice regarding consolidation and safety.

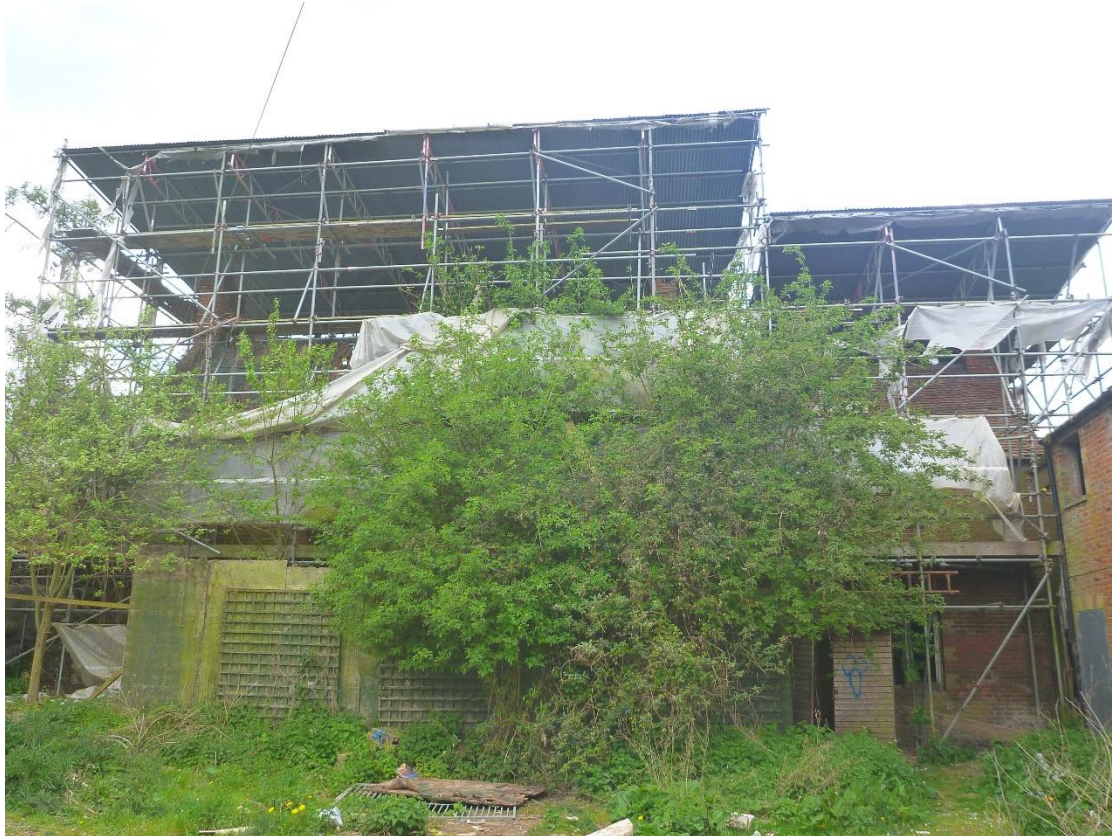
Description: Grade II. Mid-C19th Farmhouse. Red brick with white brick dressings to windows and door, red tile roof. Two storeys, symmetrical, five sash windows (now boarded). On opposite side of yard mid-C19th 10-bay aisled barn.

- General renovation to be habitable
- Assessment of damp / rot throughout
- Repairs to roof covering, possible replacement of entire roof
- Repair / replace doors and windows

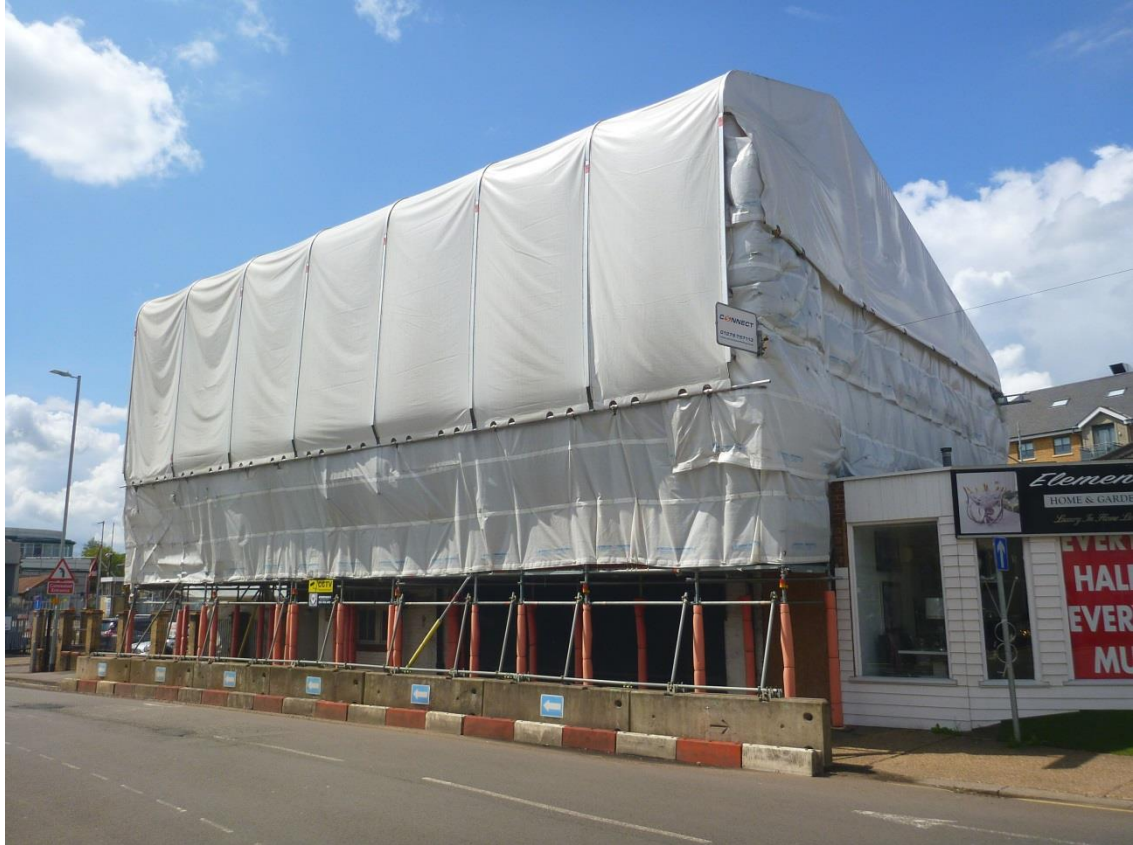
Description: Grade II. C17 timber frame, plaster and painted brick front, old red tile roof. Two and a half storeys. Central third storey overhanging sack hoist on curved brackets. Two pargetted roses on soffit and other C17 pargetted armorial motifs on walls. C19 sash windows. Modern shop front to north. Parallel timber frame pitched roof block at rear.

- General renovations to be habitable
- Assessment of damp/rot throughout
- Repairs to roof and rainwater goods
- Repairs or replacement of windows and doors

Latest update: No change. Works to repair the building throughout were granted consent by 3/20/0529/LBC which has now expired. An application for a similar scheme is being prepared for submission. The building has been kept secure and watertight, and the agents have been monitoring its condition

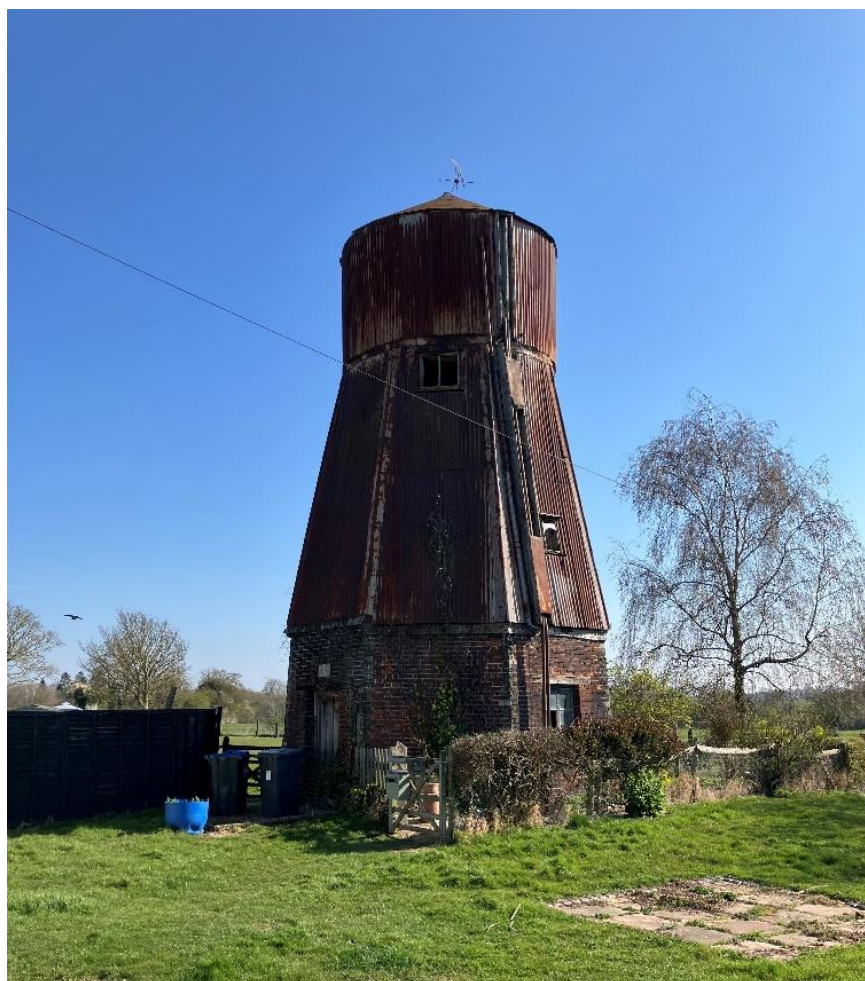
Description: Grade II. Windmill. Dated 1826 by plaque over door 'Erected by Wm Halden 1826'. Octagonal red brick base surmounted by timber smock, clad in corrugated iron, supporting a water tank. Interior denuded of all fittings, vertical softwood panelling intact on first and second floor.

- Needs to be made watertight or complete restoration
- Assessment of damp / rot throughout
- Assessment of roof structure
- Repair / replace roof covering
- Repair / replace doors and windows
- Remove vegetation to tower

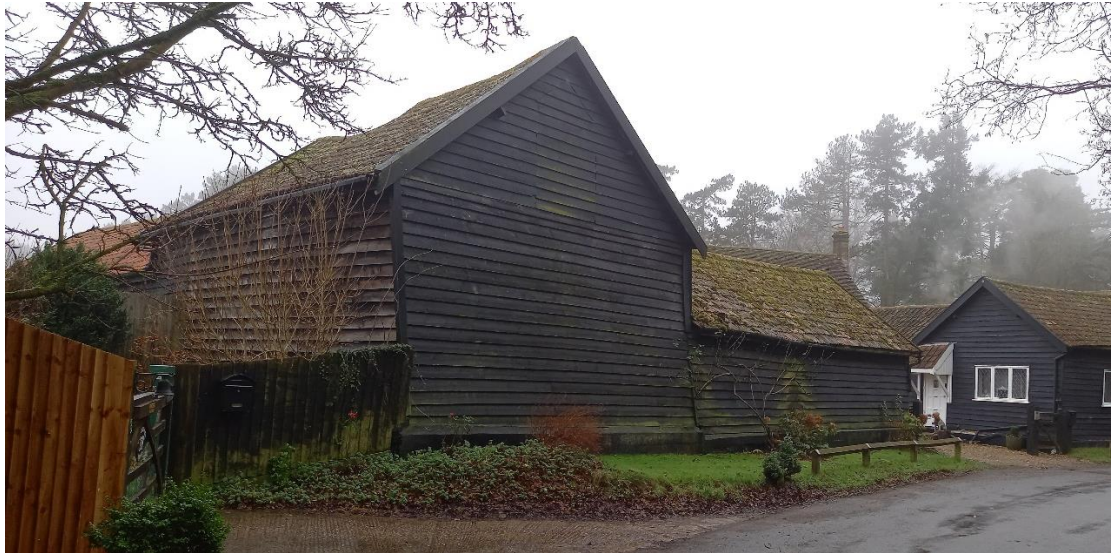
Description: Curtilage listed Farm buildings. C18/19th. Post and truss construction. Timber frame on a brick rendered sill, weatherboarding to the exterior. Doorway face into farmyard. Pantile gabled roofs. Three buildings attached to one another, L-shaped next to roadside with a third part attached at the rear. Owned by Cheynes Farmhouse.

- Repair / replace brick base
- Repair roof
- Repair gutters
- Repair doors
- Repair tie beam and reinstate post and brace to cartshed.

Latest update: Listed Building Consent granted for repairs to all farm buildings (3/25/0151/LBC). Not yet implemented.

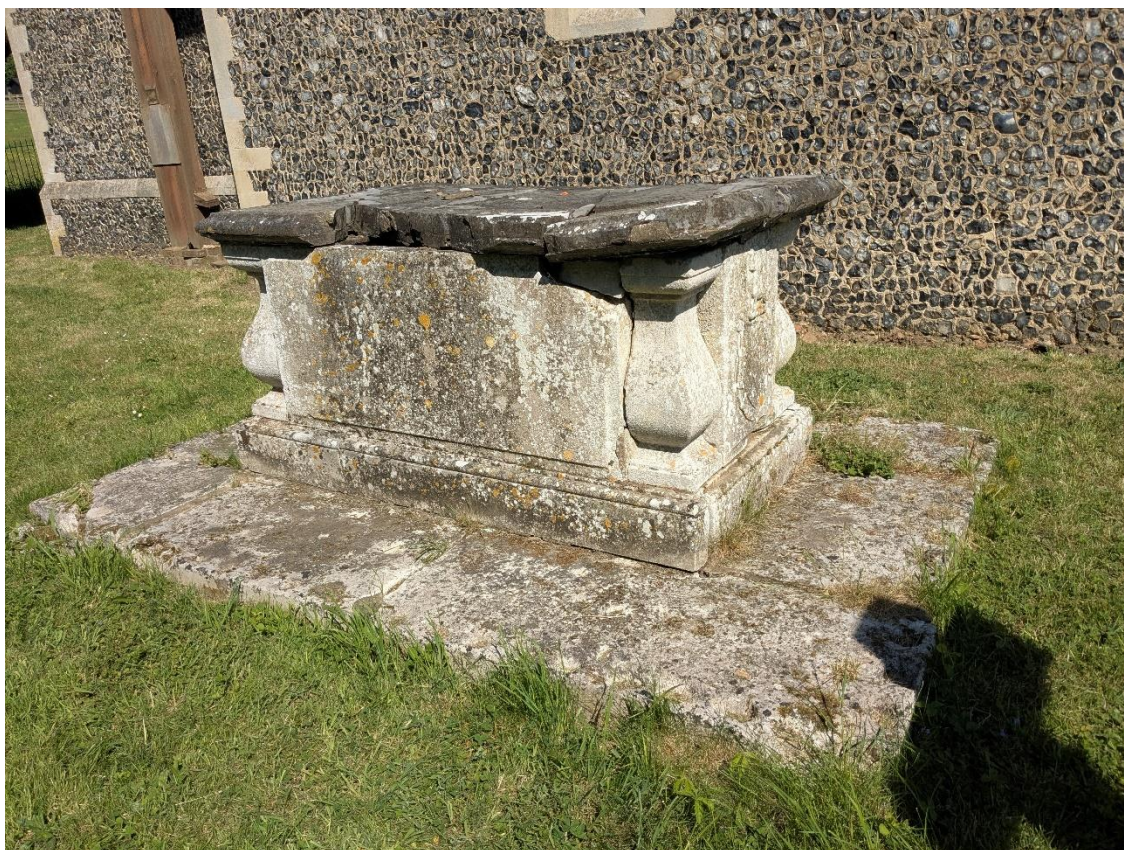
Description: Grade II. Tomb. 1789. Stone tomb chest with inset baluster corners and moulded top slab, to William Frampton, Merchant of the City of London.

Latest update: Grass and vegetation cleared from the tomb but there is masonry damage and repairs are required.

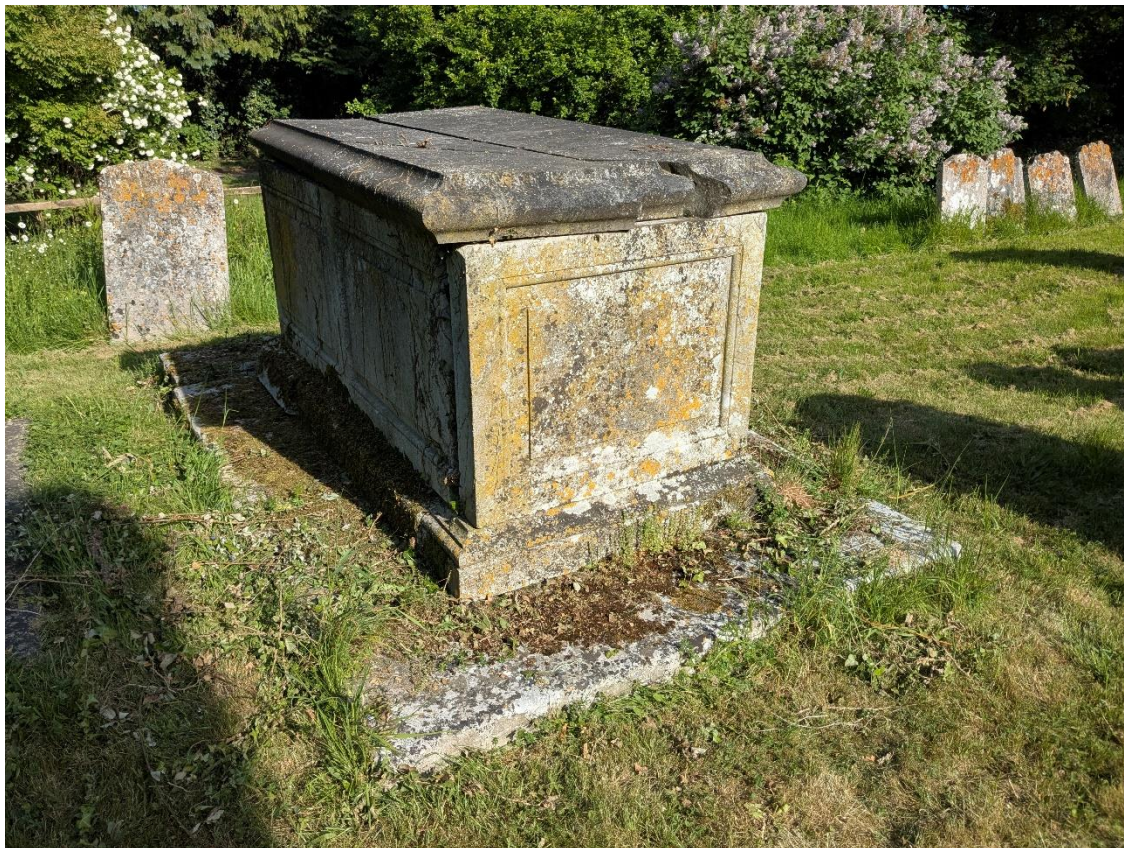
Description: Grade II. Tomb. Late C17th. Stone rectangular tomb chest with moulded plinth and boldly moulded slab. Tomb of Turvin family, owners of Terlings 1683-1847.

Latest update: Some vegetation removed from the tomb but there is masonry damage and repairs are required.

- Contact Gilston Parish Council and the Rector of St Mary's Church
- General restoration
- Re-assess the condition of the tomb

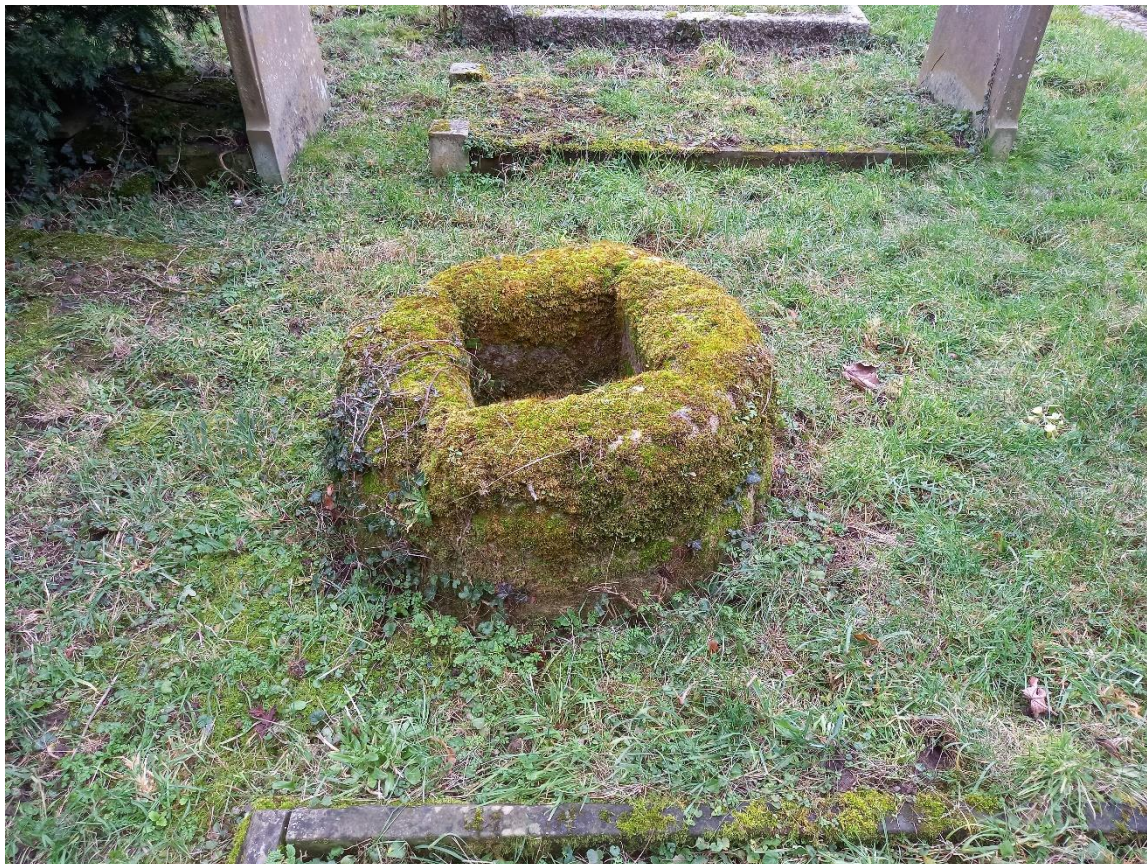
Description: Grade II. Monument. Cross base for churchyard cross. Probably C14th. Stone. A regular octagonal monolithic base about one meter wide and half a meter high with a large, deep, square socket in the middle of the upper face. Covered with moss and vegetation.

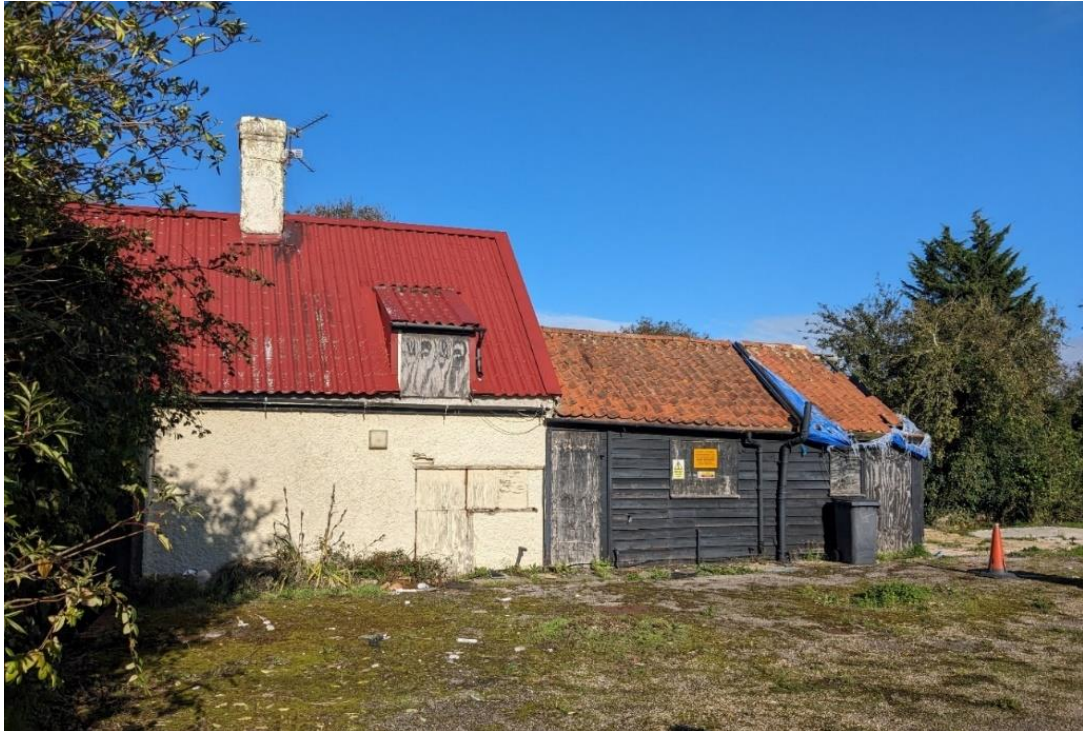
Description: Grade II House, now a public house. C17 or earlier, N wing C19 and extended to rear in early C20. Timber frame roughcast with steep pitched roof now of black corrugated iron. A 3-unit, central chimney plan house of one and a half storeys facing S. Central chimney roughcast, a third from E end. 2 lean-to dormer windows at eaves with small-paned wooden 2-light flush casements. Plank door and 2-light casement linked under a dripboard to E part. Lower single-storey long weatherboarded outbuilding with red pantile roof extends to E. W end to road has 2-light casement window in gable over pilastered window and door surround on left. Roughcast N wing has old red tile roof and gable chimney. Half glazed panelled door with casement windows, one with gothic pointed heads to top lights.

- General internal and external renovation
- Assessment of damp / rot throughout
- Assessment of structural integrity
- Assessment of roof and rainwater goods condition
- Repair / replacement of doors and windows
- New roof materials to be considered to replace corrugated iron

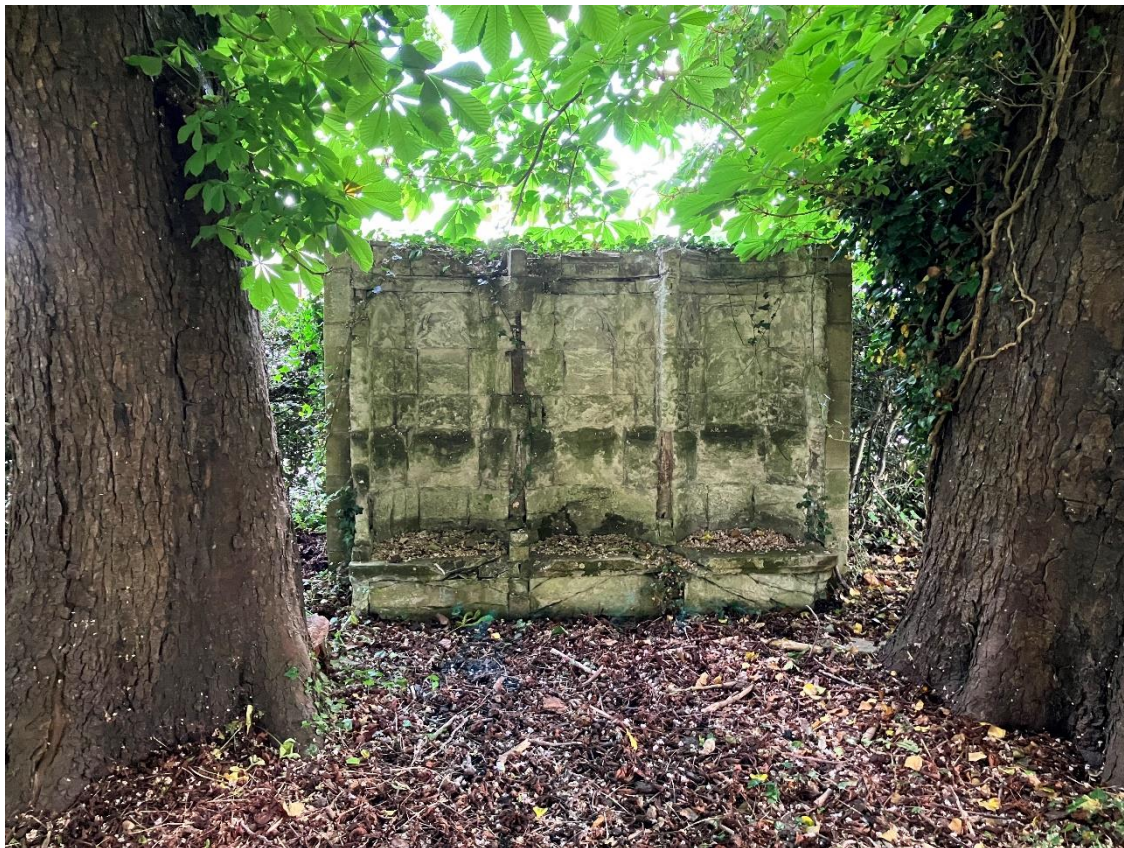
Description: Grade II. Sedilia (seats for clergy). C14th. Decorated Gothic style, triple stall, with stone seats, and three recessed bays, subdivided with attached colonnettes. Canted backs panelled with trefoil arches in blind tracery, roll moulded cornice. Badly eroded. Removed from church during restoration and rebuilding in 1891. Loss of historic C14th fabric of great concern.

Latest update: Condition has deteriorated since last inspection in 2021. Cracks worsening and further degradation of joints. Environmental conditions need to be addressed to prevent further deterioration.

- Removal of foliage growing over and around the structure
- General restoration to consolidate
- Repair to stone and joints
- Long-term protection from erosion (possibly return to within the church or construct a shelter)

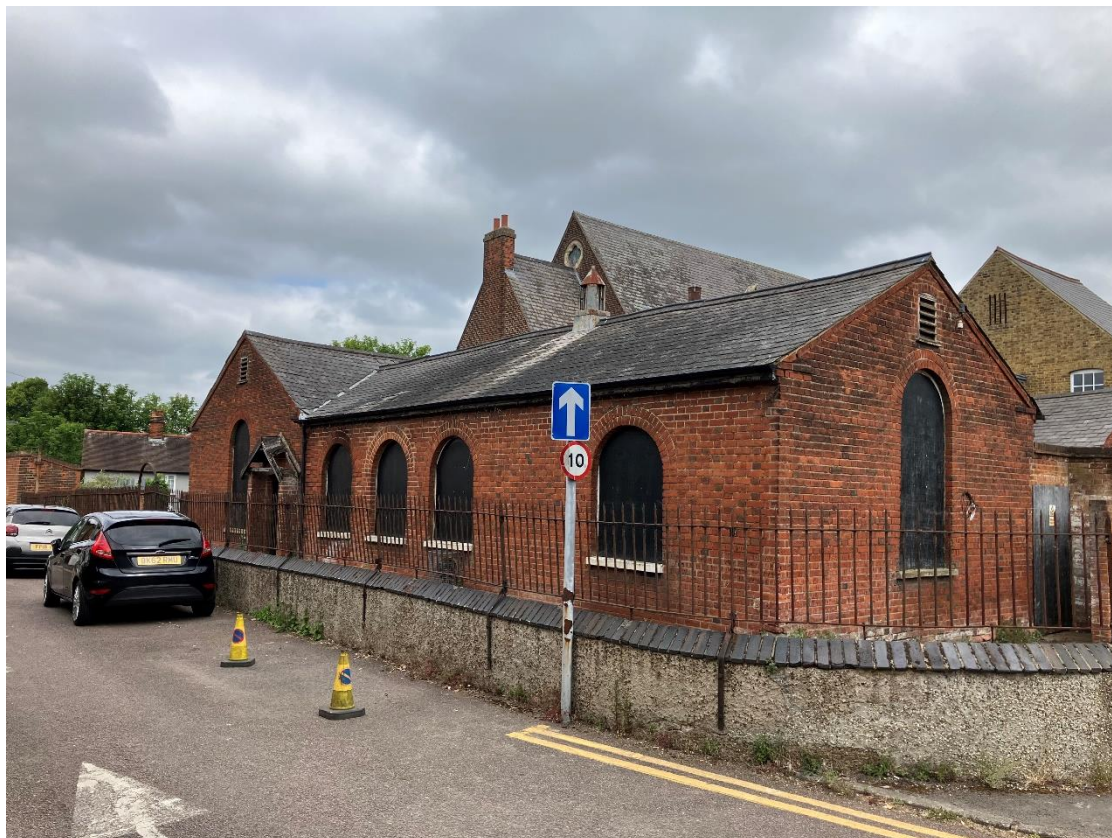
Description: Curtilage listed School buildings. Built in 1862/3 with United Reform Church (formerly Congregational Church). Architects and builders probably as for church, T Smith & Son and Henry Norris, Hertford. Stands at the rear of and is attached to the church. Three ranges in U-plan. Red gauged brick in Flemish bond. Gabled slate roof. Arch-headed windows to W and S elevations, segmental-headed windows to N range. Hooded doorway to S elevation. Three metal ventilators to roof of S, N and W ranges. Three chimneys, stepped brickwork to tops. Surrounded by low wall with railings, gate to W.

- Contact Hertfordshire County Council
- General renovation to be usable, or make watertight
- Assessment of damp / rot throughout
- Repair / replace roof covering and guttering
- Repair / replace windows and doors

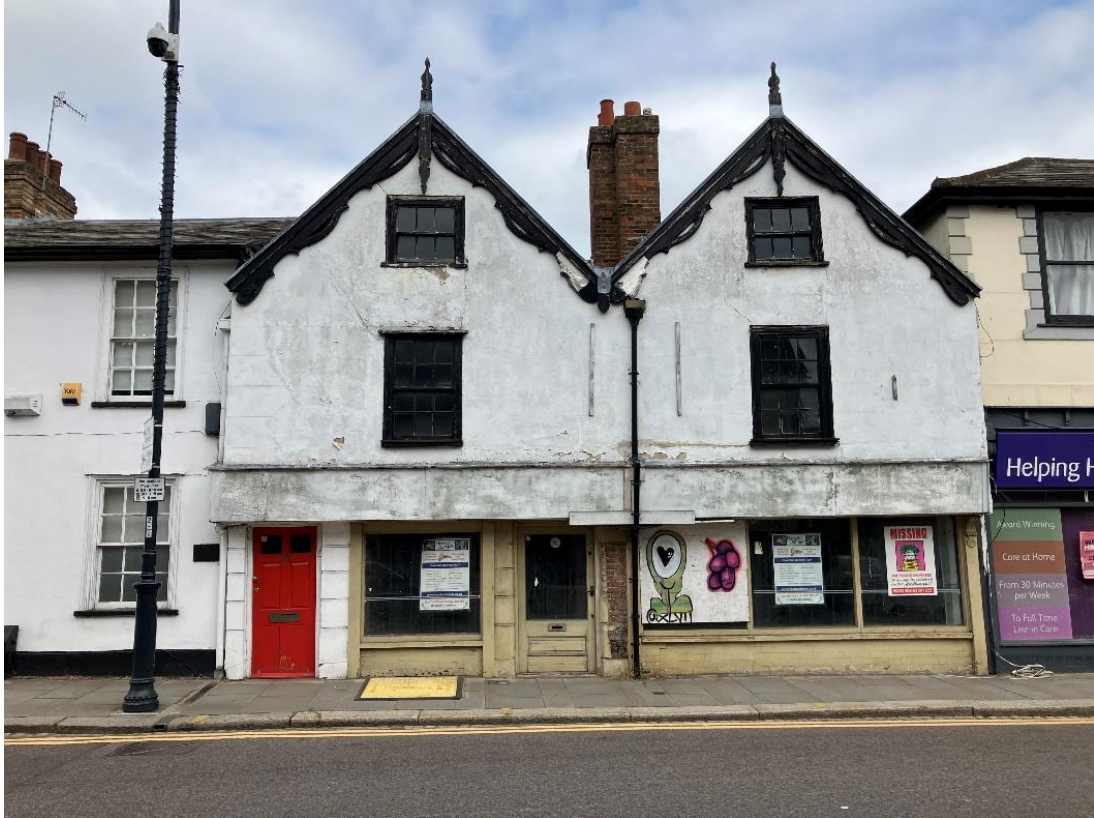
Description: Grade II House, now shops and offices, early C17th, altered C19th and extended C20th. Timber-framed and stuccoed, double gabled old tiled roofs, with early C19th Gothick moulded and traceried barge boards and cut pinnacle finials and pendants, facing street, Welsh slated, C19th raised infill between gables at rear. Red brick chimneystack of 2 back-to-back shafts with oversailing band and orange clay pots centre right. Double-depth plan with 2 bay jettied front.

- Assessment of general condition throughout
- General renovation to be habitable
- Repairs to roof and rainwater goods
- Repairs or replacement of shopfront

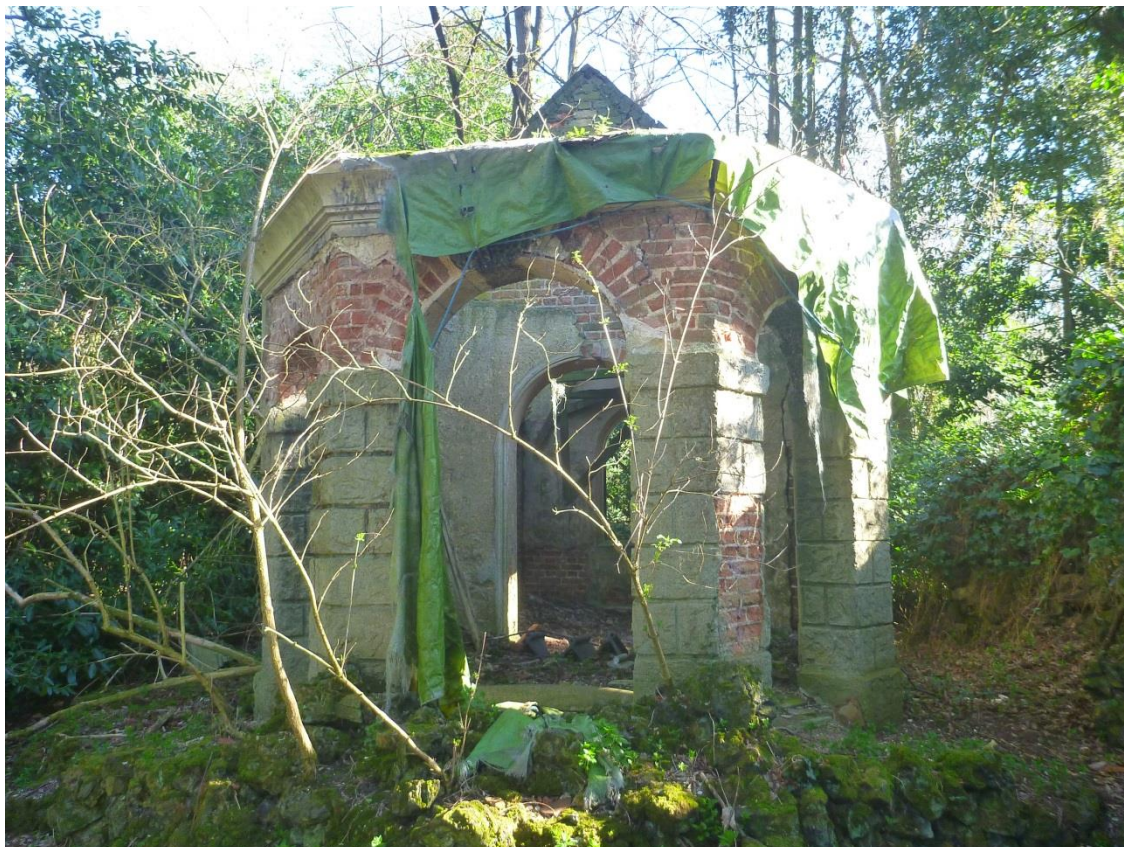
Description: Grade II. Hermitage with grotto gardens dating from C17th. Various structures. Now in ruinous condition (and as described at time of listing). Remote location in woodland setting removed from house.

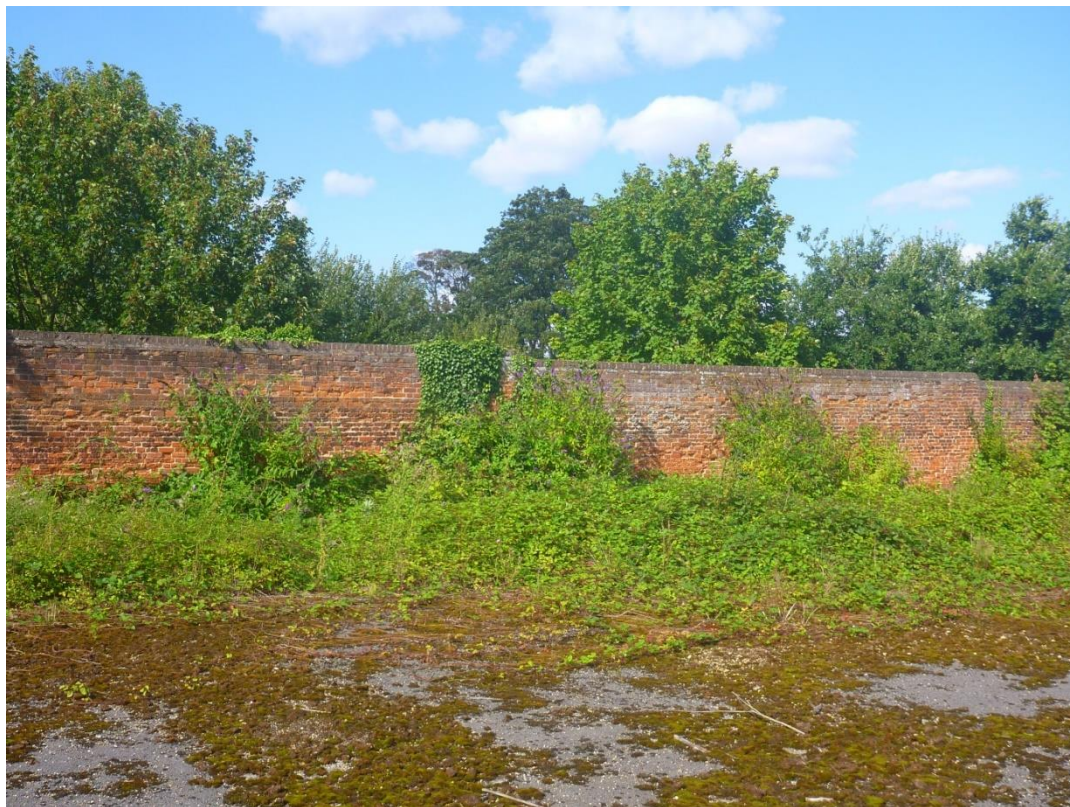
Description: Grade II. Two walled gardens. Former Kitchen Garden Walls for Balls Park. Early C18, with C19 and C20 alterations and repairs. Red brick laid to Flemish bond, with Portland stone copings and finials to piers. Lean-to glasshouse to east section of north wall in north garden.

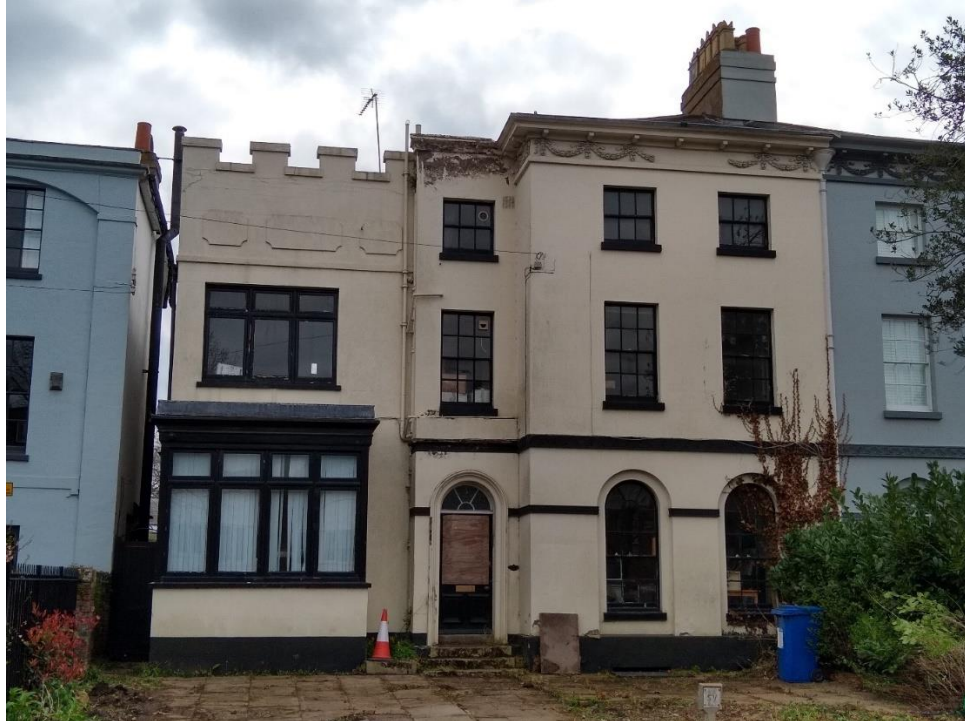
Description: Grade II. One of a pair of semi-detached houses. c1825, with C20th alterations and extensions. Stuccoed front below hipped Welsh slated roofs above moulded cornice, with widely spaced modillions and central stuccoed multi-flue chimneystack. 3 storeys, 4-bay front, with recessed single bay 3-storey wings, with later 2-storey extensions left and right with castellated parapets. Second floor has 4 recessed 6-pane sash windows, with band and swag frieze above; first floor has 4 recessed 12-pane sash windows above band with honeysuckle ornament. Ground floor has 4 recessed 15-pane sash windows, with semi-circular heads, set within outer arched recess with projecting impost band, stucco plinth. Entrance doors below semi-circular fanlights. Later wings, early C20, have projecting bay windows on ground floor. This development of semi-detached housing was part of the growth of Hertford along North Road towards the County Hospital during the late 1820s. It was shown as 'North Crescent' on an 1830 map.

- General renovation
- Assessment of rainwater goods and roof
- Assessment of damp / rot throughout
- Repair doors and windows

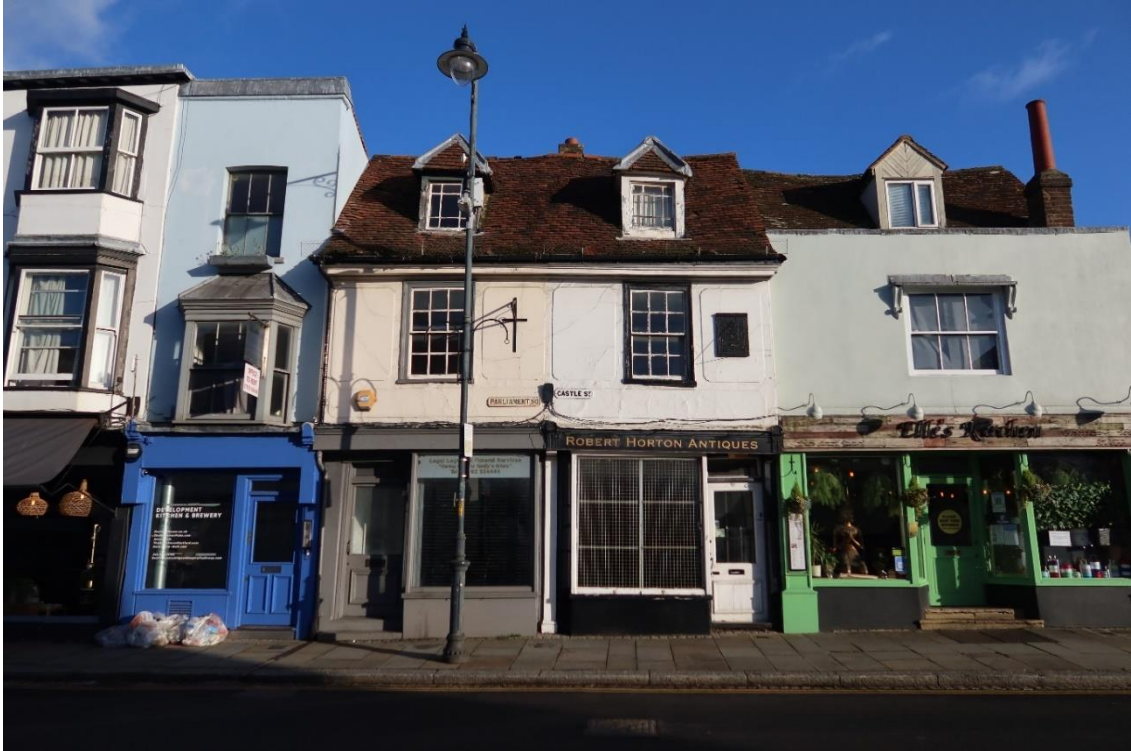
Description: Grade II. One building, formerly houses, now shops. C16th, substantially rebuilt early-C18th, extended and altered C19th. Timber-framed, plastered, old tiled roofs with moulded eaves cornice at front. First floor has 2 flush-set 12-pane sash windows with architrave surrounds, with plastered front divided into large, raised panels. Jettied first floor with C19 shopfronts on ground floor below, and fascias on bressummer. Timber framing exposed inside both shops; in No.13 Castle Street downward curved bracing indicates C16th origin of building, which incorporates a lower 2 bay outshut with a pegged rafter roof. No. 25 Parliament Square has a central chamfered beam with tongue stop above ground floor, steep winder stair alongside fireplace and party wall, wide boarded cambered first floor, corner fireplace.

Latest update: New addition. A temporary roof has been installed, and permission has been given to carry out full roof repairs, but not yet carried out.

- General renovation including to timber-frame.
- Repairs to roof and gutters.
- Repairs to windows.

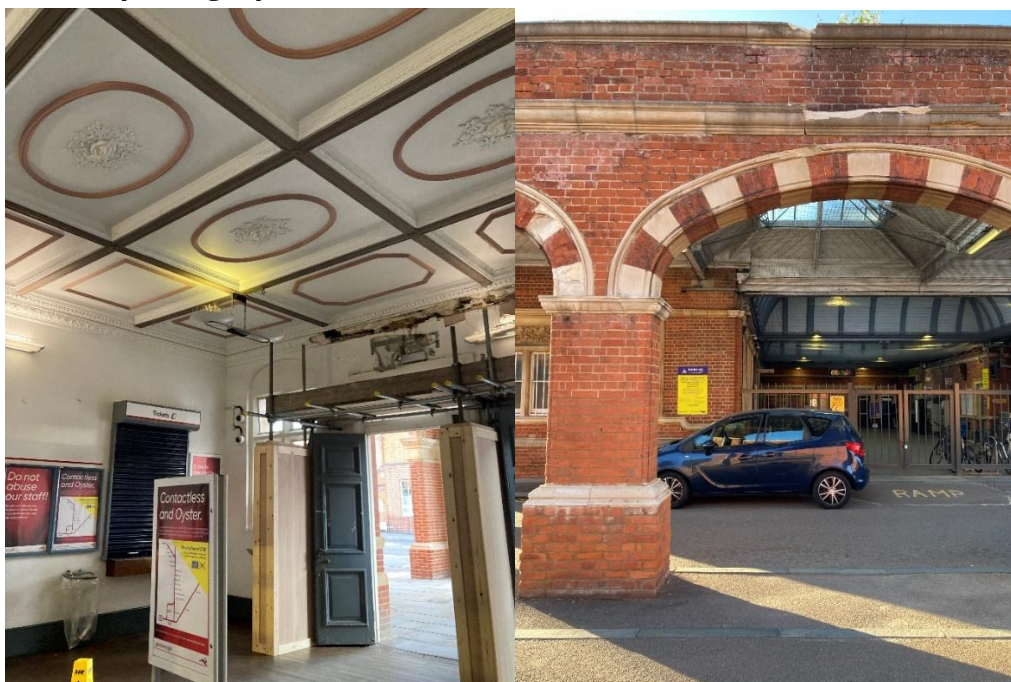
Description: Grade II Railway station with terminal booking hall, concourse, porte cochère, platform canopies and screen walls. 1888, with C20 alterations. Built for the Great Eastern Railway. Architect WN Ashbee (d.1919).

Latest update: New addition. Schedule of repair works being drawn up by the railway company.

- Addressing water ingress to booking hall roof/ceiling.
- Addressing vegetation at roof level.
- Check general condition of stonework and brickwork and repair where necessary.

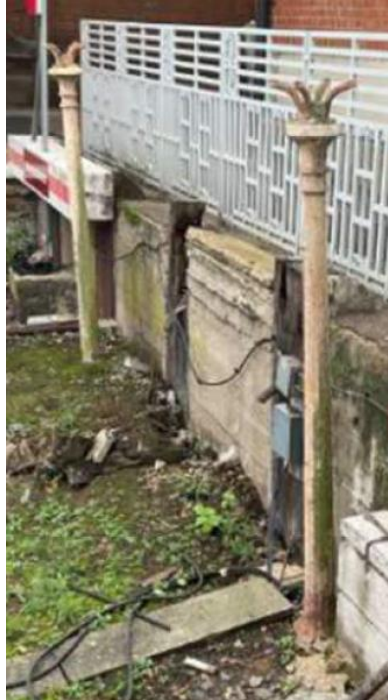
Description: Grade II 2 columns, supporting lamps at terminal end of station platform. c1843. Cast-iron fluted columns with bell caps. Reset 1888 having been brought from the earlier station, built 1843 by the Eastern Counties Railway, further east along Railway Street, and demolished 1964 after use as goods station.

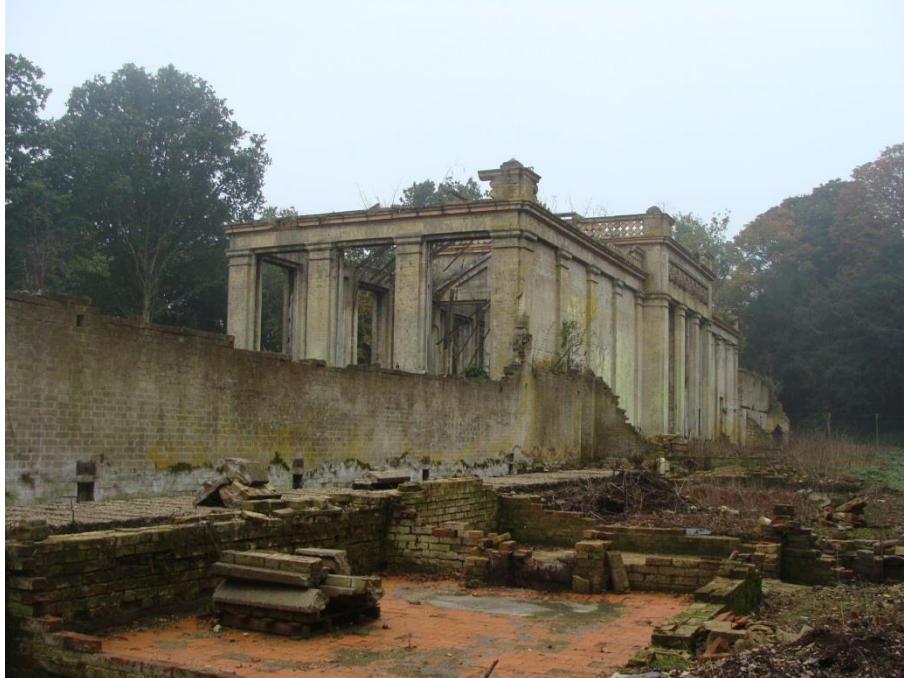
Description: Grade II. Mid-C19th former Orangery and Conservatory to Panshanger House for the 7th Earl Cowper in classical style with rich distinctive detailing. Formal gardens once lay south of Orangery leading on to landscaped grounds and Mimram valley laid out by H. Repton, 1799-1801. Panshanger House demolished mid-C20th; footprint still exists adjacent to the Orangery.

Works required: A clear vision for the future of this unique building is needed. It should be returned to its original use, or to a use that complements the form of the building. A potential candidate for consideration of an associated enabling development, possibly involving the replacement of Panshanger House. Further strategic discussions needed that work with the Country Park use of the wider site and respect the significance of the designed landscape.
