EAST HERTS COUNCIL HERITAGE AT RISK REGISTER

Updated October 2025

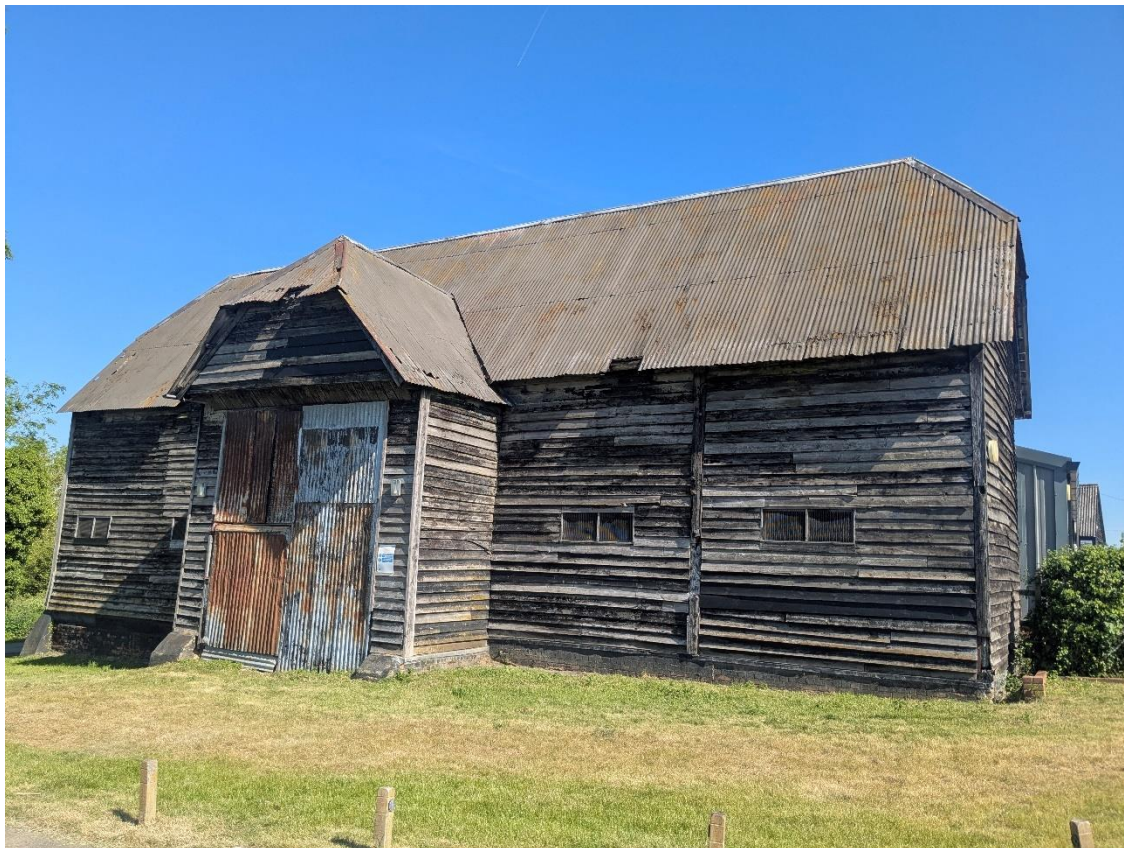
Description: Grade II. Barn. C17th. Timber framed on a brick sill, weather-boarded. Steep pitched corrugated roof, half-hipped at ends. Projecting central porch with half-hipped roof and overhanging gable. Double doorway to porch currently without doors. Clapsed purlin roof structure with collars and inclined queen struts. Long curved braces from posts to tie beams.

- General renovation
- Assessment of damp / rot throughout
- Assessment to condition of timber frame
- Repair / replace weatherboarding and roof covering
- Repair / replace doors

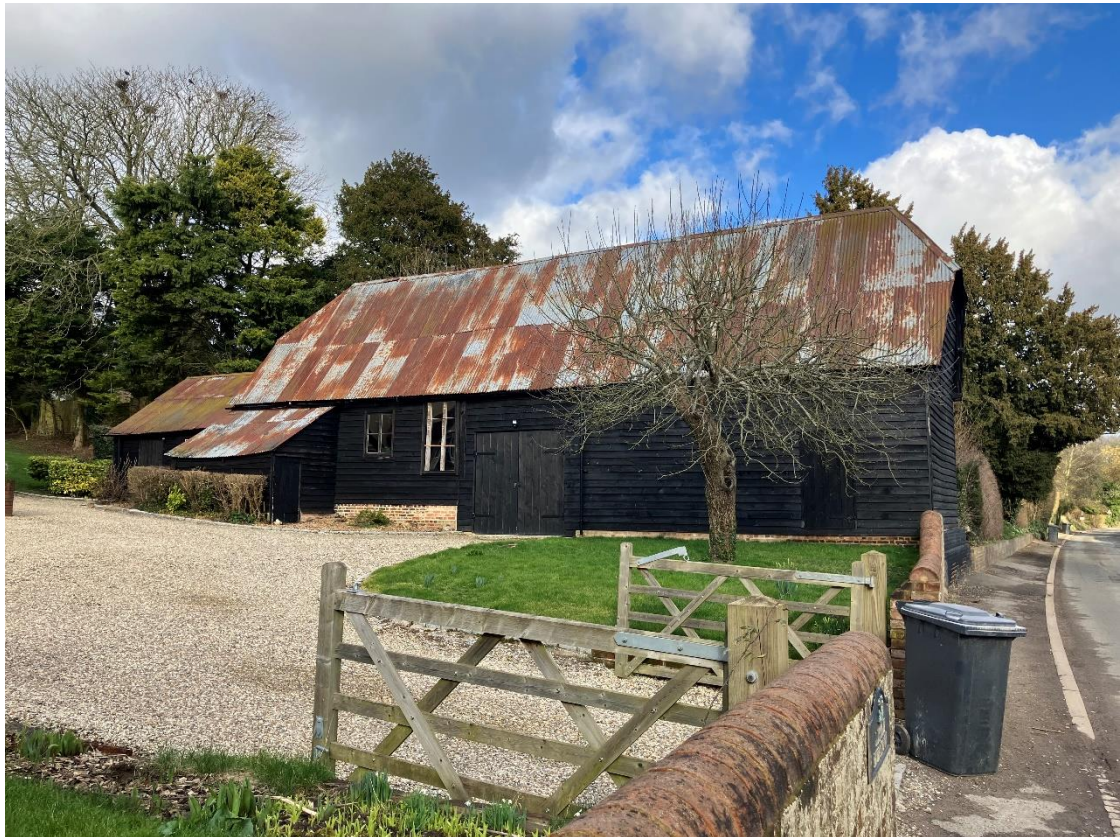
Description: Grade II. Barn. C17th. 5-bay. Timber frame on tarred offset brick plinth. Part externally weather-boarded, part corrugated iron walls. Steep half-hipped corrugated iron roof. Central bay rear outshot opposite the central double doors. Jowled posts, long curved braces to tie-beams, clasped purlin roof with thin rafters. Mid height rail staggered with straight tension braces above and below. Face-halved bladed scarf joint in wall plates. Owned by Little Meadow.

Latest update: 3/19/0854/LBC granted that does not appear to have been implemented however the lean-to on the southwest elevation has been removed and weatherboarding and doors reinstated on the southwest elevation. The overall condition has improved.

- General renovation
- Assessment of damp / rot to timber frame and roof structure
- Repair / replace weatherboarding including some reinstatement
- Replace roof covering

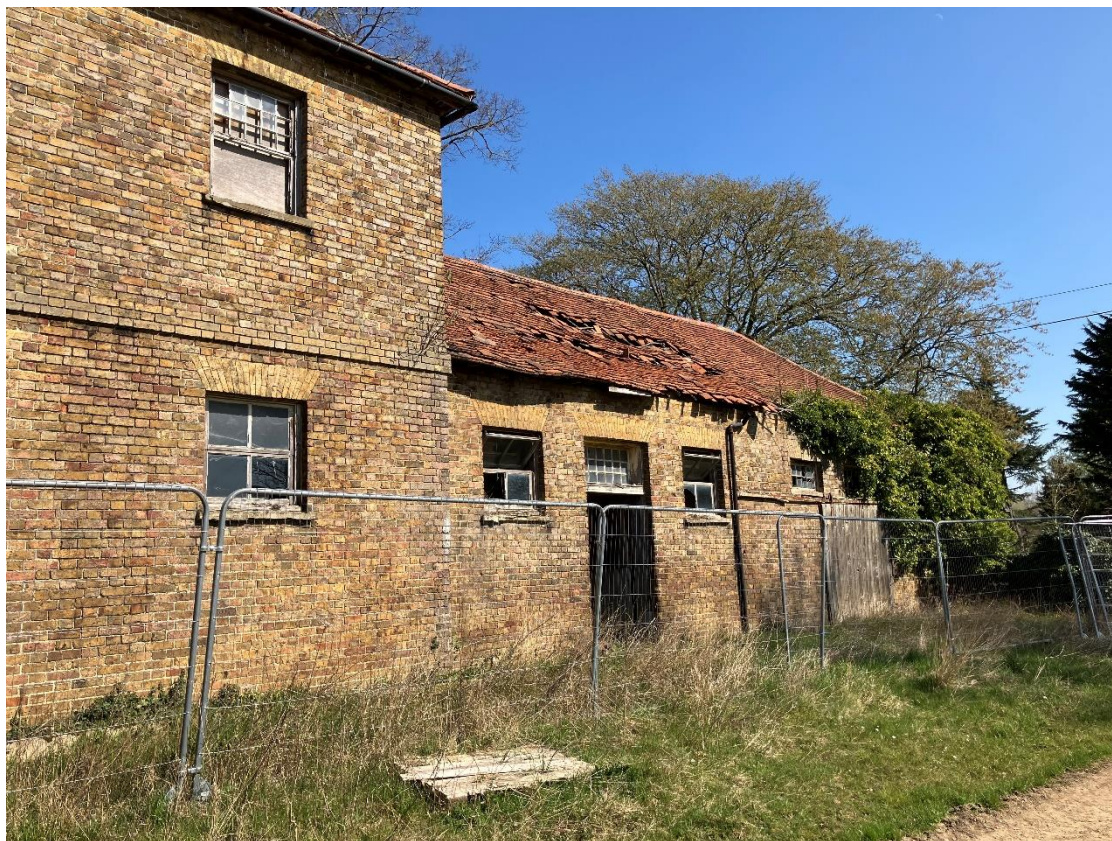
Description: Grade II. Stables attached to separately listed central granary and further stables. Early C19th. Brick stable range with hipped red tile roof. Four boarded stable doors with multi-light fanlights under a yellow brick gauged arch. Flanked by small high-set windows, each under a yellow brick gauged arch.

Latest update: Further deterioration of roof covering, windows, and sills.

- General renovation, or to be made watertight
- Assessment of damp / rot to roof structure
- Repair / replace roof covering
- Repair / replace doors and windows

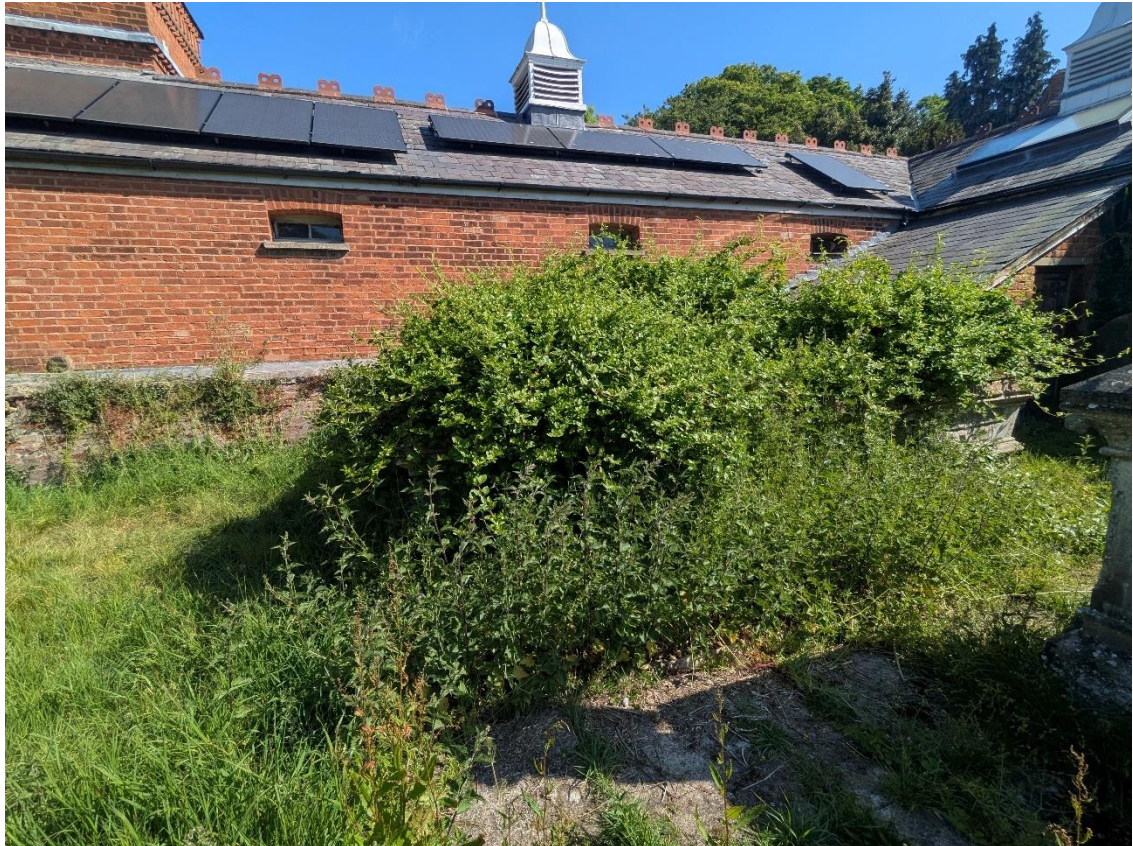
Description: Grade II. Monument. 1881. White limestone, hard plaster mouldings to surrounding wall. Rectangular Gothic tomb chest within a stone walled enclosure. Random squared rubble walls, freestone quoins, base topped by a heavy ogee base moulding. Row of five trefoil pierced stones in the middle of long side. Heavy series of plaster capping mouldings. Upper part with foliate recumbent cross carved in high relief. Lombardic lettered inscription to Walter family. Significant vegetative growth needs to be removed.

- Contact Hunsdon Parish Council and the Rector of St Dunstan's Church
- Assess stability and damage by tree stump
- General restoration
- Complete removal of vegetation from the monument
- Long term maintenance to be agreed

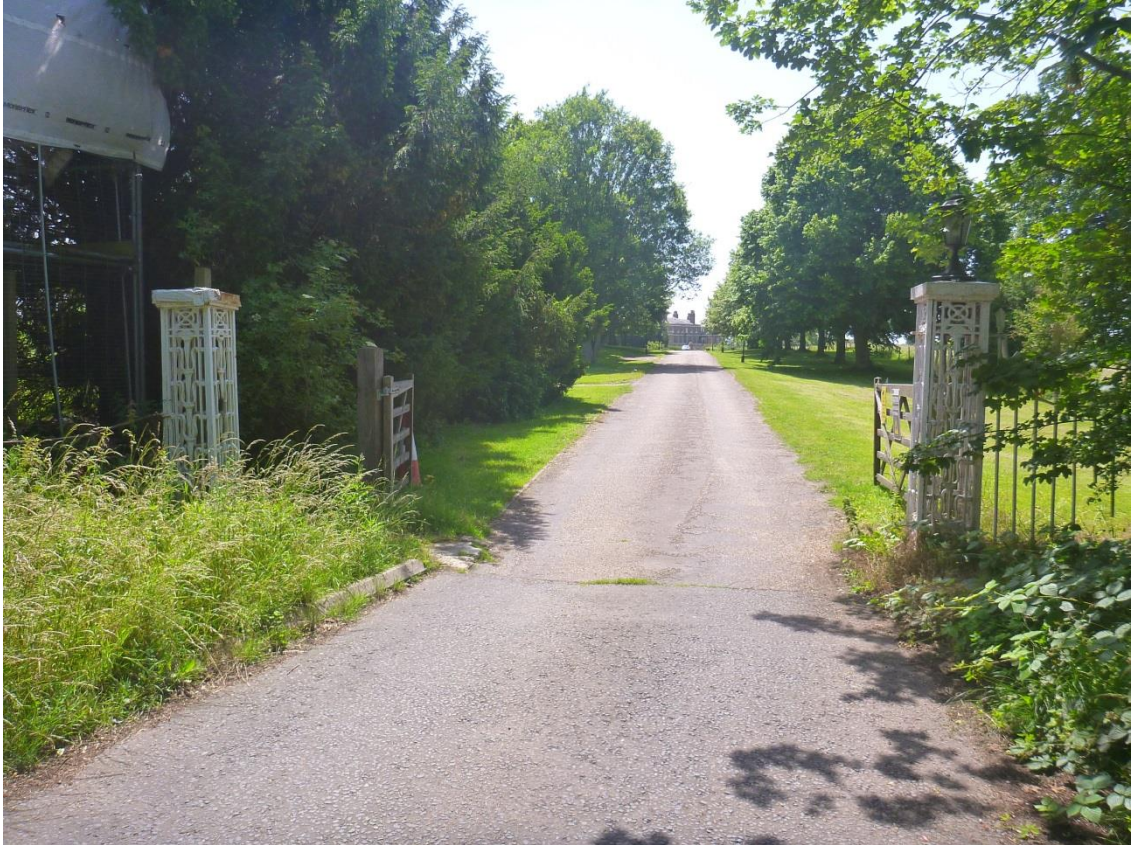
Description: Grade II. Gates and gate piers. Early C19th. Neo-classical cast iron gates and piers at entrance to North Drive at Briggens. Tall openwork cast iron piers in the form of tapered square pylons on ball feet, a saltire with superimposed oval at top and bottom, and a stylized anthemion ornament up each face within a margin of rosettes, all topped by deep flat square caps. Similar side railings sweep down to lower terminal piers of cast iron of similar design to the higher piers. Gates have been removed.

- General repairs to surviving piers and side railings
- Repair and reinstatement or replacement of gates and pier
- Replacement of missing railings

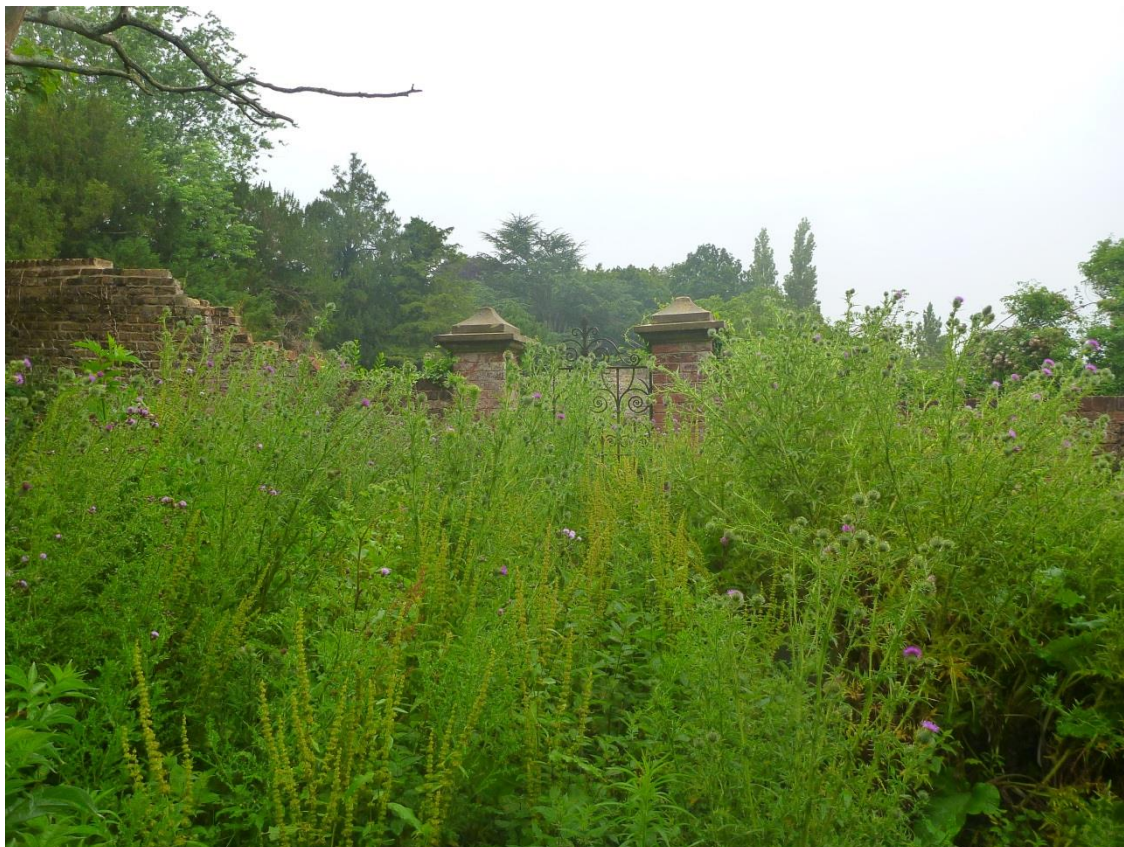
Description: Grade II. Kitchen garden walls, sundial, and 2 gates, dating from C18th. Probably part of the extensive works at Briggens c1770 by the Blackmore family. Gates probably for H C Gibbs c1908. An historic C18 walled garden.

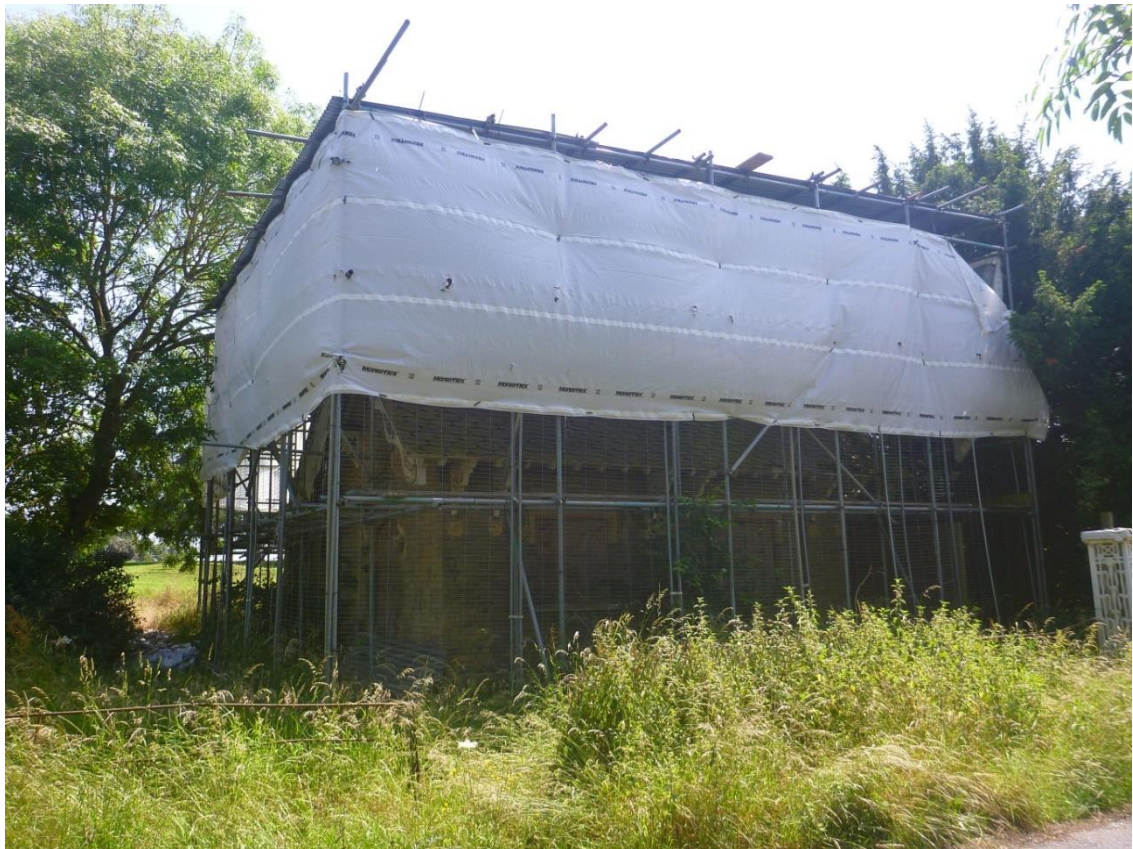
Description: Grade II. Lodge. Mid-C19th. Single storey grey brick Tudor style gate house at the entrance to the North Drive. Low pitched gabled roofs of large patent scalloped buff tiles. Stone coat of arms over the door with motto 'Pro Ars et Focis' and a serpentine, pierced wooden bargeboard with finial to the roof overhang. Tall brick central chimney with 2 square shafts. Similar details on lower gabled wing set back to E. (Note: For other lodges at Briggens see Stanstead Abbots parish).

Latest update: No change to condition, but the building has been secured and a temporary roof protection installed.

- General renovation to be habitable
- Assessment of damp / rot throughout and condition roof structure
- Longer term repairs to roof and guttering
- Repair or replace windows and doors

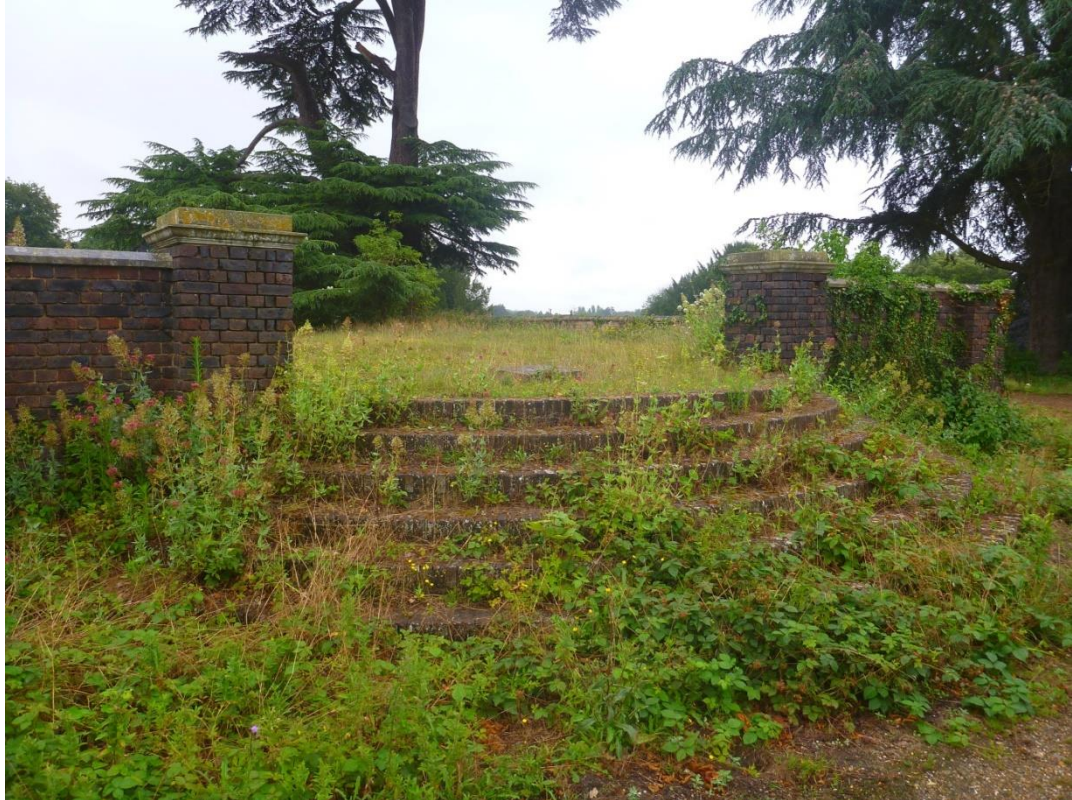
Description: Grade II. Terrace walls and steps. Circa 1908 for H C Gibbs. Plum brick with recessed joints in walls, deeply chamfered stone copings, stone and moulded stucco seat, York stone paving. Formal lower terrace to S of house, 80 metres long with seat in recess at W end at upper level. 2 flights of 7 semi-circular brick steps project southward, 1 near each end, flanked by low square brick piers with stone capping set in the long brick retaining wall with similar capping. Seat modelled in Florentine style with circular central achievement in the back with motto 'Tenax roposite'. An impressive architectural feature, essential to the setting of the house.

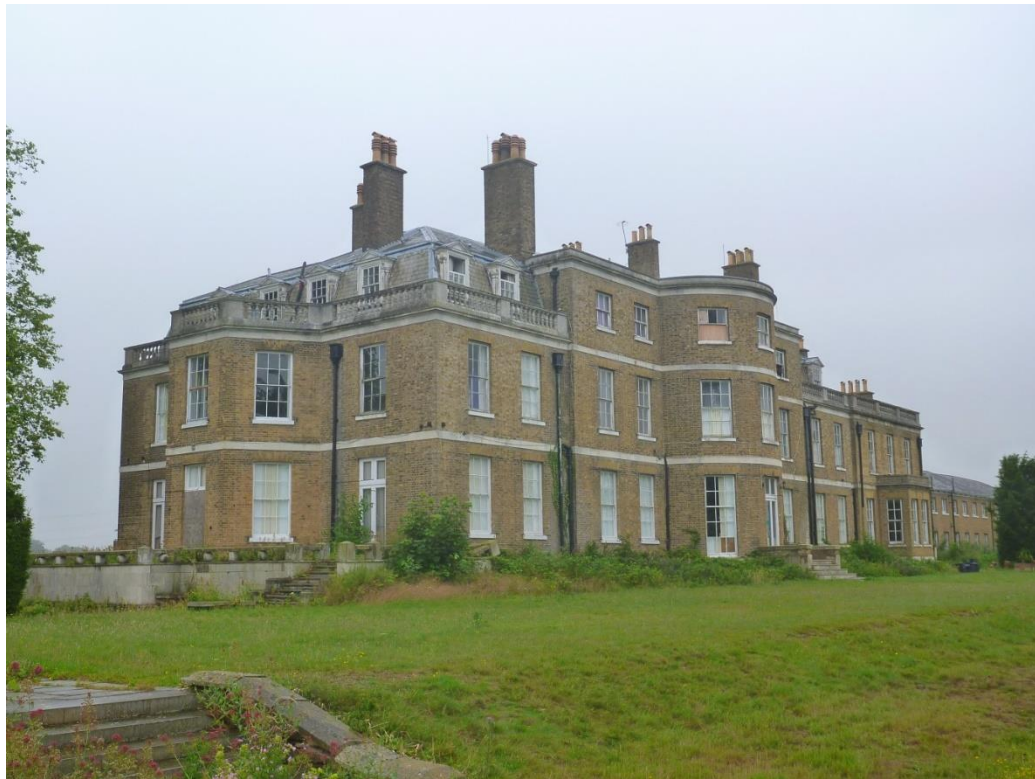
Description: Grade II. Country House. Circa 1719 by the mason Christopher Cass (1678-1734) for Robert Chester, a director of South Sea Company: 2-bay N and S blocks and 2nd floor added for Thomas Blackmore probably c1770. N end and W side extensions in 1899: alterations 1908. On hilltop site facing W in a landscaped park designed by Charles Bridgeman in c.1720. Grey brick with stone dressings, hipped slate roof, Portland stone upper terrace on S end overlooking a tank of York stone. 3 storeys above basement, 7 windows front. Balustrade of low square piers with stone rails between supported on stone balls.

Latest update: No change to overall condition, but the house has been secured, and some localised temporary works to address water ingress have been carried out.

- General renovation to be habitable
- Assessment of damp / rot throughout
- Assessment to condition roof structure
- Repairs to roof and guttering
- Repair / replace windows and doors

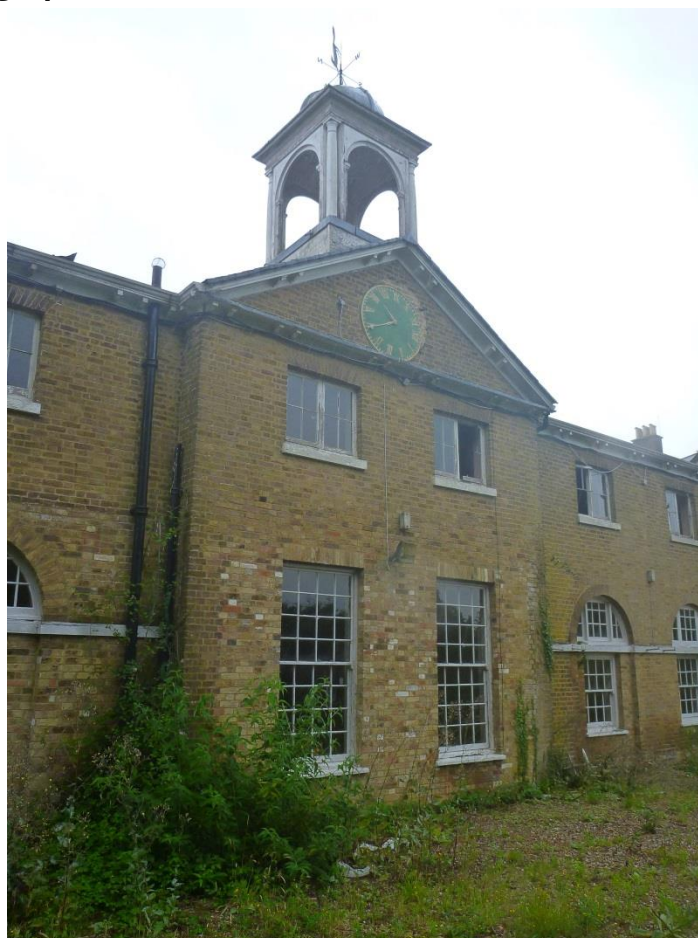
Description: Grade II. Stable block. C18, probably 1770 for the Blackmore family. 2 storeys. Wooden cornice with paired brackets. Rectangular block with 2-window central projection on W with triangular pediment and clockface in tympanum. White wooden square cupola over, topped by low dome and windvane with a fox. Round-headed openings in each face, dentilled cornice and Tuscan columns recessed at each corner. Bell said to be cracked. Recessed sash windows with glazing bars. Front arches now blocked and large sash windows inserted.

- General renovation to be habitable
- Assessment of damp / rot throughout
- Assessment to condition roof structure
- Repairs to roof and guttering
- Repair / replace windows and doors

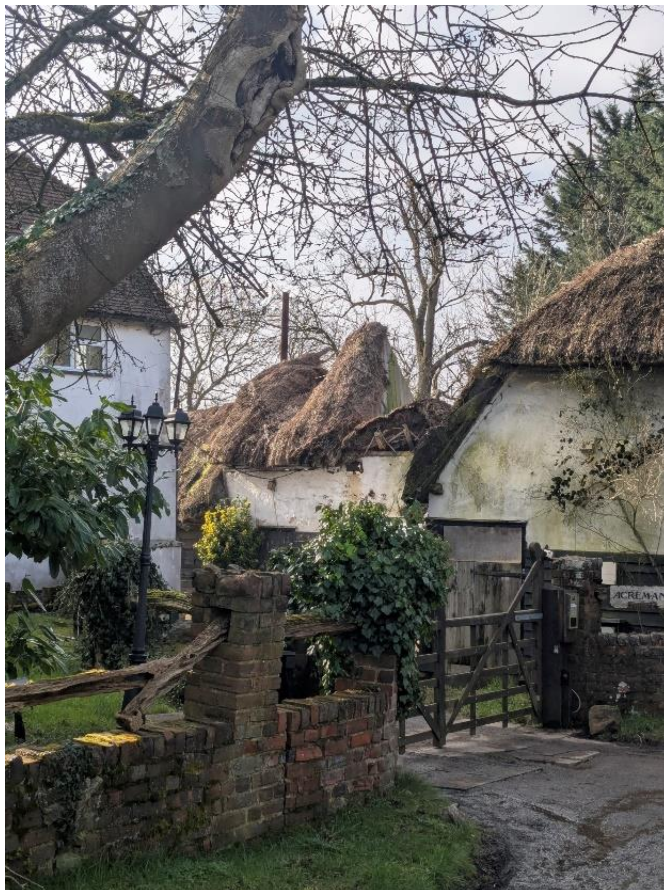
Description: Grade II. Farm buildings. Later C17th. L-shaped range, thatched, timber framed, on roadside. T-plan barn with longer part N-S and projection on W. Lower stables extend to E along roadside and at S end. Red brick bases in English bond, plastered walls with weather-boarded aprons to all. Barn has ventilation holes under eaves, closed by battens. Wind-vane with stork. Steep thatched roofs half-hipped at ends. All doors open to yard on SE.

Latest update: Rapidly deteriorating, at risk of total loss. A vehicle strike in 2021 has caused extensive damage to the range on the roadside. Building has partially collapsed. Other range also in disrepair and roof has collapsed.

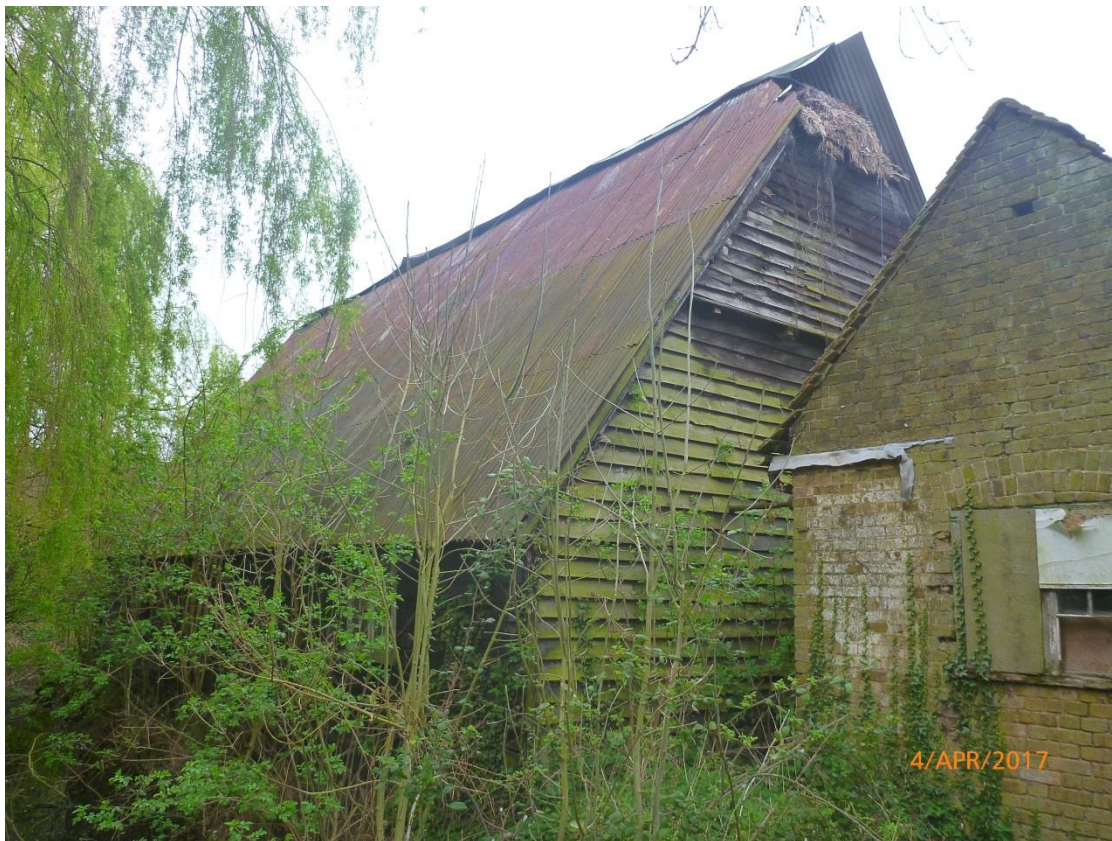
Description: Grade II. Aisled barn. C17th or earlier. 4-bay. Timber framed on a red brick sill, external weatherboarding. Steep gabled roof thatched with red tiled valleys to thatched gabled porch in second bay from E. Rear slope now covered in corrugated iron. Shouldered jowled posts, curved braces to tie beams and arcade plates. Thin clasped purlin roof with curved wind braces and lap jointed collars. Arcade plate scarfed over entrance with face halved and bladed scarf. Wall plates have edge-halved scarf joints with bridled butts. Owned by The Old Farmhouse.

- General renovation
- Assessment of damp / rot to timber frame and roof structure
- Repair / replace weatherboarding
- Repair / replace thatched roof
- Repair / replace doors and windows

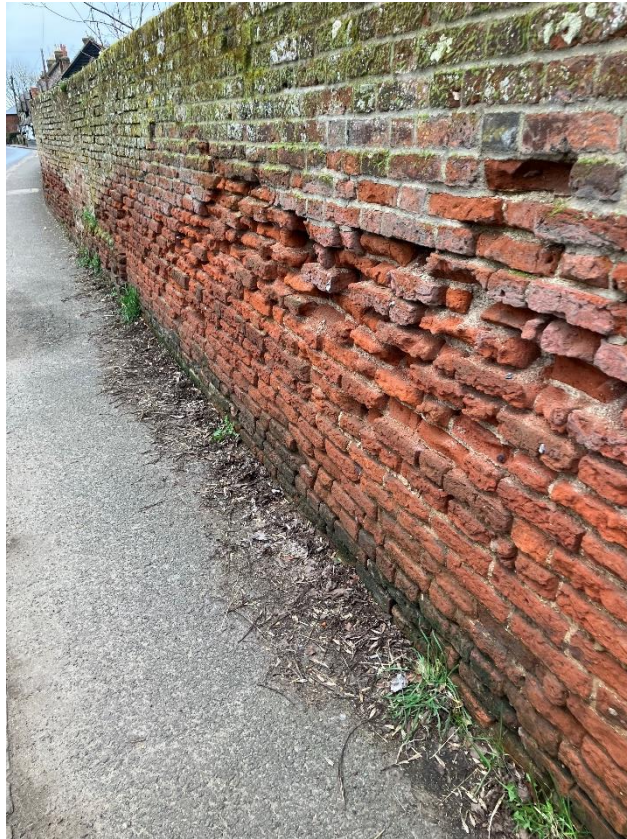
Description: Grade II. Wall. C18th or earlier red brick wall, top rebuilt in C19th. C18th to early-C19th single storey, brewhouse adjoining N end of wall, facing E. Red brick W, N and E walls of brewhouse. Steep red tiled gabled roof. Long red brick wall fronting street. Old irregularly bonded brickwork with chamfered plinth offset stepping up at piers for wide and narrow gateways beside house. Now blocked and small gateway next to S pier of larger opening. Owned by Ford House.

Latest update: No change. Repairs discussed with owner in March 2024, but not yet carried out.

- Repairs to wall / assess if need to rebuild in sections

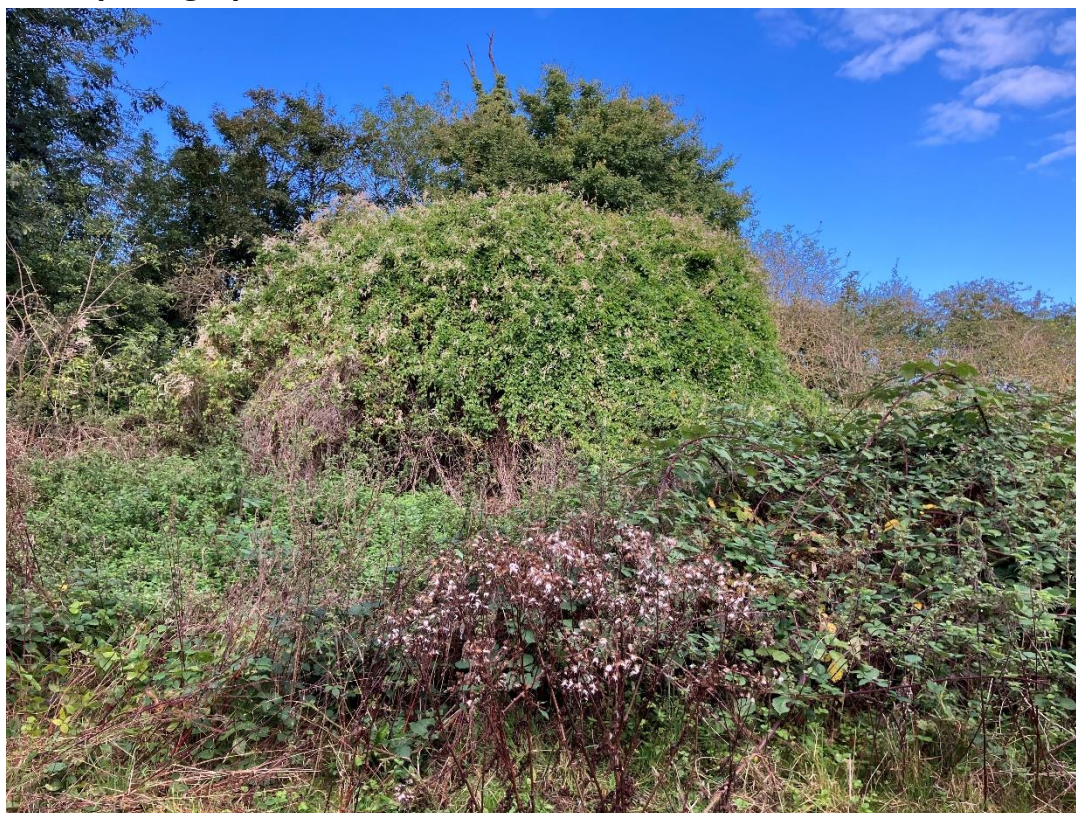
Description: Grade II Windmill tower. Upper part destroyed by fire in 1981. Mid-C18th. Formerly a tall 2 storeys red brick octagonal tower. In use up to 1930s. Used to represent a striking industrial monument of considerable historic and technological interest. Now only a stump remains.

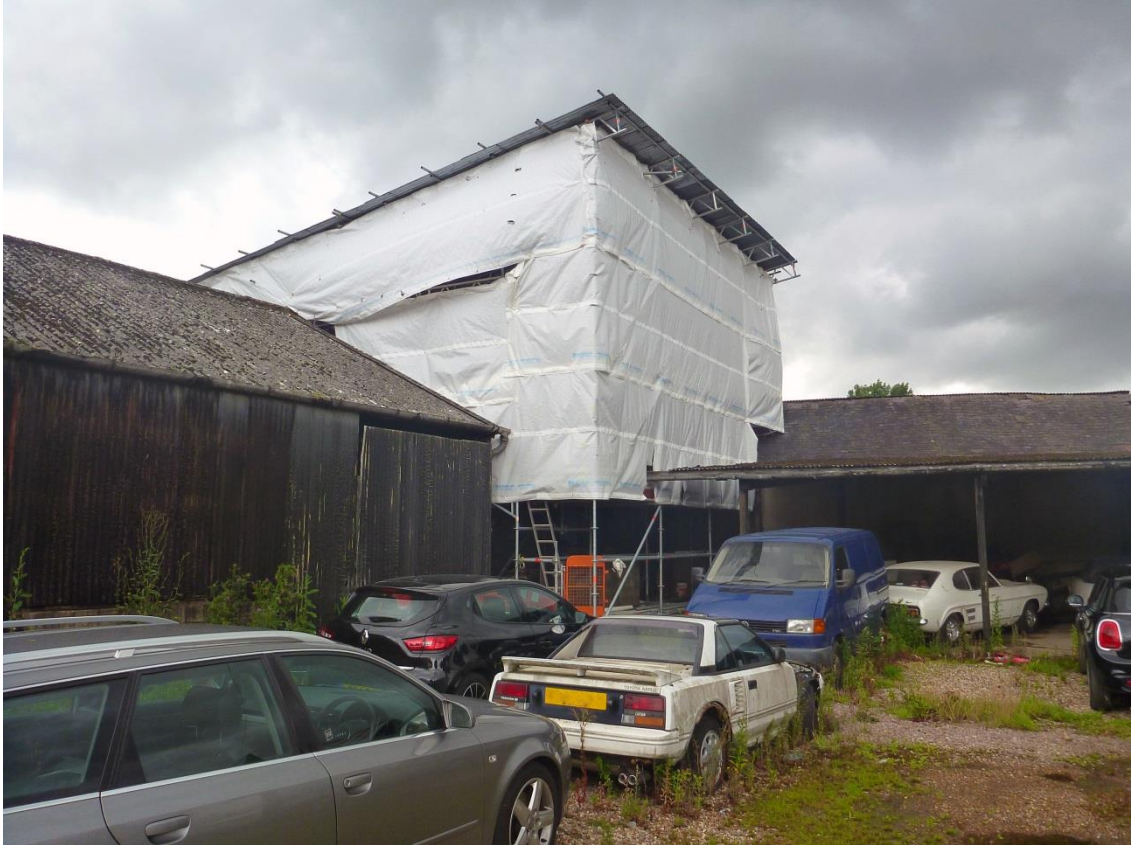
Description: Grade II Stable. C17th. Timber-frame stable with steep pitched roof. Part of a courtyard group. List description advises it is an “unusual survival”. Now in an advanced stage of deterioration but capable of restoration.

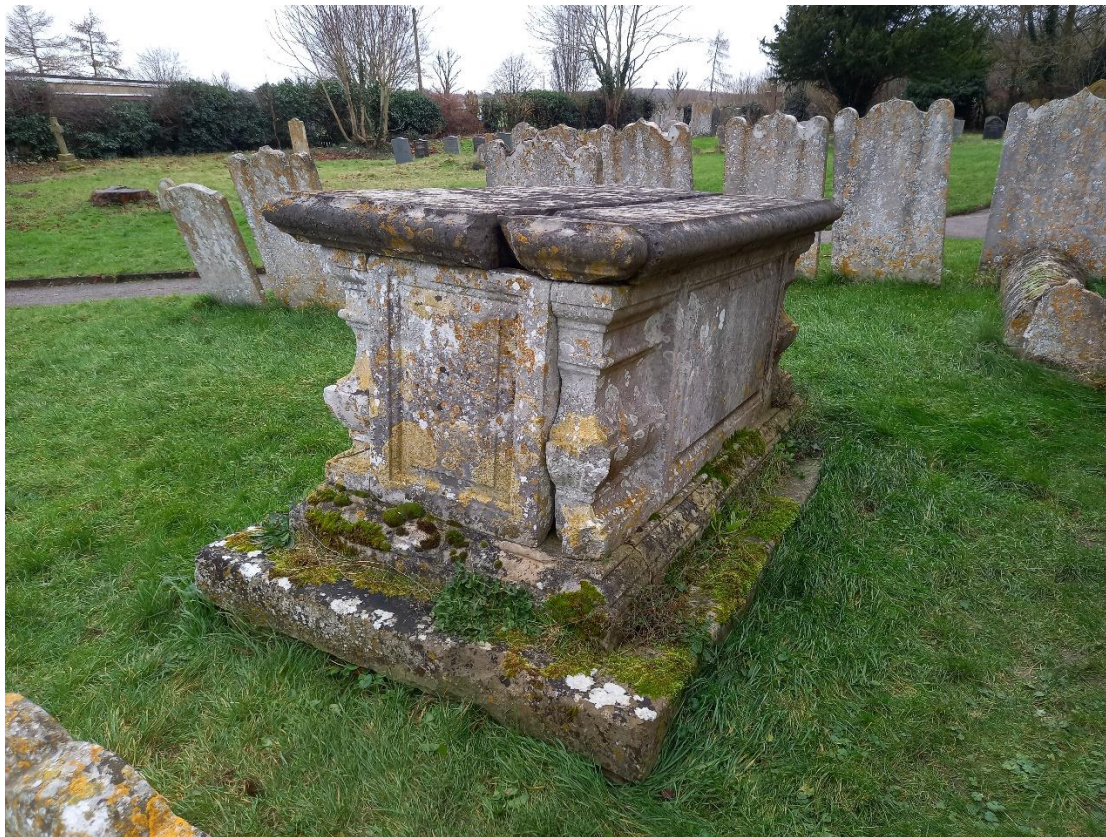
Description: Grade II. Chest-tomb. C18th. White limestone with grey stone top slab. Rectangular chest-tomb with a step, a moulded base, and moulded edges to the outstanding top slab. Rectangular fielded panel in the middle of both sides and end with recessed moulded and gadrooned corners.

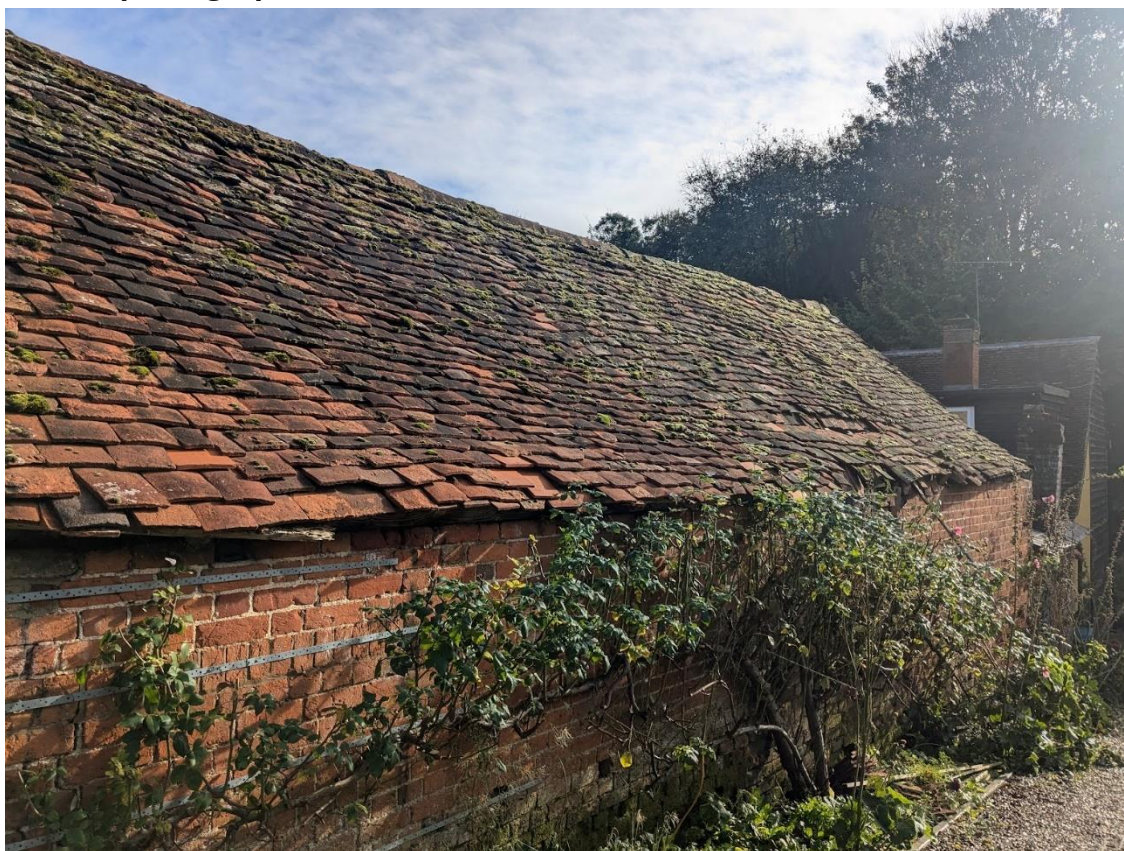
Description: Curtilage listed barn to the rear of main dwelling, running parallel. Red brick with clay tiles above. Evidence of prior uses including a brick chimney stack.

- Assessment of structural integrity of existing roof structure and overall structure.
- Reinstatement of tiles to replace temporary roof.

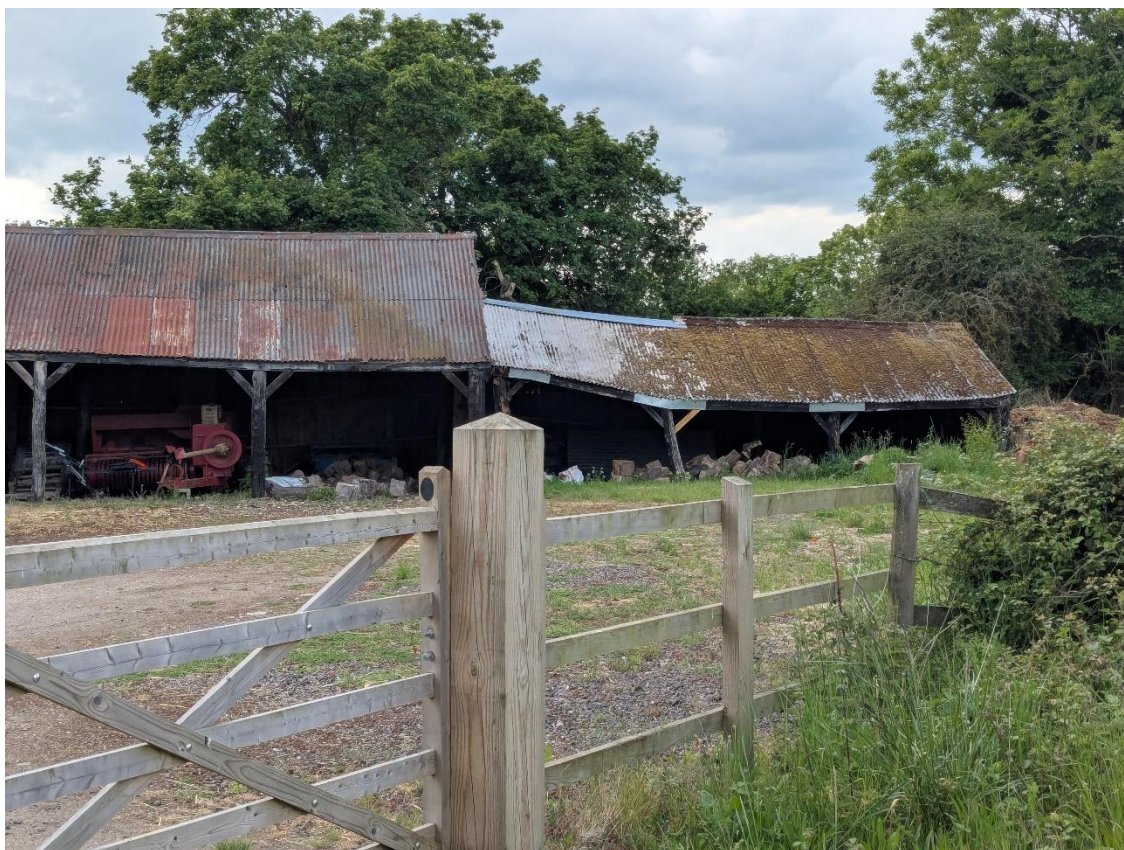
Description: Curtilage listed Farm buildings. C18th to C19th. Two 3-bay cart-sheds. Post and truss construction. Timber frame on a brick sill with external weatherboarding. Corrugated iron gable ended roofs. Open sided into farmyard.

Latest update: Condition is deteriorating.

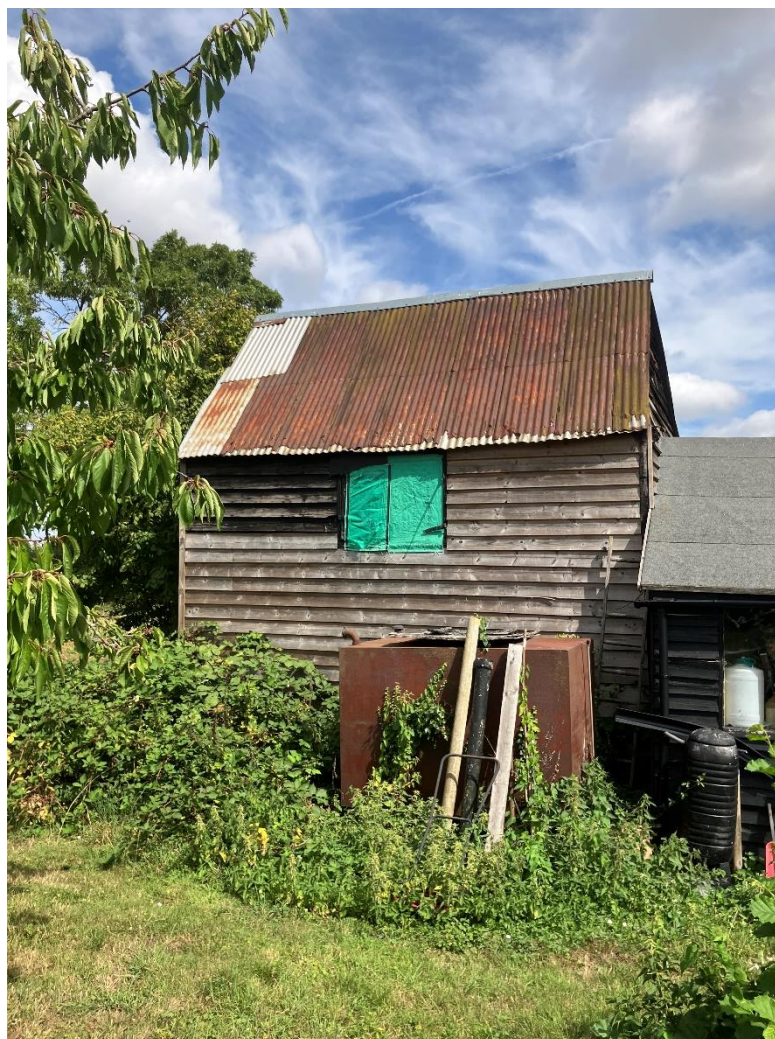
Description: Grade II. C16th Granary. Two-storey two-bay timber-frame building. Weather-boarded. Corrugated iron roof. Owned by Camwell Hall Farm.

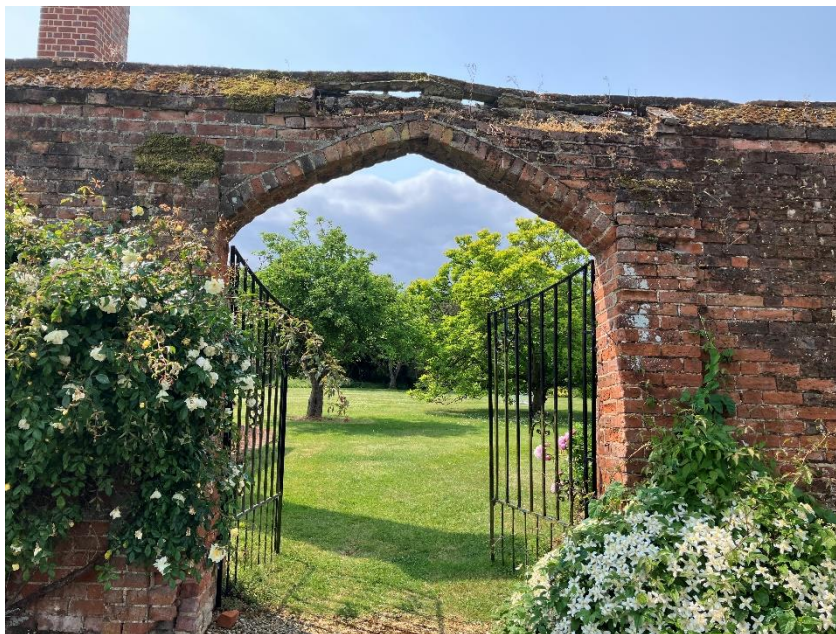
Description: Grade II. Former Kitchen Garden Wall to Moor Place. C18th in red brick, and approximately 3 metres high. Owned by Montagu House.

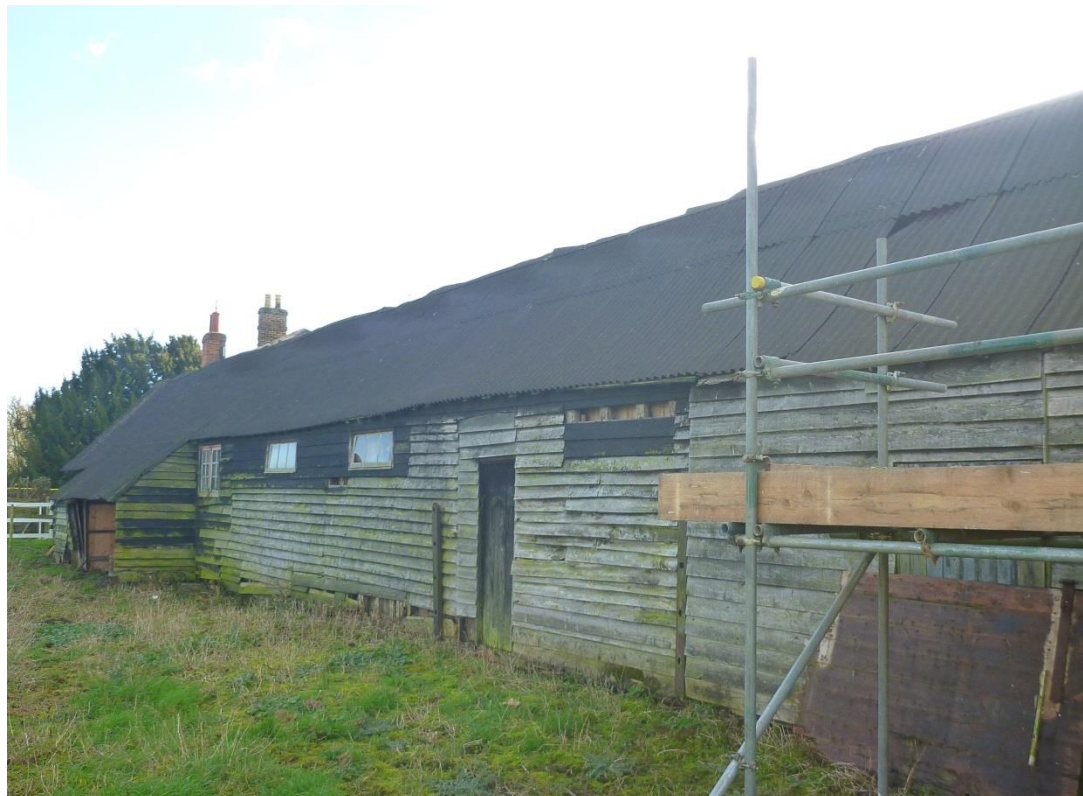
Description: Grade II C19th timber-framed and weather-boarded with corrugated iron roof. All elements in poor condition; roof appears to leak in places; some weatherboarding missing. Used for accommodation of 100 Shire horses in late-C19th when owner of this time had a Hackney carriage enterprise.

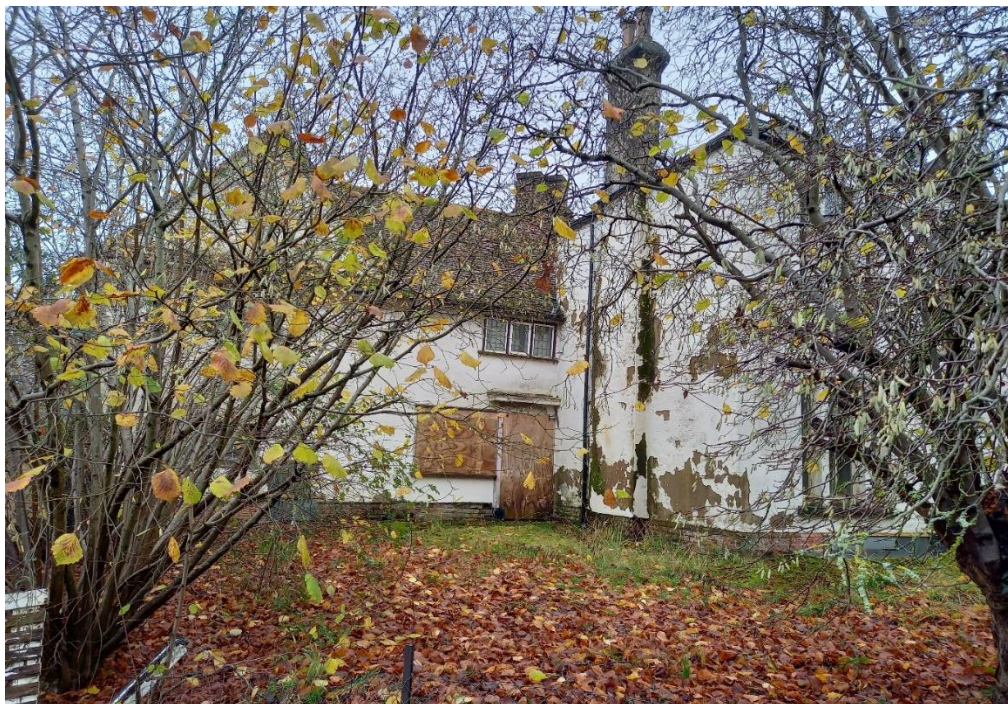
Description: Grade II. C17 or earlier, late C19 front wing. 2 storey timber frame plastered house under steep old tiled gabled roof. Front wing 2 storey brick rendered under hipped slate roof. Main range has low 1st floor windows suggesting that it is possibly C16 or earlier with C17 floor and chimney stack inserted in hall. A massive chimney with stumpy diagonal shafts rises through rear slope of roof near middle of range. 3 light wood mullioned windows with rectangular leaded panes and iron casement. Single storey C18 timber-framed gabled rear storage wing on S. Weatherboarded and pantiled. Some scalloped slating, metal ridges and square finial.

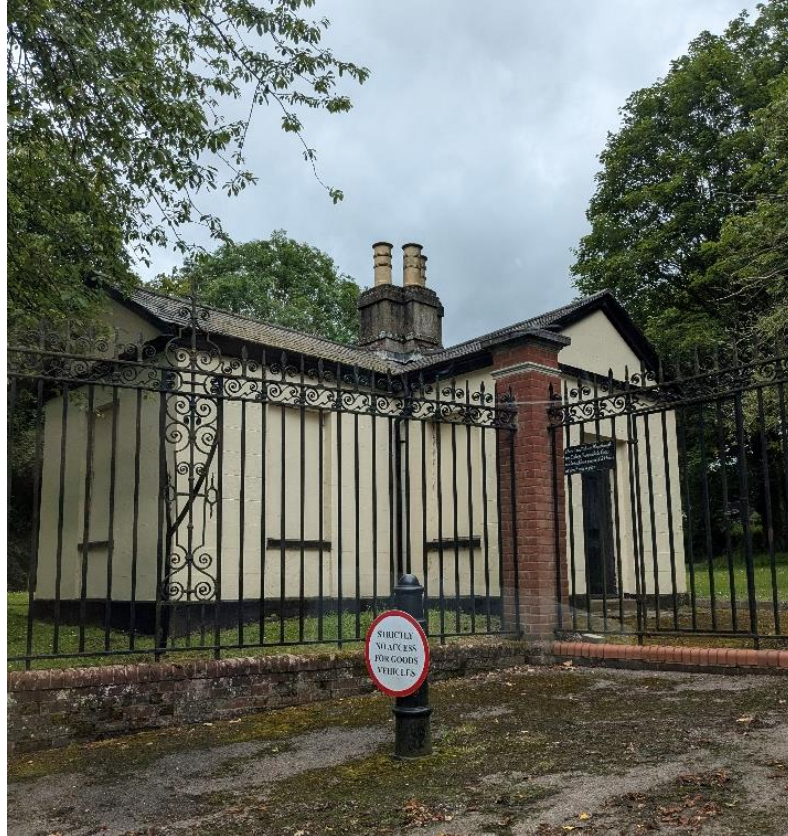
Description: Curtilage listed Gatehouse. C19th. Single storey. Classic style building at front entrance of St Edmund's College next to gate and gate piers. White painted render over yellow brick scored to look like ashlar. Black painted render base sill. Slate gable ended roof. Simple pediment to ends. Two rendered yellow brick chimney stacks with pots. Blind and open windows. 6-over-6 sash windows with stone/concrete sills. Door to north side. Owned by St Edmund's College.
