EAST HERTS COUNCIL HERITAGE AT RISK REGISTER

Updated October 2025

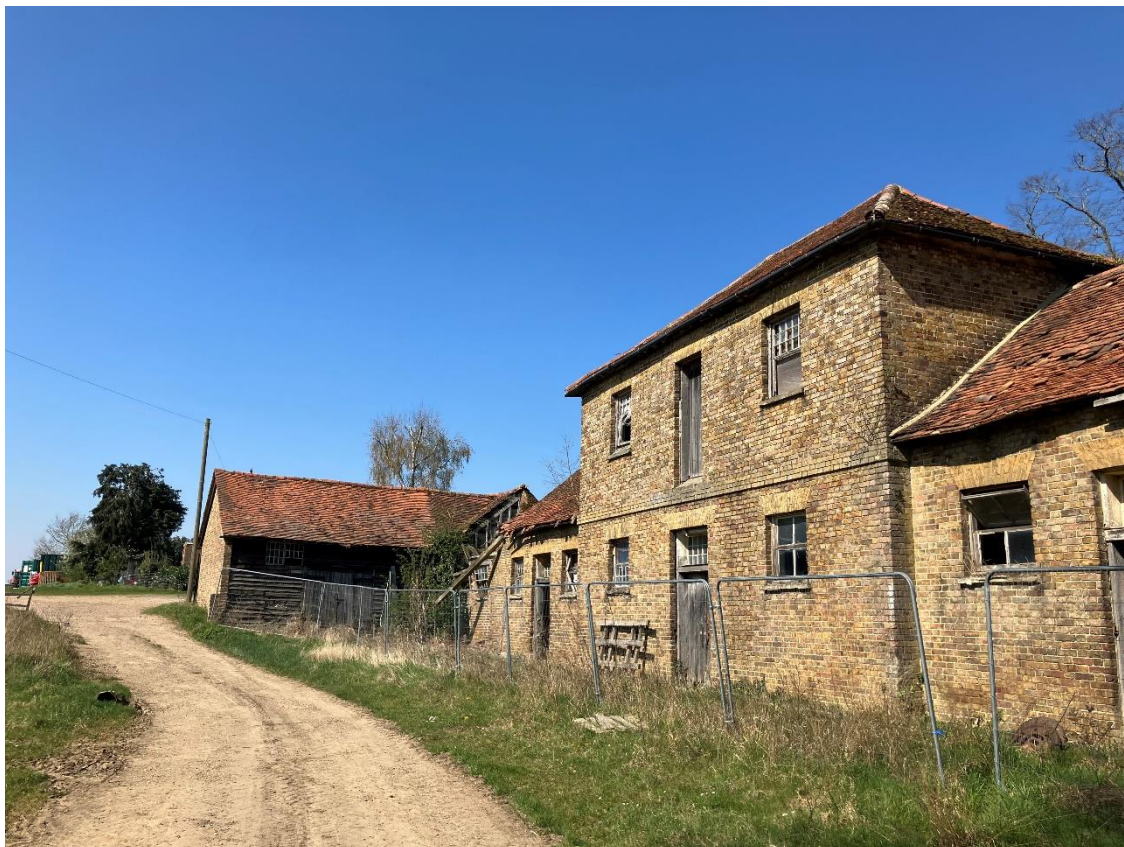
Description: Grade II. Central granary and stables attached to separately listed further stables. Early C19th. Brick stable range with hipped red tile roof. Four boarded stable doors with multi-light fanlights under a yellow brick gauged arch. Flanked by small high-set windows, each under a yellow brick gauged arch. Each window has a wooden frame with 10/10 or 2/2 panes. Granary with brick band at mid-height. Central doorway under a yellow brick gauged arch to ground and first floor. Each flanked by 2/2 window to ground floor and 15/10 window to first floor.

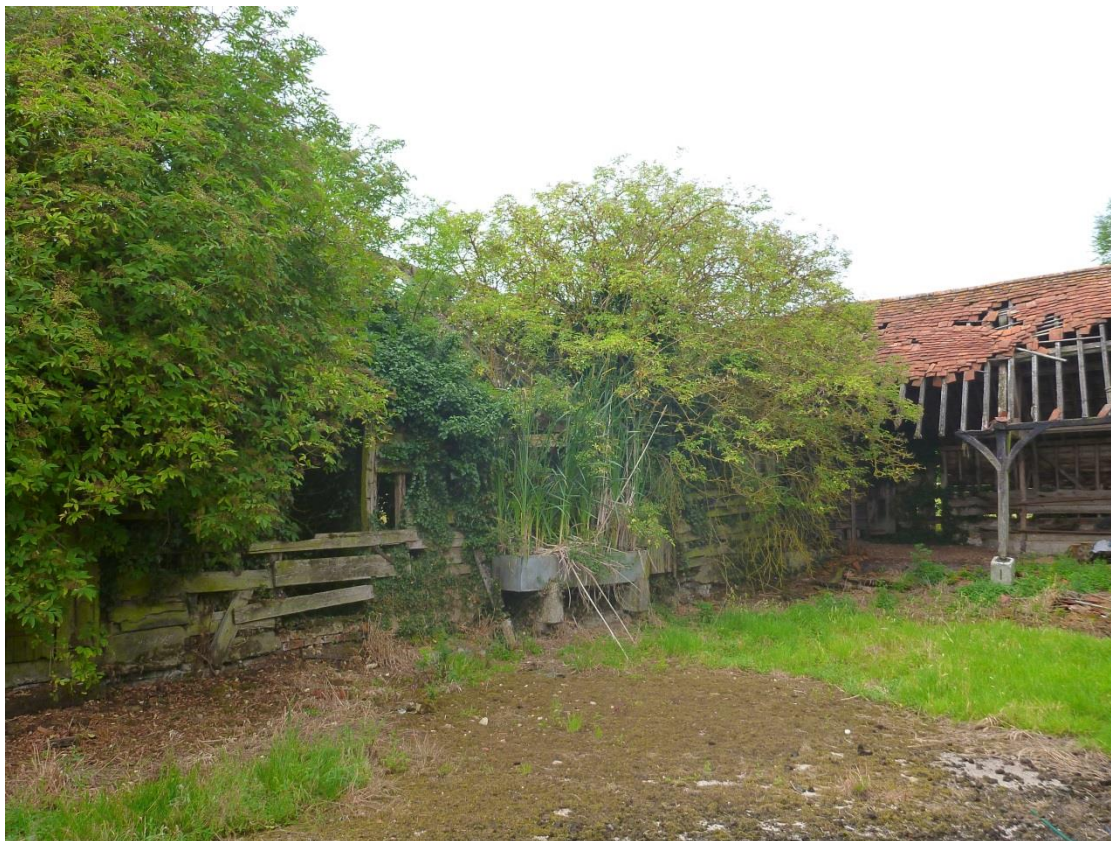
Description: Curtilage listed Stables. C19th. Timber framed on a brick sill, weather-boarded with steep hipped roof exposed. Attached to large barn to W. Series of stable doors to N. Brick boundary wall to E. Further building to S completing U-plan with barn.

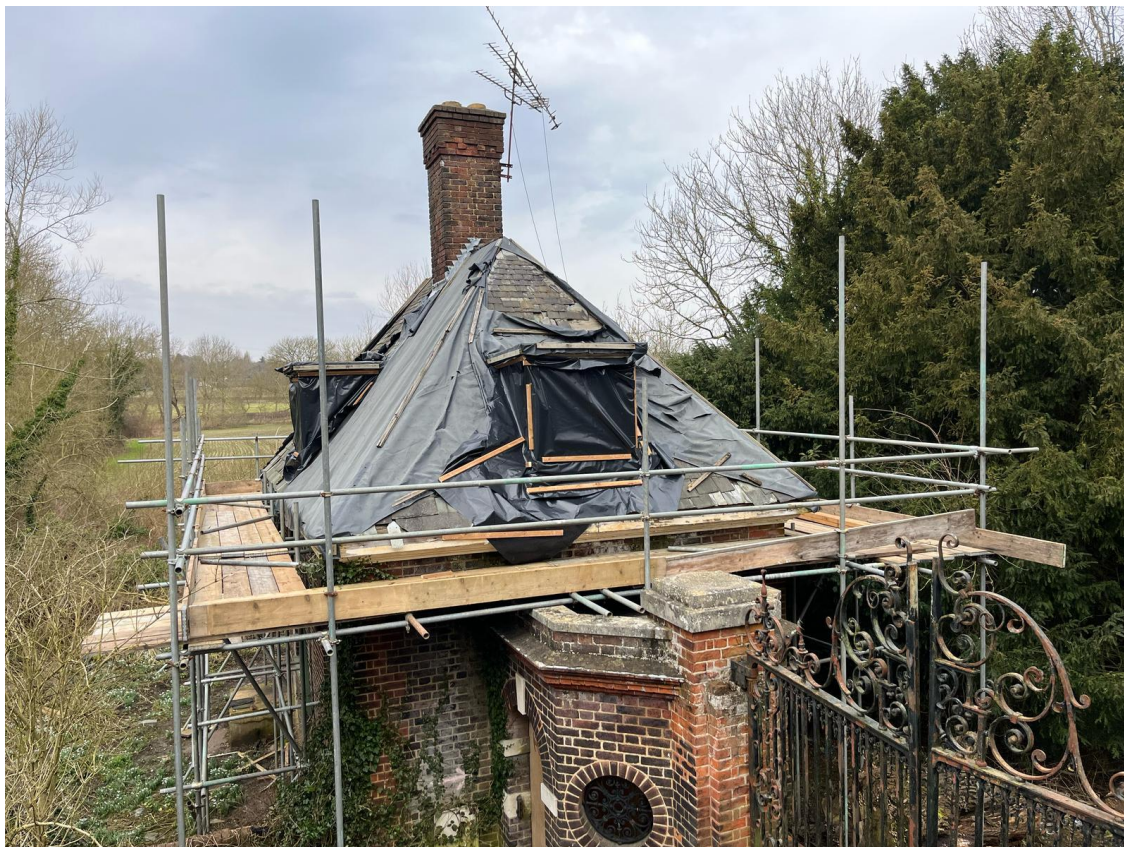
Description: Grade II. Pair of gate-lodges 'HCG 1914' on approach bridge parapet. Plum brick with red brick dressings, steep Coniston slate hipped roofs. Tall single-storey and attics. Square central chimney and flat-topped dormer with moulded cornice on each side. Two flush box sash windows with 6/6 panes, each set in a round arched panel with keystone. Moulded wooden eaves cornice. Matching brick extensions at rear of each lodge. Parapeted flat roofed open porch links each lodge to a gate pier with wrought iron gates. (Note: For another lodge at Briggens see Hunsdon parish).

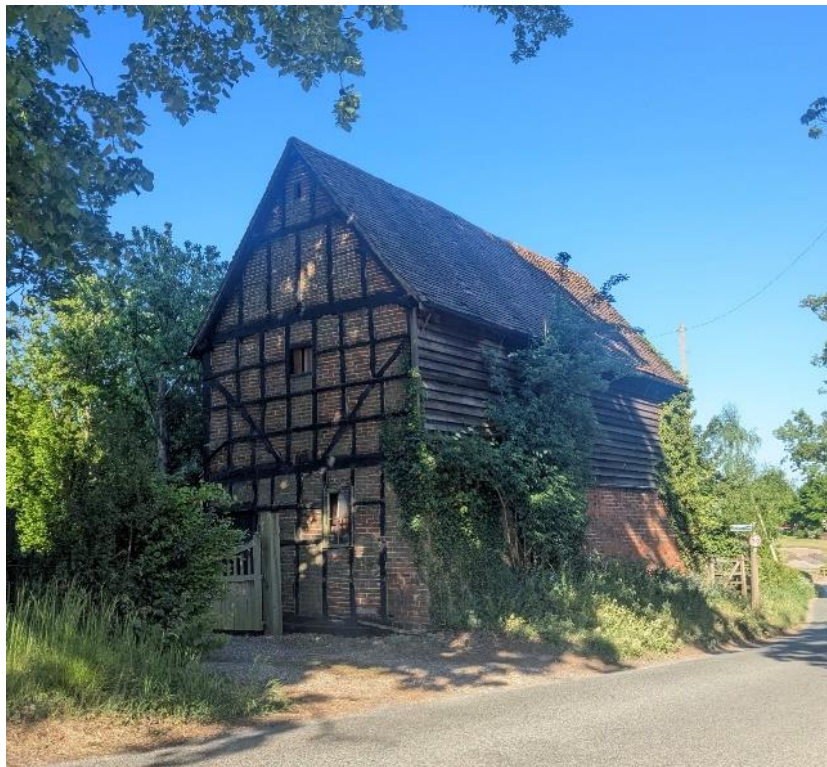
Description: Grade II. Former stables with hay loft, now workshop and storage. Late C17 / early C18. Exposed timber frame with red brick, largely infill. Some weather-boarding. Steeply pitched tiled roof. 3 bays. Left gable end exposed small panel framing of thin scantling, mid rail with upper tension braces, cambered tie beam, struts to collar clasp purlins. Ground floor plank door and small pane casement. First floor 2 light window with a diagonal mullion. Right gable-end all boarded. Rear catslide roof over a boarded and rendered lean-to. Central double doors with ground floor boarding. First floor 2 loft doors, exposed framing with a tension brace, 2 light window with a diagonal mullion. Owned by the Old Rectory.

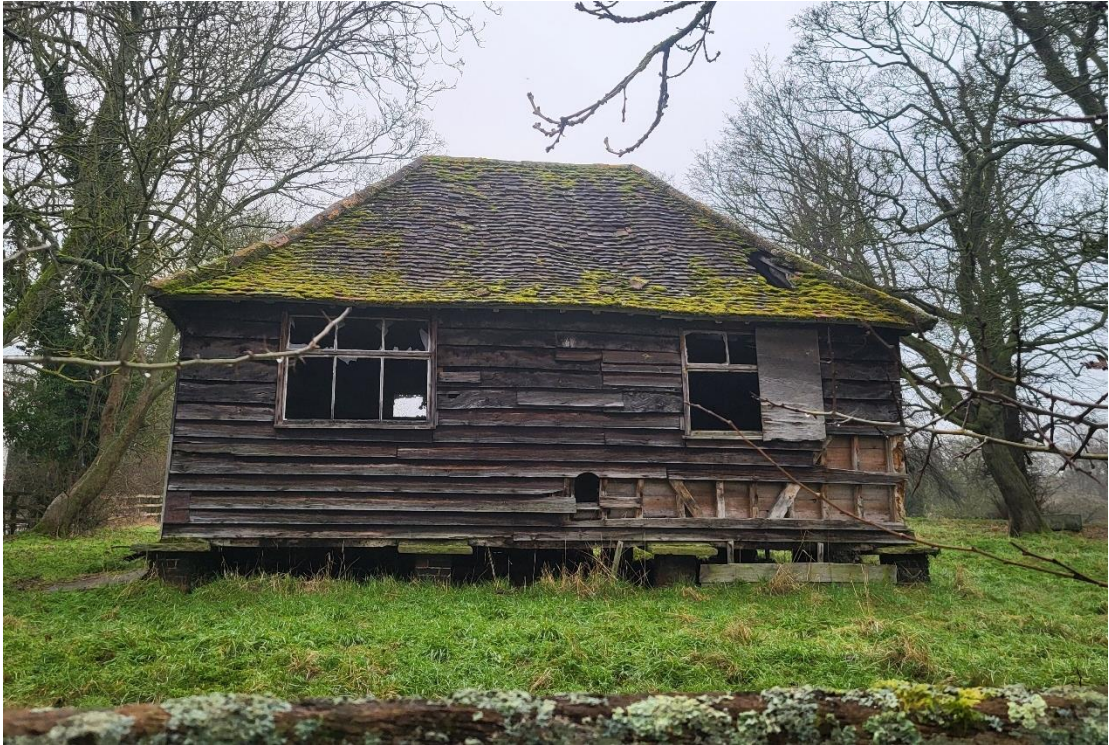
Latest update: Condition is deteriorating.
