## *Hunsdon Airfield Heritage Assets Feasibility Study*

# Gilston Park Estate Strategic Landscape Masterplan (SLMP)

## Hunsdon Airfield Feasibility Study

March 2025

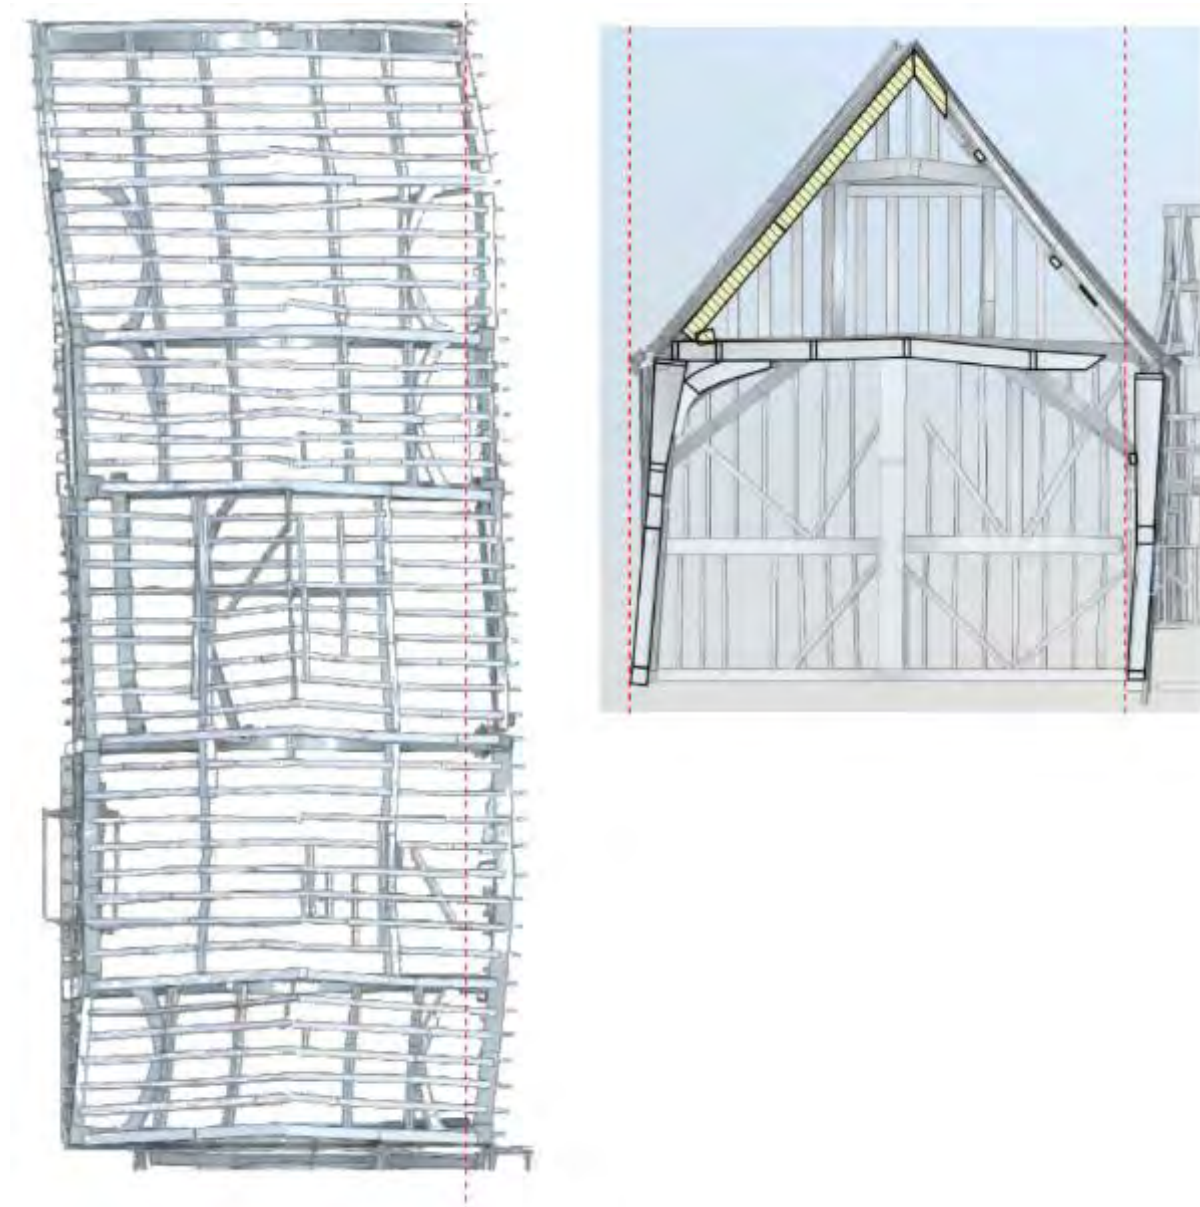
*Figure 2: Extract from digital model showing extent of visible racking within frame*

There was significant racking of the frame observed, particularly the middle frames either side of the door (Figure 2). The racking was less pronounced towards the ends where the cross walls provide resistance.

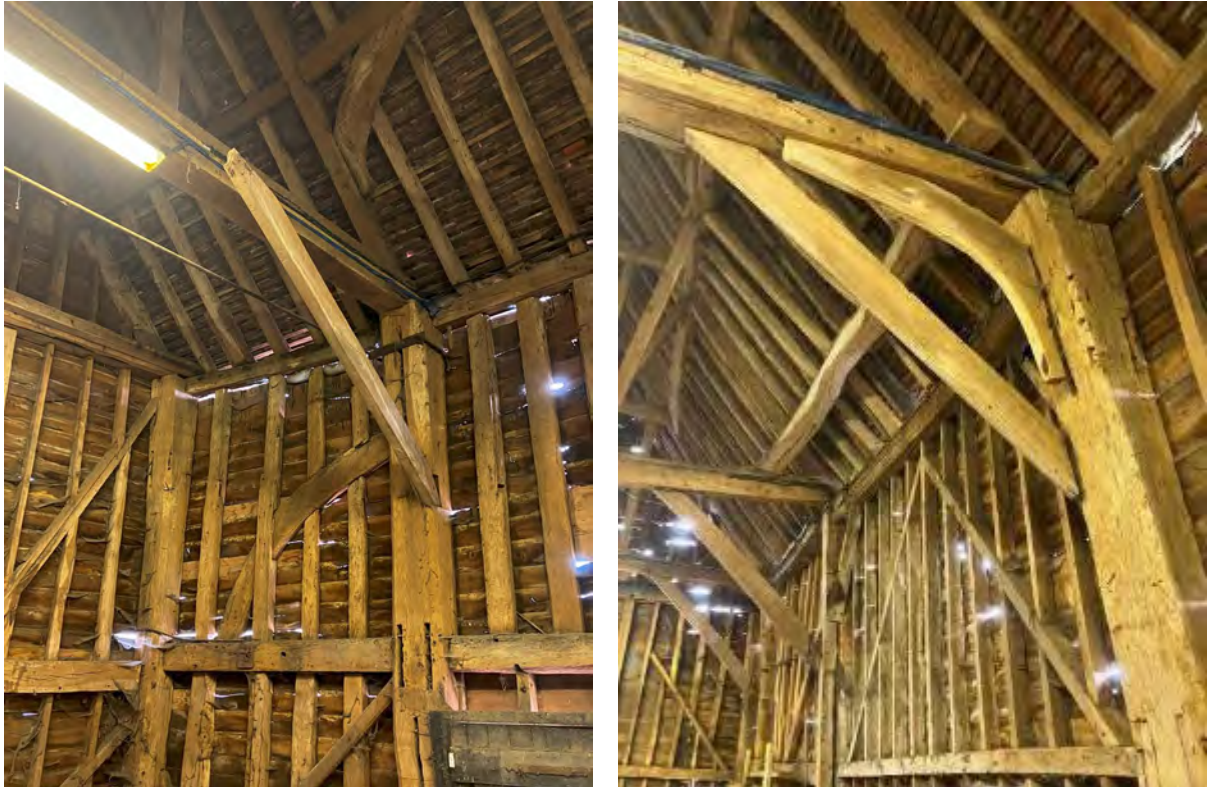
*Figure 3: Black Barn northern diagonal additional braces*

Diagonal braces had been added to the primary frames to supplement/ replace the original arched braces. This appeared to be an attempt to improve each frame's resistance to the racking movement observed. On the northwestern side, where the braces would be in tension, the joints have failed the and braces are coming loose (Figure 3).

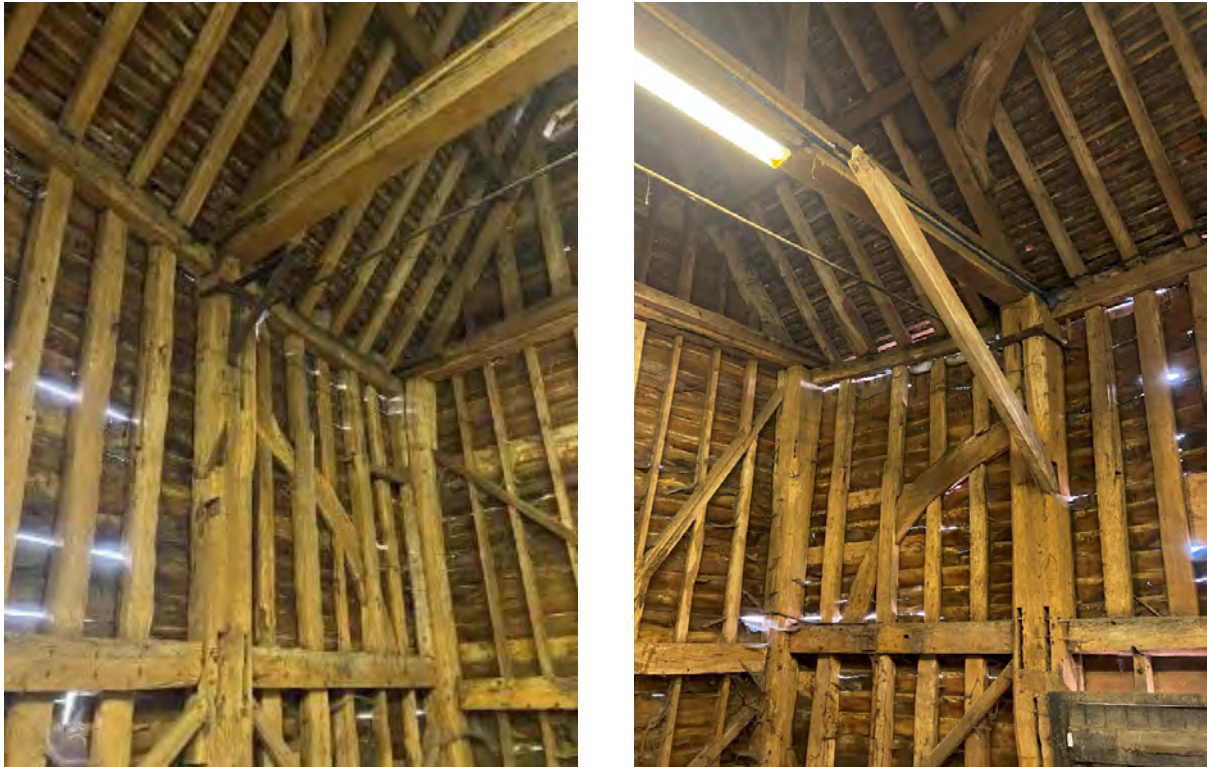
*Figure 5: Black Barn eastern frame issues*

It appeared that the easternmost frame had as some point had structural issues. The southern post is out-of-plumb, the tie beam had been replaced and augmented with a metal tie rod (**Figure 5**).

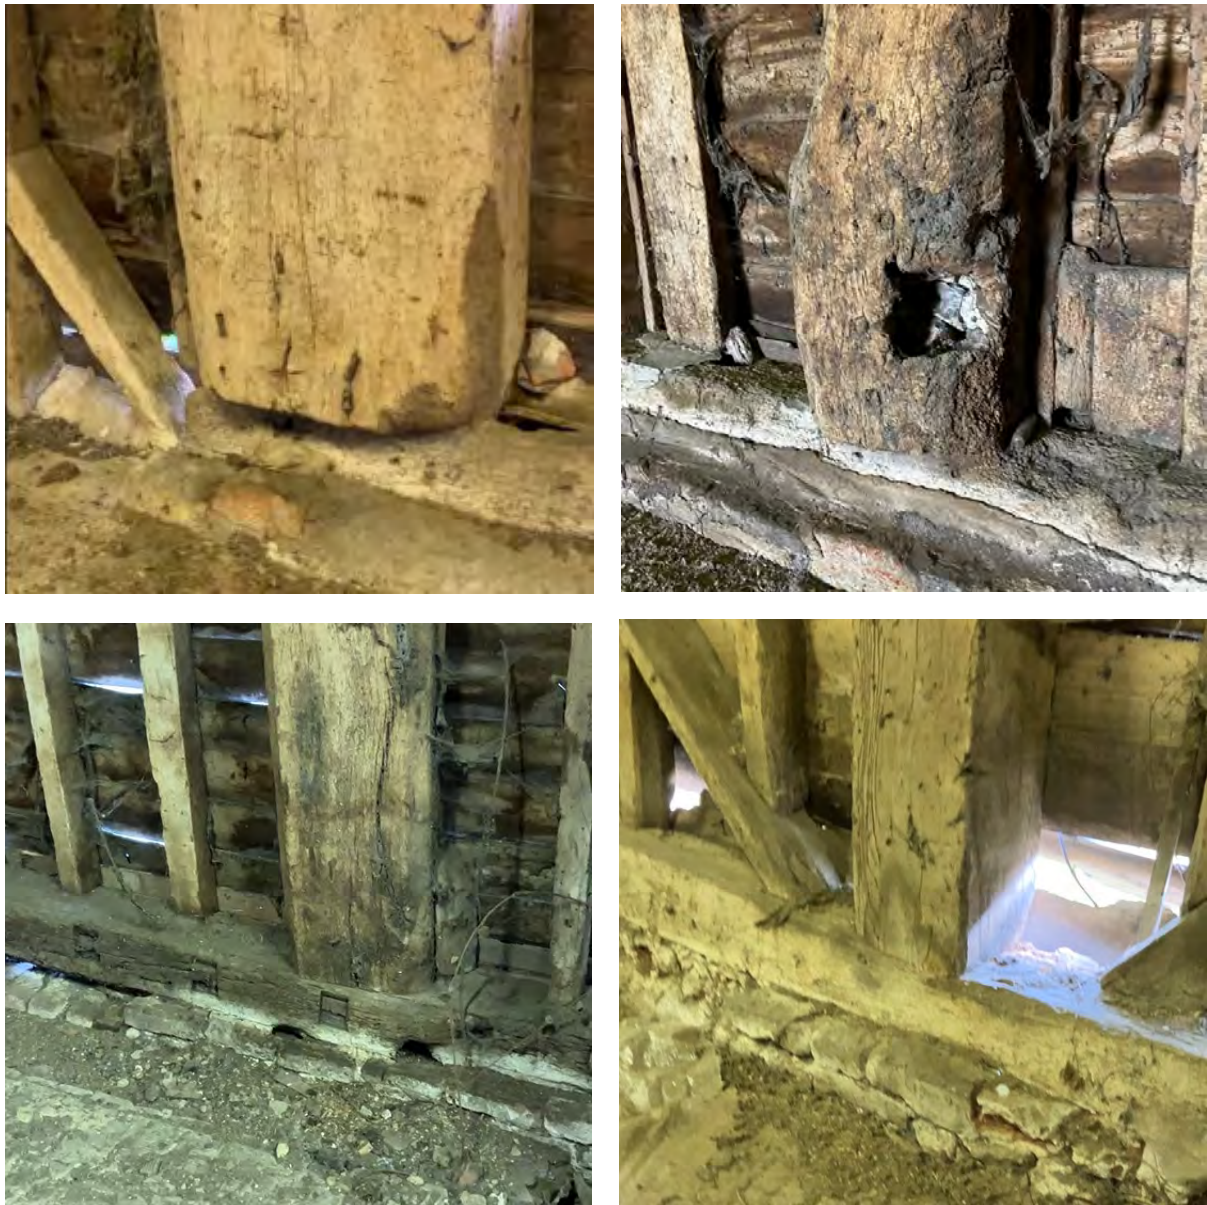
*Figure 6: Black barn main post bases and sills*

Other structural damage observed appeared to be primarily caused by material deterioration. Generally, the timber had a mixed condition, with indications of insect and moisture damage observed in multiple locations along with signs of movement such as open joints. The weatherboarding in particular showed signs of deterioration. On the northwestern elevation a wall panel was supported by temporary propping where the girding appeared to have failed, and from ground level several wall plates appeared to have significant shakes potentially affecting structural performance. Some sections of sill beam had been replaced and others showed signs of decay that in some cases extended into the base of the main posts (Figure 6).

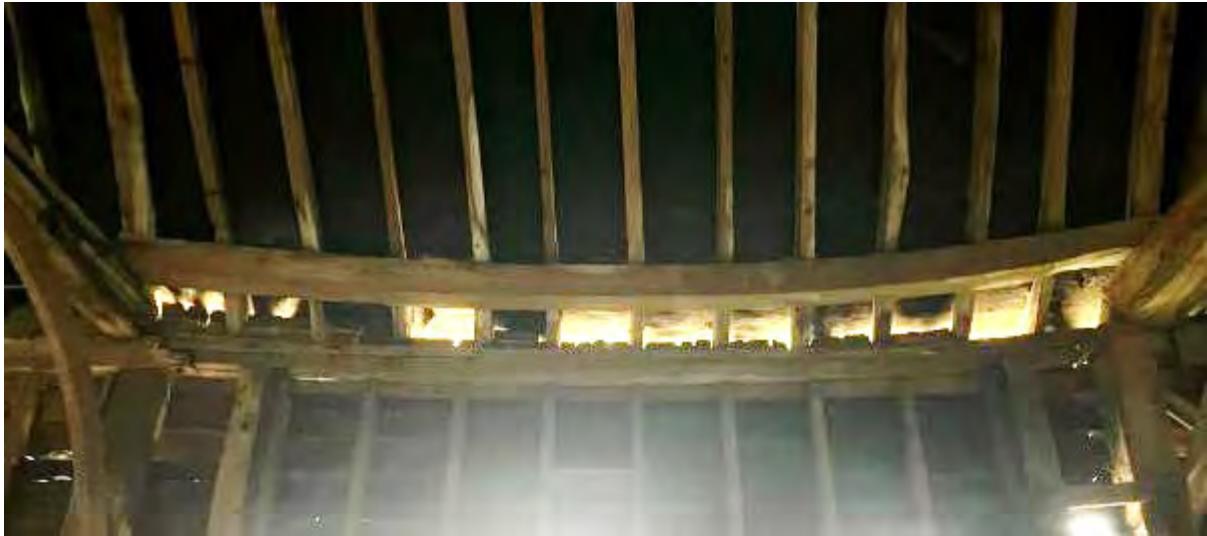
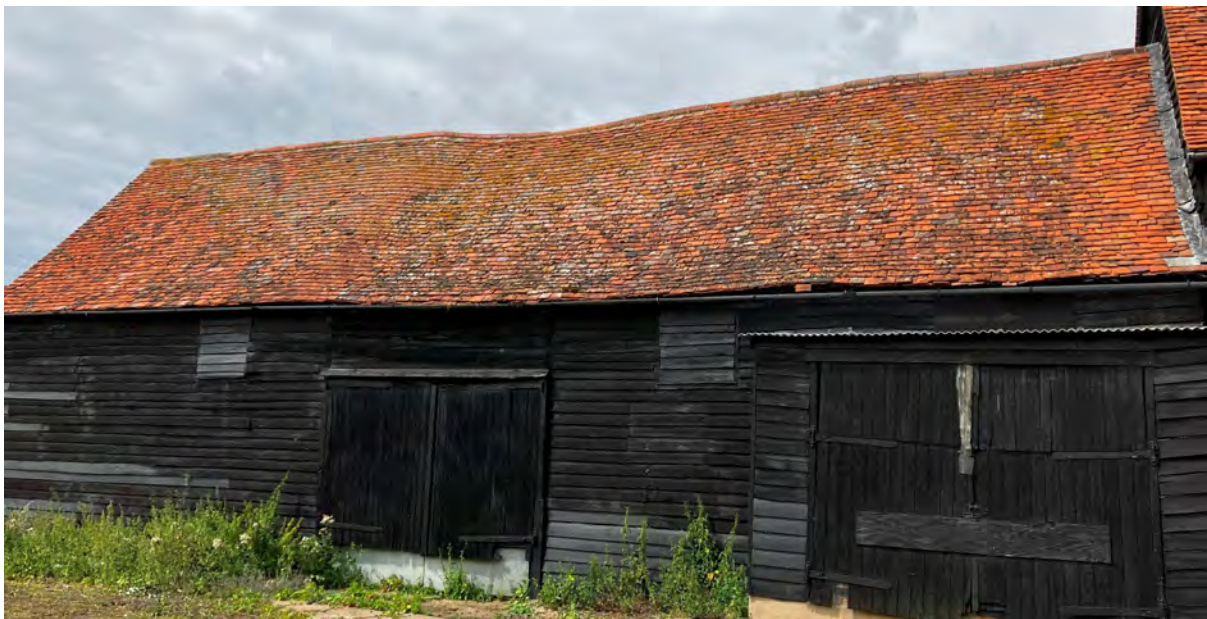
*Figure 8: South barn sagging roof*

The frame appeared to be sound with limited structural movement. The porch tie beam and door header beam were undersized and had sagged leaving the rafters in this area poorly supported resulting in a corresponding sagging of the ridge (Figure 8).

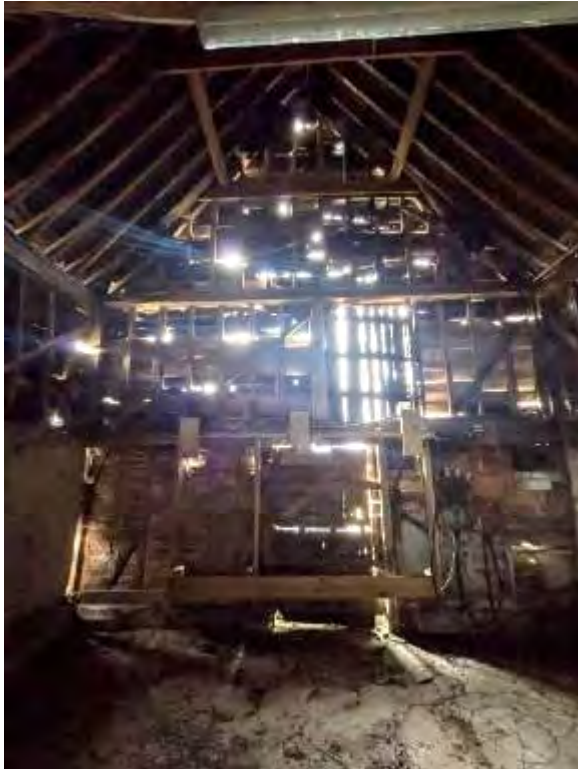
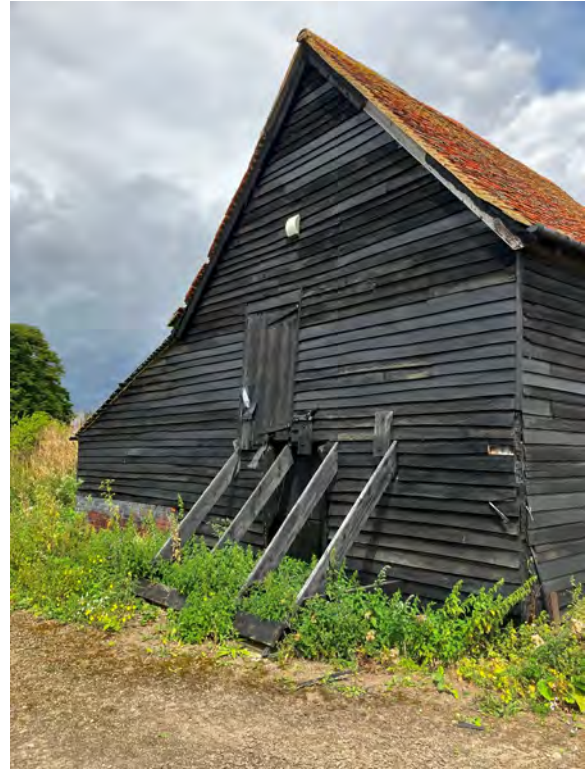
*Figure 9: South barn southwest gable*

The southwest gable had been propped and tied. It appeared to have been the subject of various alterations over the years likely compromising the supporting structure. The poor condition of the weatherboarding may have also caused deterioration on this elevation, especially as it faces the prevailing wind.

- The South Barn has experienced localised damage (such as the southwest gable) that require considered structural repair in the medium term potentially including works such as repair and replacement of structural members, sections of cladding, plinth walls and infill wall panels. The majority of the timber frame does not warrant material repairs in the short-term, with the exception of some localised areas of deterioration.

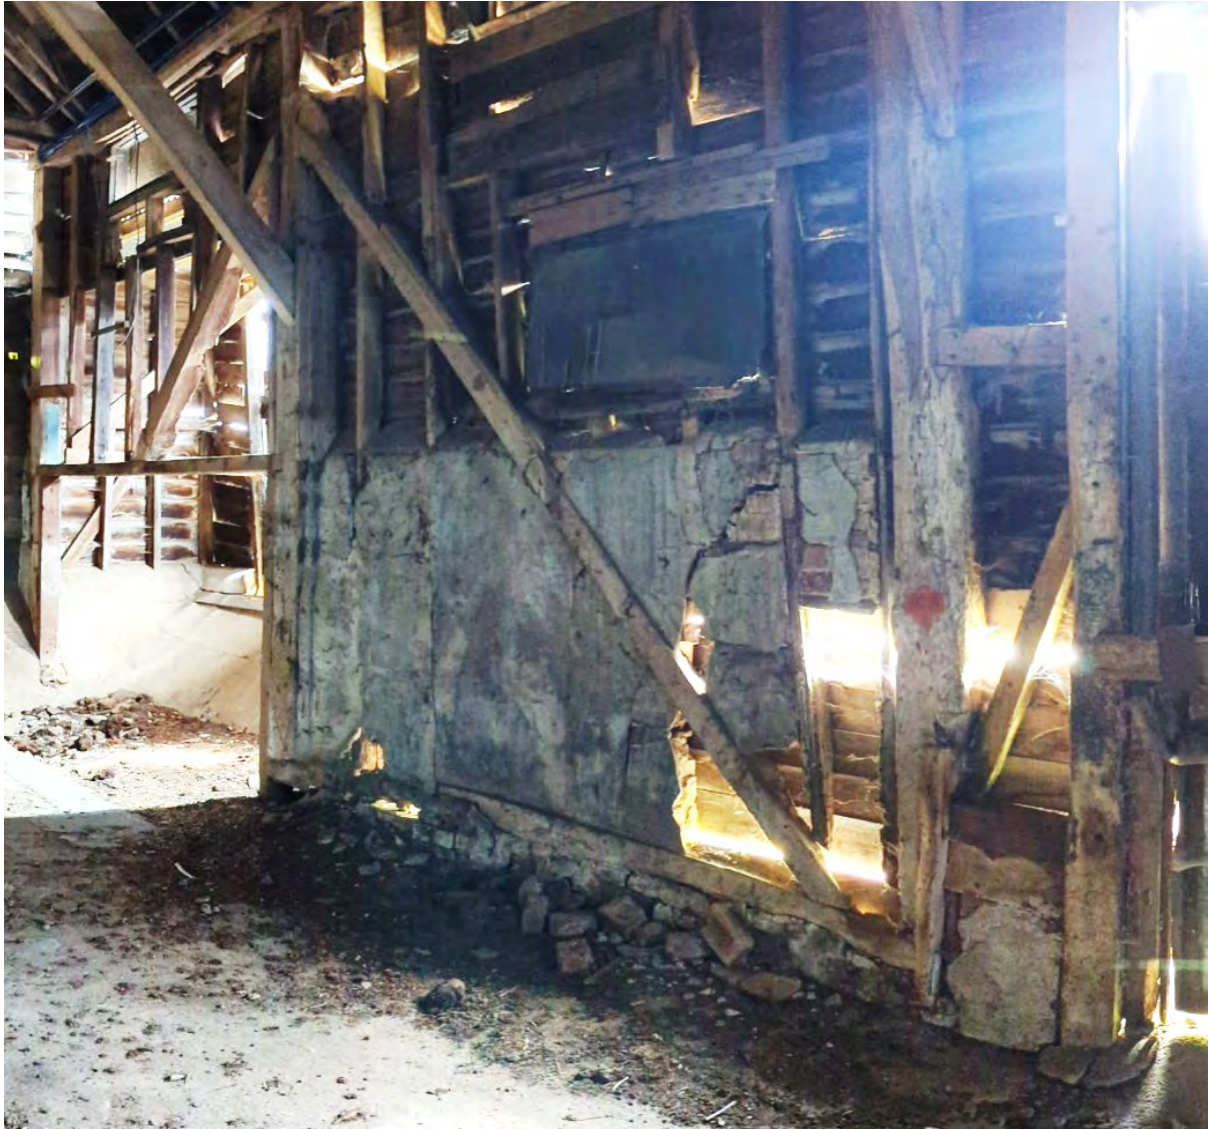
*Figure 10: South barn material deterioration*

The condition of the building fabric was mixed with some areas, generally higher up, in a fair condition and other areas, generally lower down, in a poor condition. Sections of plinth wall had failed and there were isolated areas of timber decay and section loss. Cladding, infills and internal wall finishes were also of mixed condition (Figure 10).

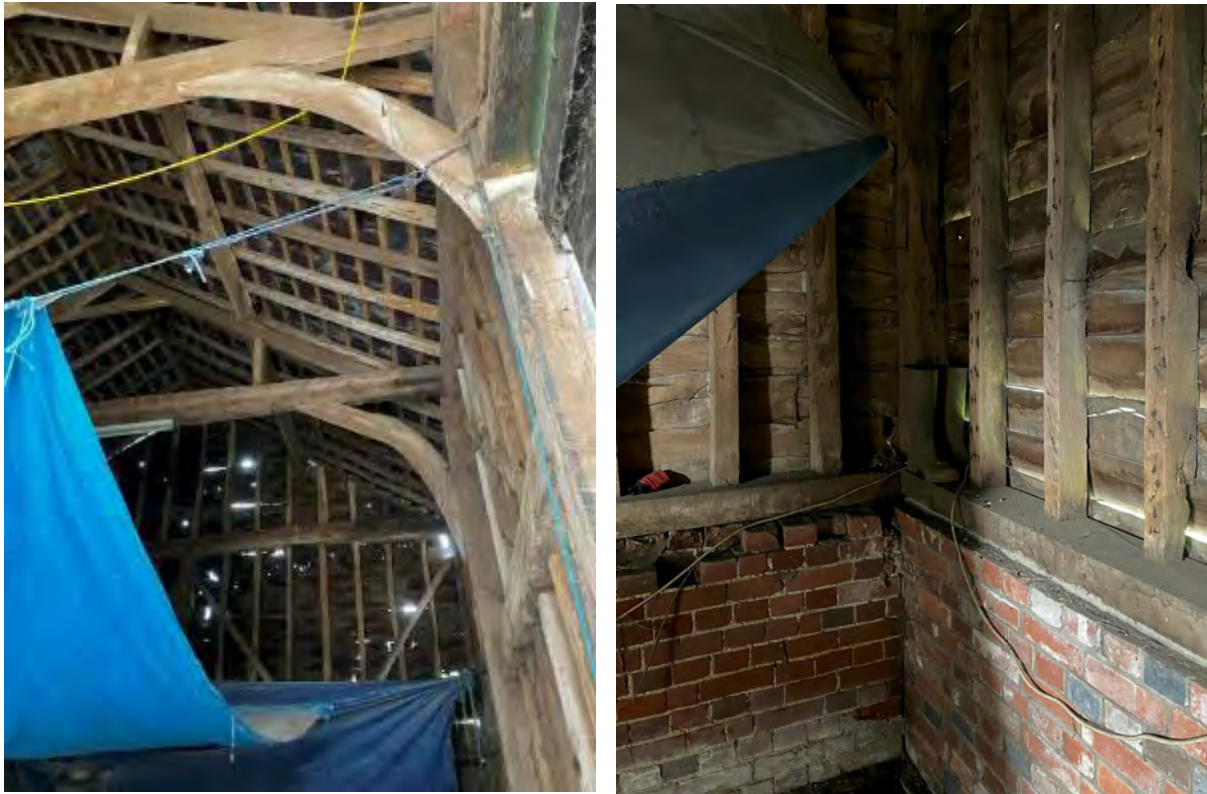
*Figure 12: Essex barn interior*

Internal access was very restricted due to stored equipment (**Figure 12**), but the condition of the structure was generally fair. Timber members were in a fair condition and the verticality and level of the frame were good for the age and form of construction. No significant structural distress was visible beyond minor damage to the top of the plinth wall and other minor localised issues. The lean-to

sections were of slightly poorer quality construction but also appeared to be in a fair condition, commensurate with age and use.

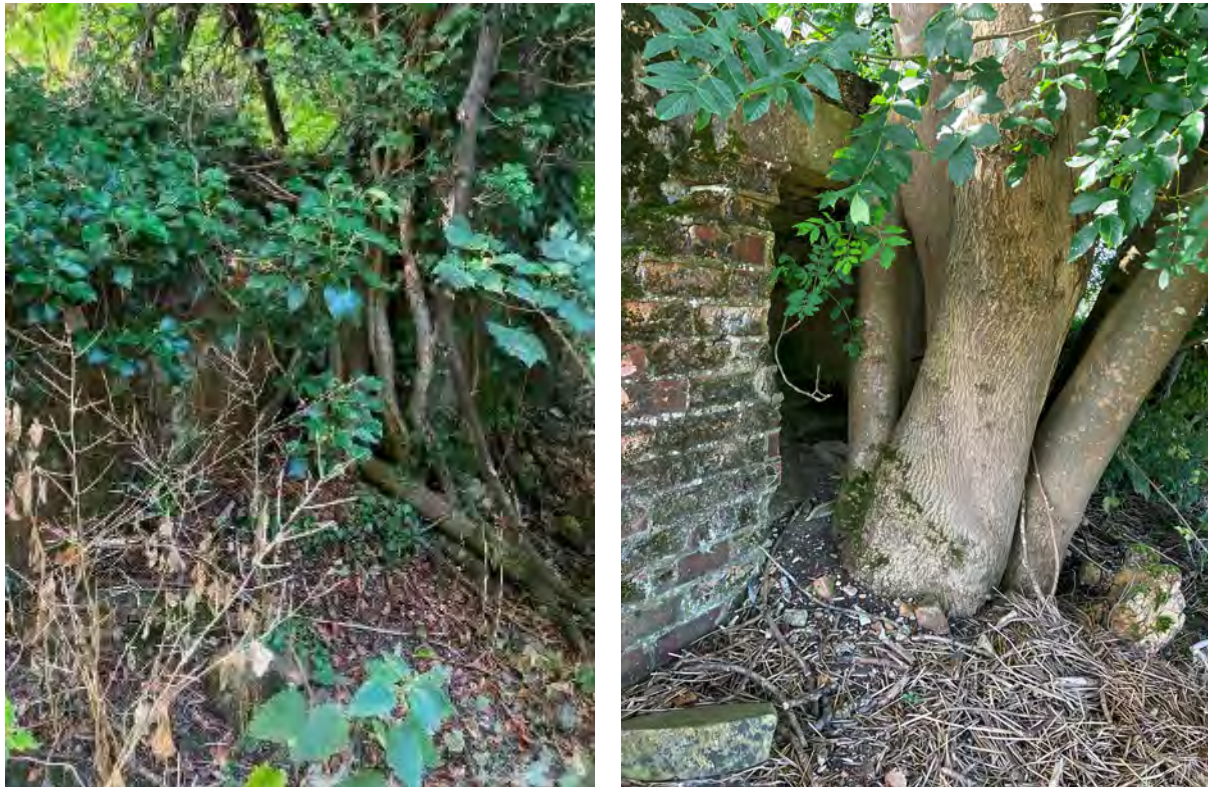
*Figure 15: Example pillbox vegetation*

The concrete elements were generally in a fair condition with only isolated and small areas of spalling observed. In the majority of cases a significant proportion of the brick facing to the wall had fallen away and there appears to be no ties back to the concrete wall behind. The primary factor generally affecting condition appeared to be vegetation. Most of the pillboxes have large quantities of vegetation around the perimeter including relatively mature trees and other woody rooted plants (Figure 15). These did not appear to have affected the primary concrete structure to date but have probably contributed to the loss of facing brickwork.

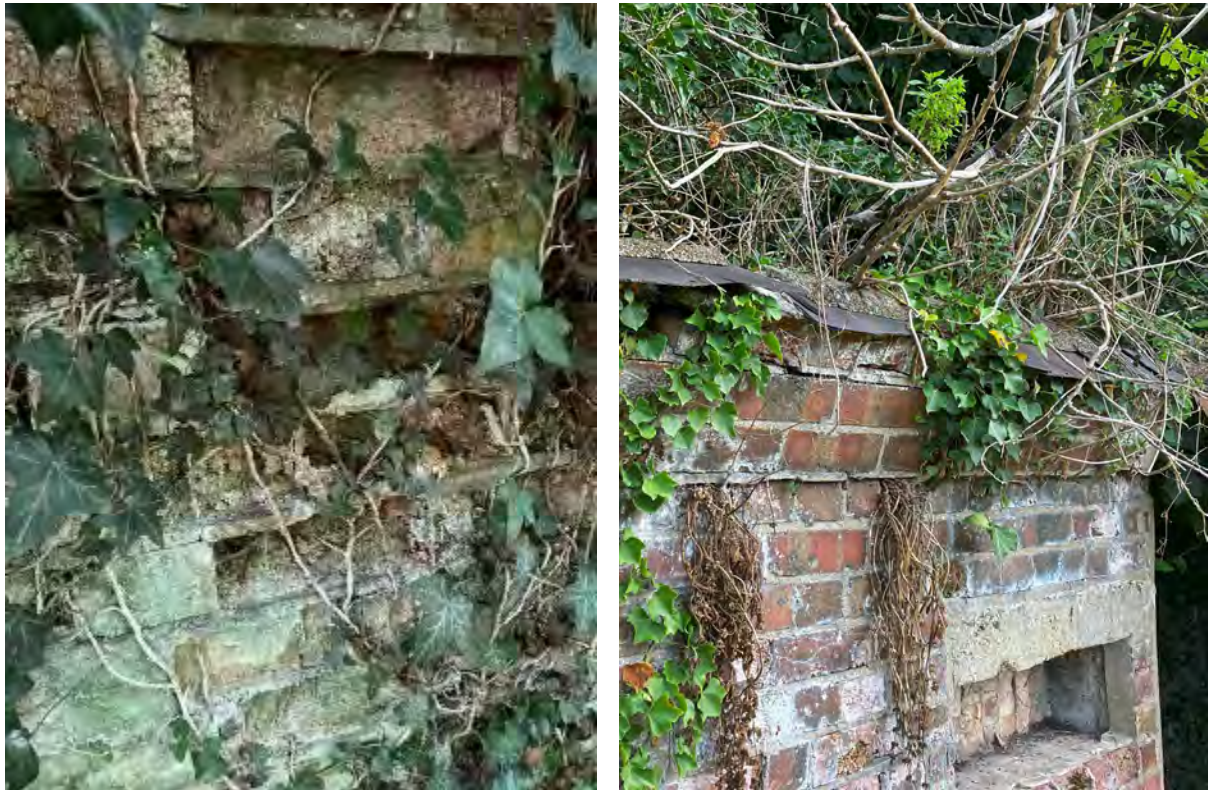
*Figure 16: Pillbox 2 brickwork damage (Monument ID 6)*

Pillbox 2 (Monument ID 6) differed from the other pillboxes as the walls were solid load-bearing brick. The exact make-up of the roof could not be determined due to restricted access. Externally large parts of the brickwork had severely deteriorated, in part due to vegetation growth which was also dislodging significant sections of brickwork around the perimeter of the roof (Figure 16).

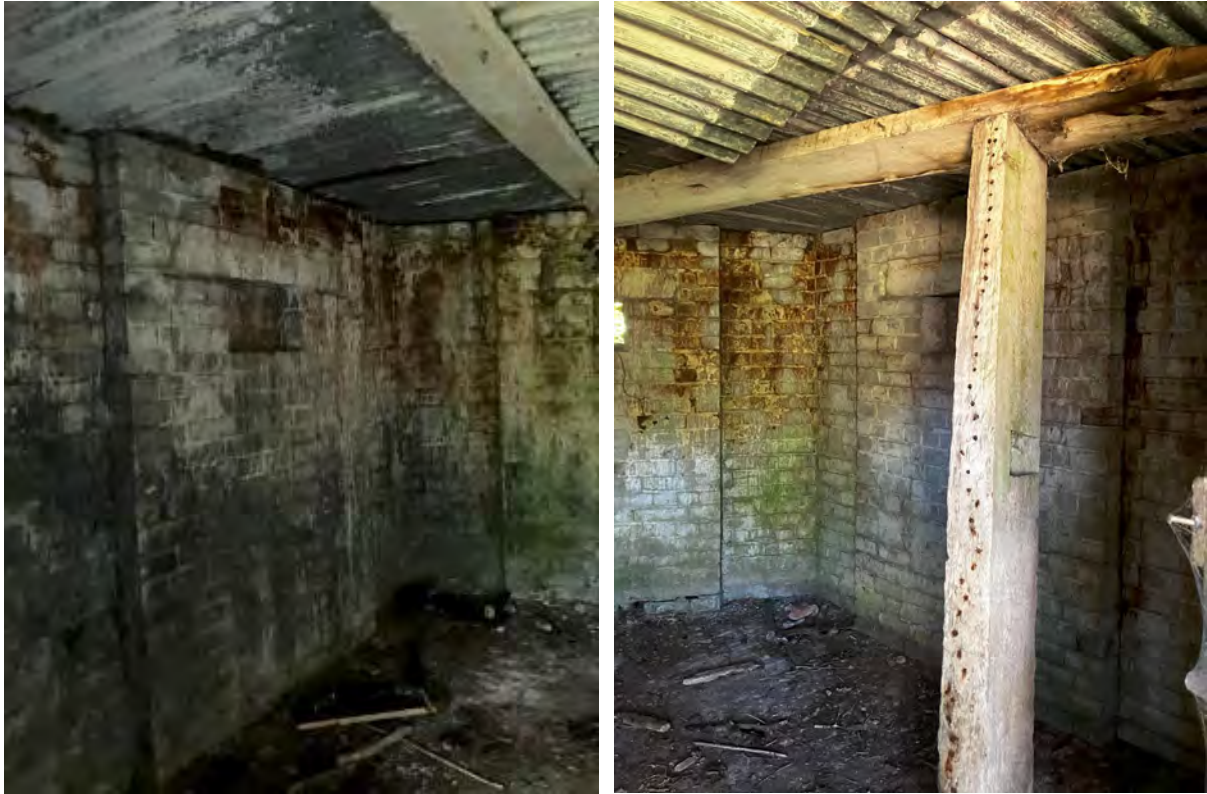
*Figure 17: Pillbox 2 interior (Monument ID 6)*

Internally the brickwork appears to be in relatively good condition but there is timber propping to the roof. It is not clear at what point this was installed as the timber appears to have some age but may have been reused from elsewhere (Figure 17).

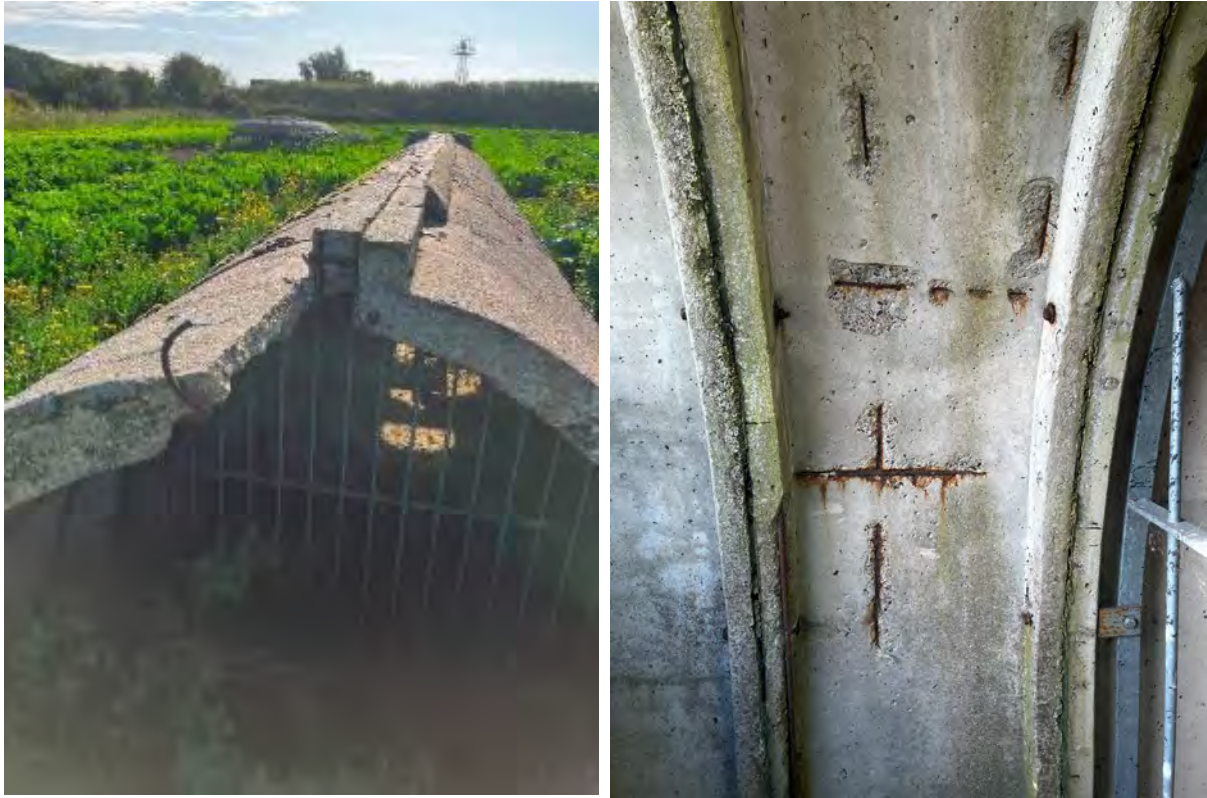
*Figure 20: Air raid shelter (Monument ID 8)*

The air raid shelter (Monument ID 8) comprised precast concrete segments bolted together to form a single tunnel form (Figure 20). Given the exposed location the condition was relatively good but metal fixings between segments had corroded and there were some small areas of concrete spalling internally. One of the northern segments appeared to have collapsed along with what could have been end walls.

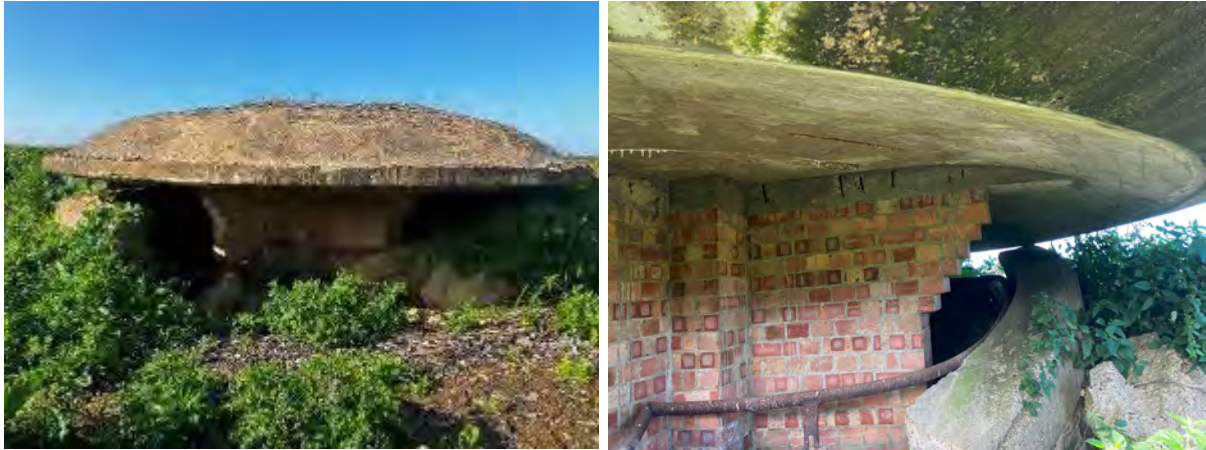
*Figure 21: Cantilever Pillbox (Monument ID 9)*

The cantilever pillbox (Monument ID 9) is an interesting arrangement comprising a reinforced concrete shallow domed cantilever roof supported on a central cruciform of brickwork, with a masonry and concrete wall around the perimeter (Figure 21). The condition of the roof is fair, and the central brick support appears to be in good condition. The perimeter wall had in sections collapsed into the centre. This is likely either due to an agricultural accident and/or failure of the wall's foundations over time. There was a significant amount of water in the base of the pillbox.

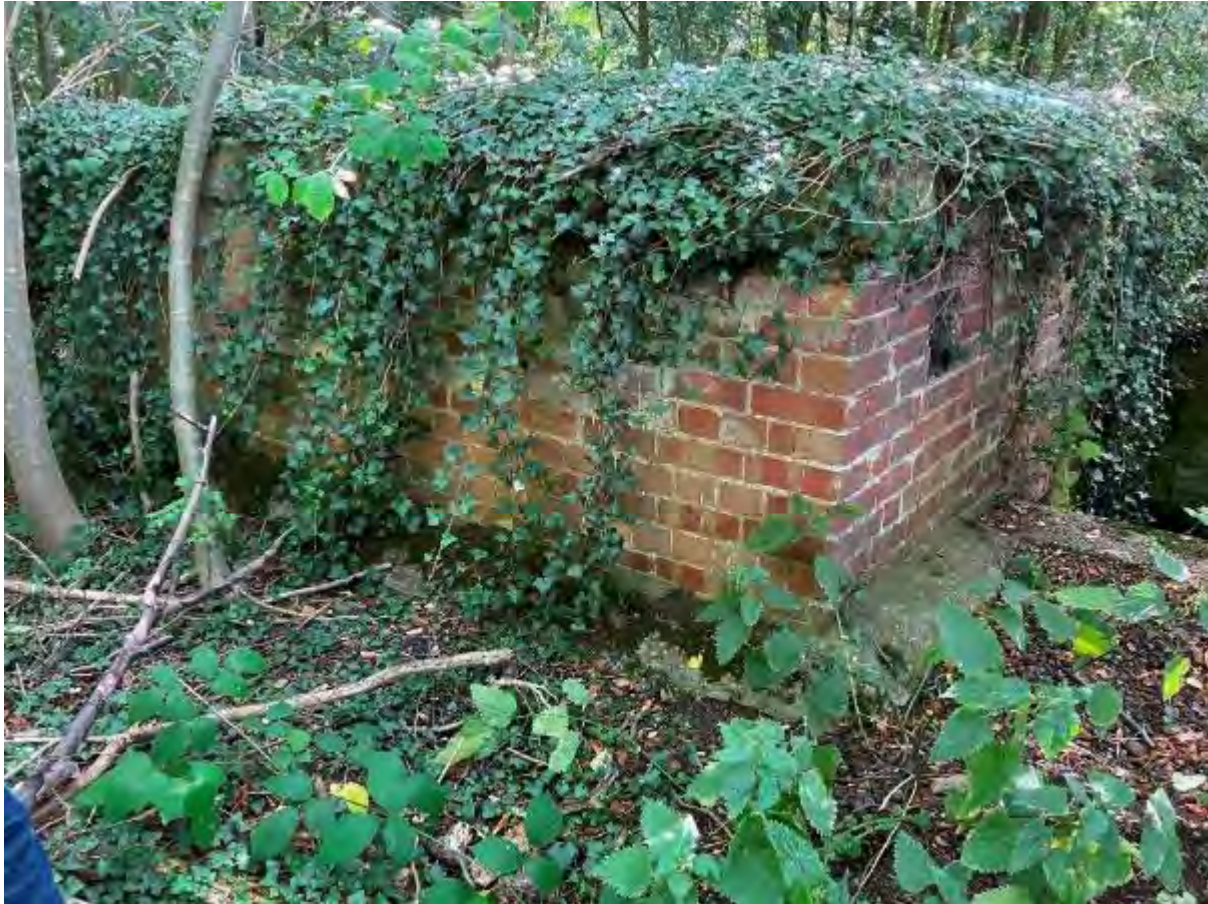
*Figure 22: Ammunition store to pillbox 6 (Monument ID 11)*

The ammunition store to pillbox 6 (Monument ID 11) comprised thick masonry load bearing walls set into the ground to create a semi-basement and supporting a flat concrete roof. The structure appeared to be in reasonable condition given its exposure but with some deterioration to the external walls, primarily from vegetation (Figure 22).

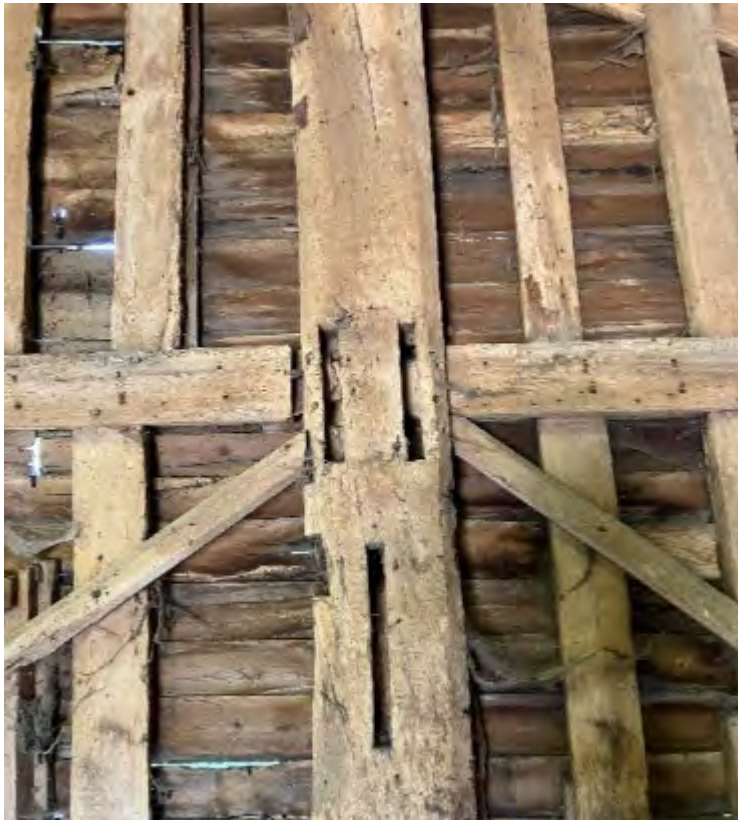
*Figure 3: Oak timber frame*

Many cross members and supports have been replaced over time whether that be through failure (rot), woodworm (evidence still there), or re configuration of the building from a lodge to a barn.

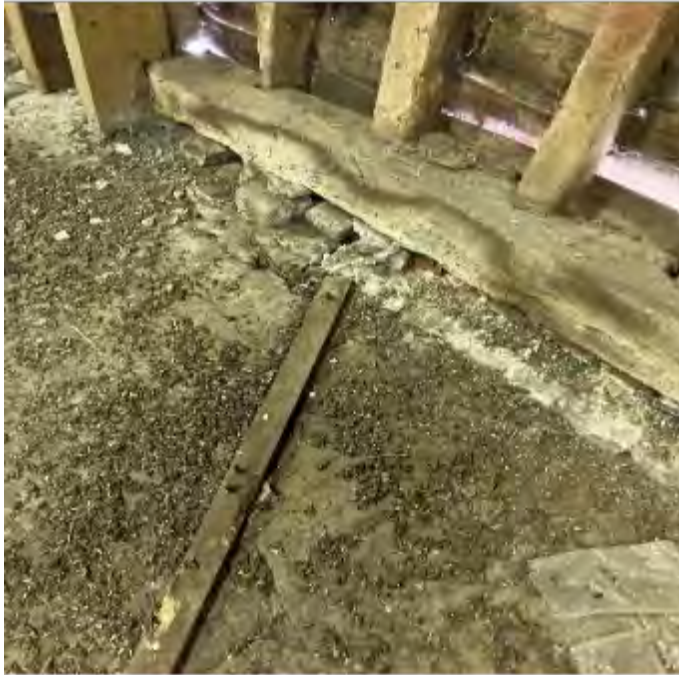
*Figure 4: Deteriorating sole plate*

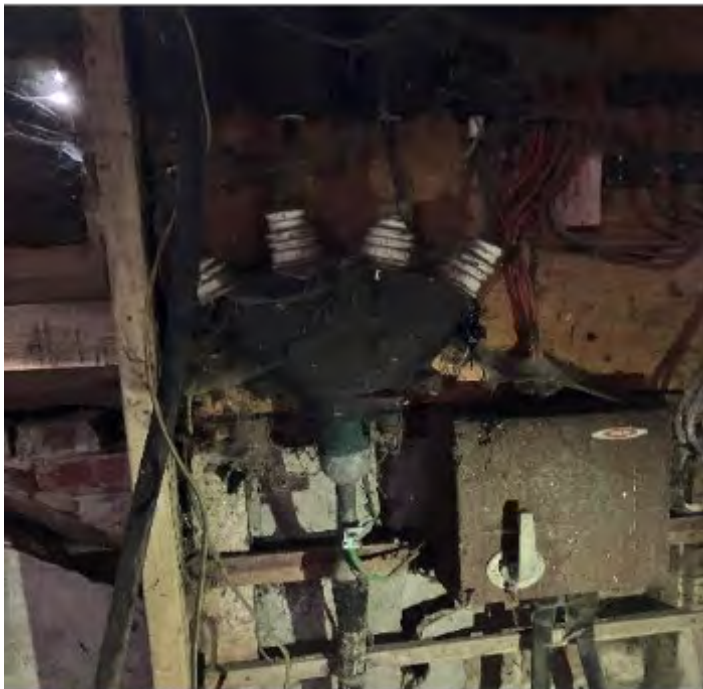
*Figure 5: Electrical Distribution panel*

The electrical system although only supplying lights and power sockets should normally be expected to have had a periodic electrical 5-year inspection, of which there was no evidence of this having taken place. The equipment therefore in my opinion is potentially dangerous and should be isolated or replaced immediately.

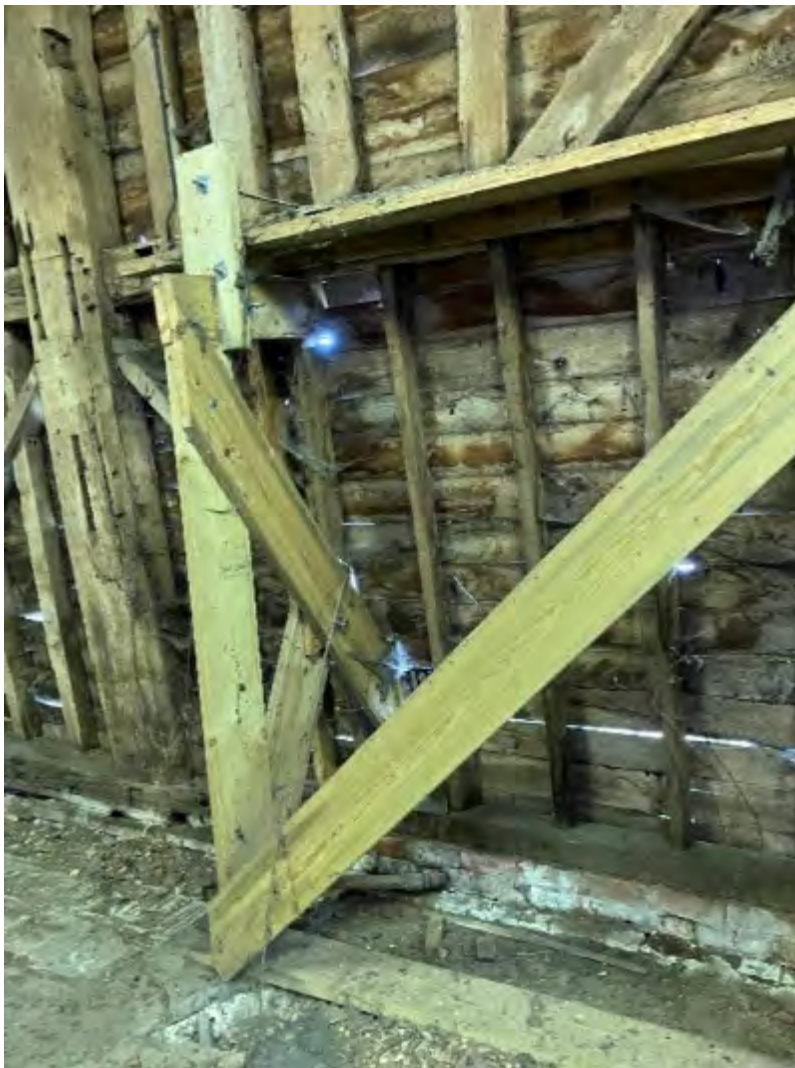
*Figure 6: Internal Shoring*

Some internal structural shoring has taken place in recent times, presumed to support the bowing on the front elevation.
