EAST HERTS COUNCIL HERITAGE AT RISK REGISTER

Updated July 2021

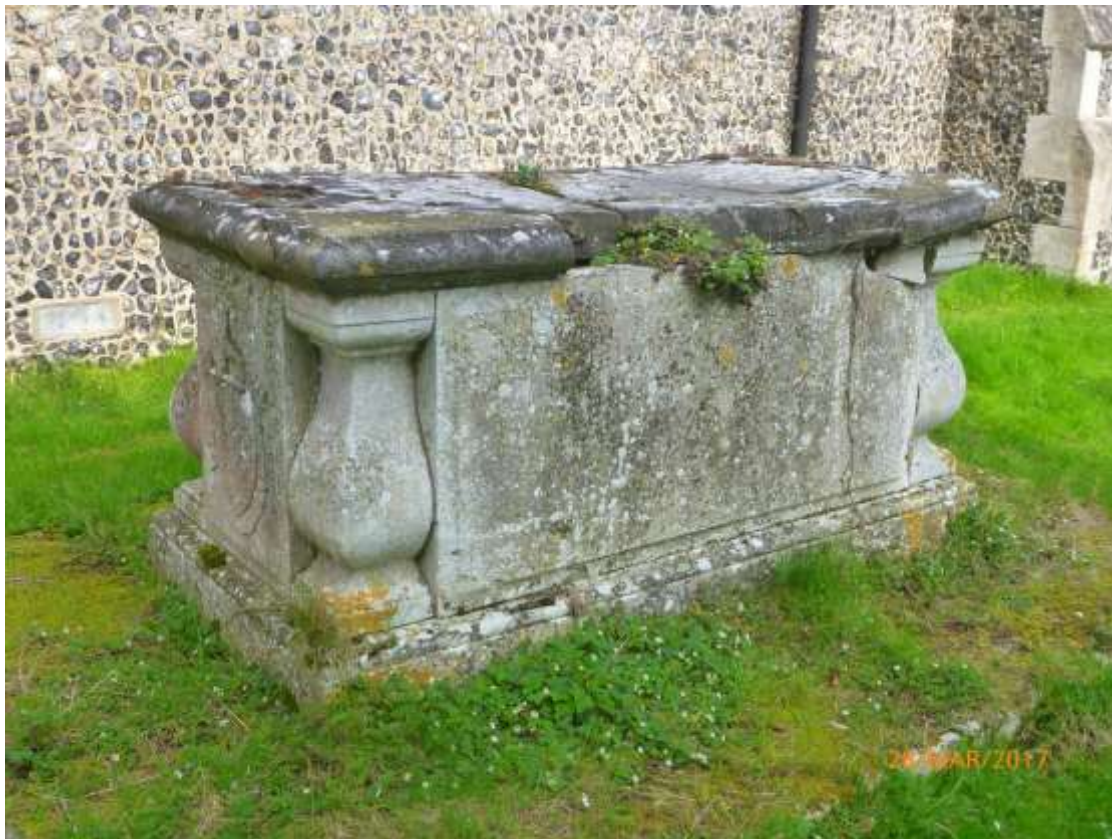
Date of photograph: 28/03/2017

Description: Grade II. Tomb. 1789. Stone tomb chest with inset baluster corners and moulded top slab, to William Frampton, Merchant of the City of London.

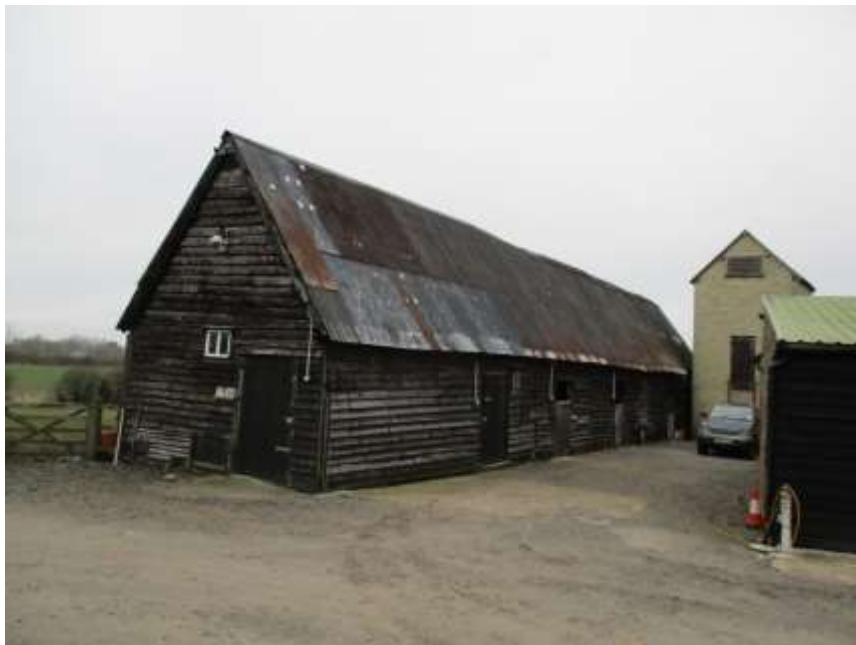
Date of photograph: 15/03/2016

Description: Grade II. Barn. C17th. 6-bay. Now stables. Timber frame on stuccoed brick sill, weather-boarded. Corrugated iron steep roof. Internally divided in two with later subdivisions. Jowled posts with braces to tie beams. Cranked queen-struts to collars in clasped-purlin roof. Stable doors on S side and W end.

- General renovation, or to be made watertight
- Assessment of damp / rot throughout
- Assessment to condition of timber frame
- Repair / replace walls, roof structure and roof covering
- Repair / replace doors and weather-boarding

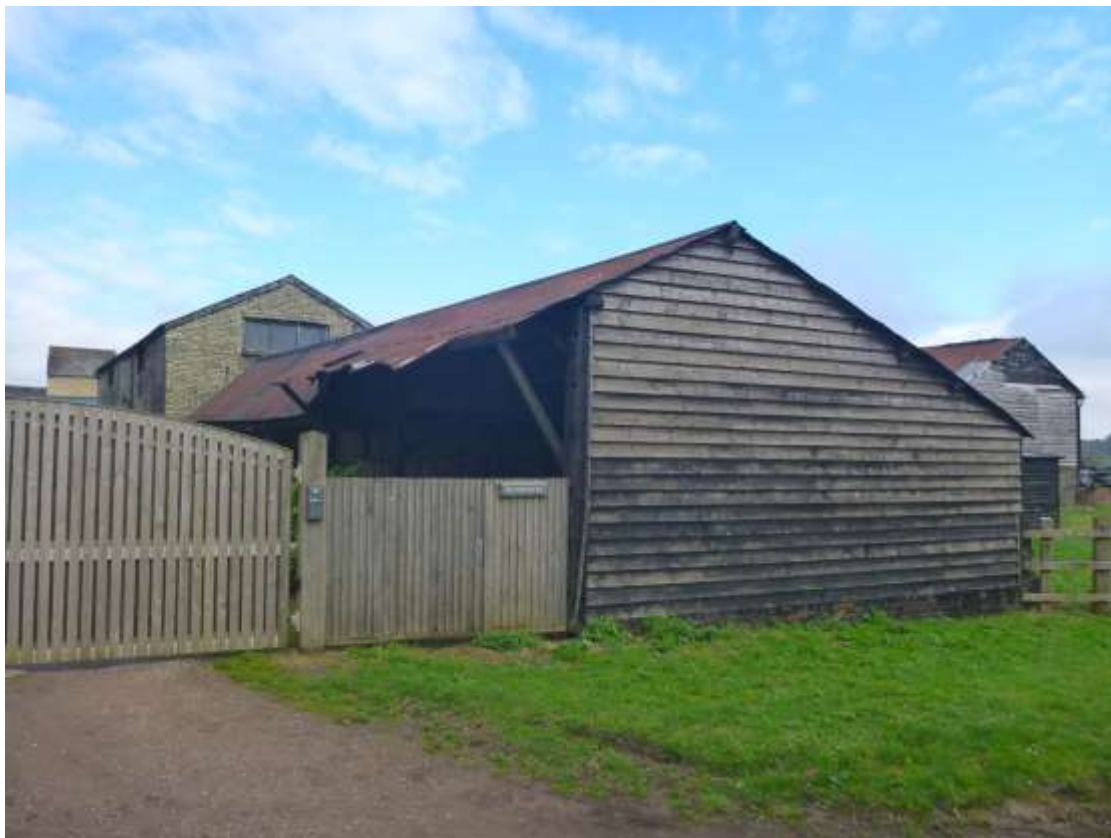
Date of photograph: 19/03/2019

Description: Farm buildings. C19th. Two cart-sheds, 3-bays each, open to farmyard. Post and truss construction. Timber frame on a brick sill with weatherboarding. Corrugated iron gable ended roofs. Buildings abut one another with a brick barn to one end.

- General renovation, or to be made watertight
- Assessment of damp / rot throughout
- Assessment to condition of timber frame
- Repair / replace walls, roof structure, weather-boarding, and roof covering

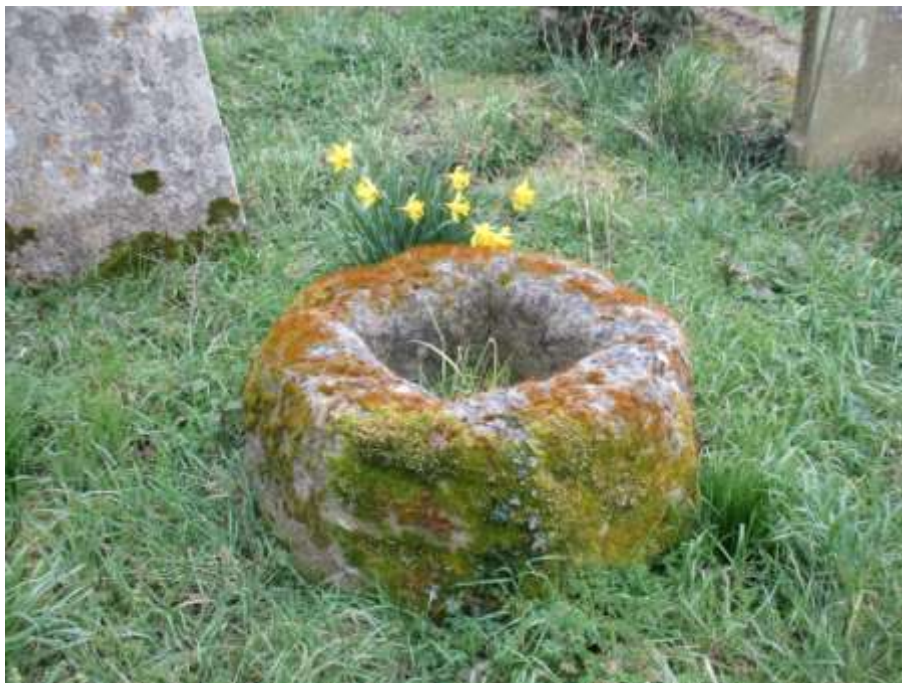
Date of photograph: 15/03/2016

Description: Grade II. Monument. Cross base for churchyard cross. Probably C14th. Stone. A regular octagonal monolithic base about one meter wide and half a meter high with a large, deep, square socket in the middle of the upper face. Covered with moss and vegetation.

Works required: Removal of vegetation and cleaning of stone.

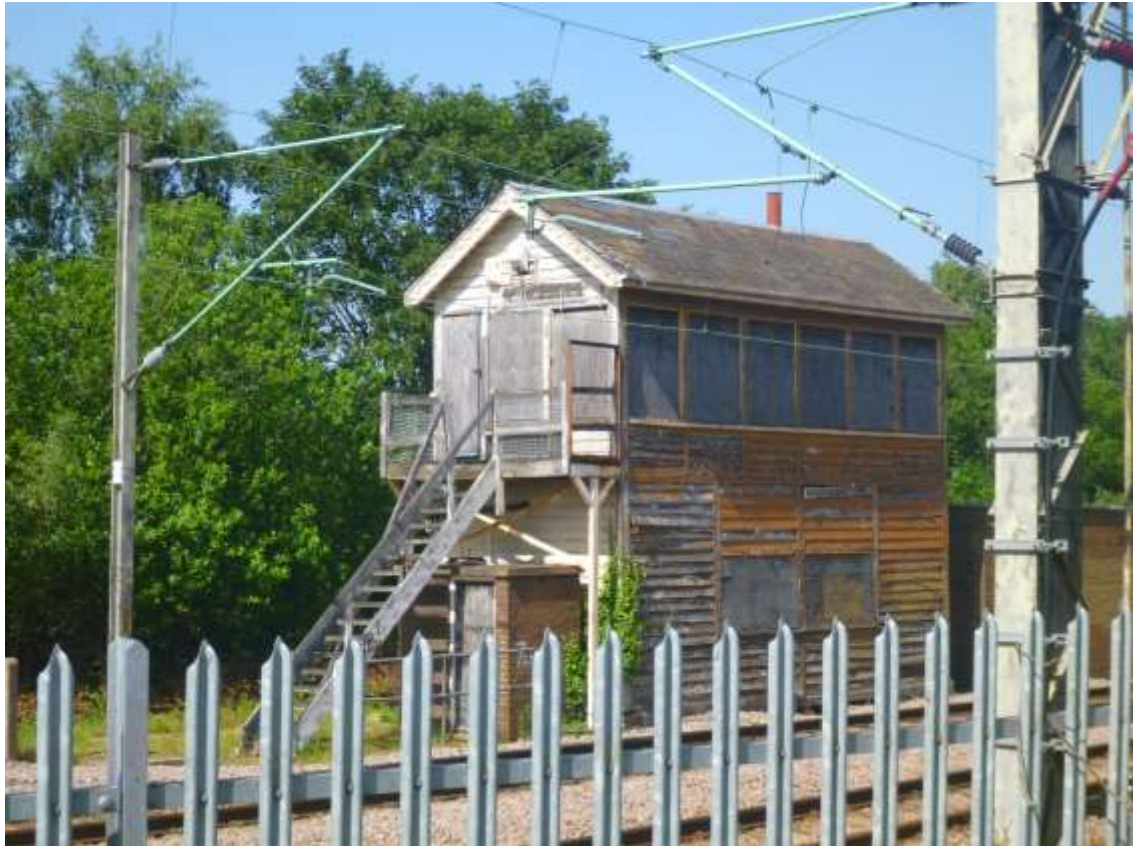
Date of photograph: 28/06/2019

Description: Grade II. Signal box (that housed railway control equipment). 1888. Timber-framed and weather-boarded, with gabled Welsh slated roof with brick chimney on NE corner. Built by the Great Eastern Railway. 11ft 4in wide and 26ft long. 2-storey. First floor; 6 bays of 9-pane windows (boarded over), 2 module return glazed ends, door in W elevation approached by external timber staircase and balcony. Ground floor weatherboard clad with 2 coupled 10-pane horizontally proportioned windows on ground floor (now boarded). Door to W.

- General renovation
- Assessment of damp / rot throughout
- Repair / replace weatherboarding
- Repair / replace doors and windows
- Long-term use needs to be found to ensure future maintenance

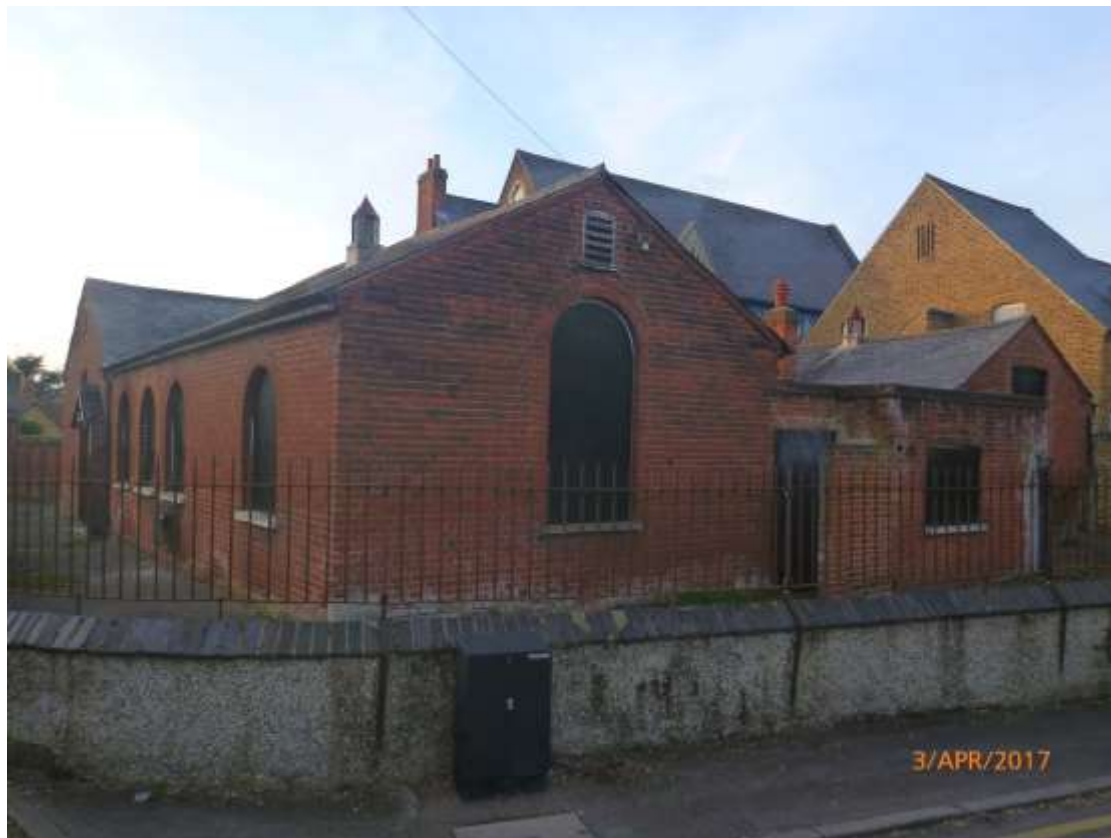
Date of photograph: 03/04/2017

Description: School buildings. Built in 1862/3 with United Reform Church (formerly Congregational Church). Architects and builders probably as for church, T Smith & Son and Henry Norris, Hertford. Stands at the rear of and is attached to the church. Three ranges in U-plan. Red gauged brick in Flemish bond. Gabled slate roof. Arch-headed windows to W and S elevations, segmental-headed windows to N range. Hooded doorway to S elevation. Three metal ventilators to roof of S, N and W ranges. Three chimneys, stepped brickwork to tops. Surrounded by low wall with railings, gate to W.

- Contact Hertfordshire County Council
- General renovation to be usable, or make watertight
- Assessment of damp / rot throughout
- Repair / replace roof covering and guttering
- Repair / replace windows and doors

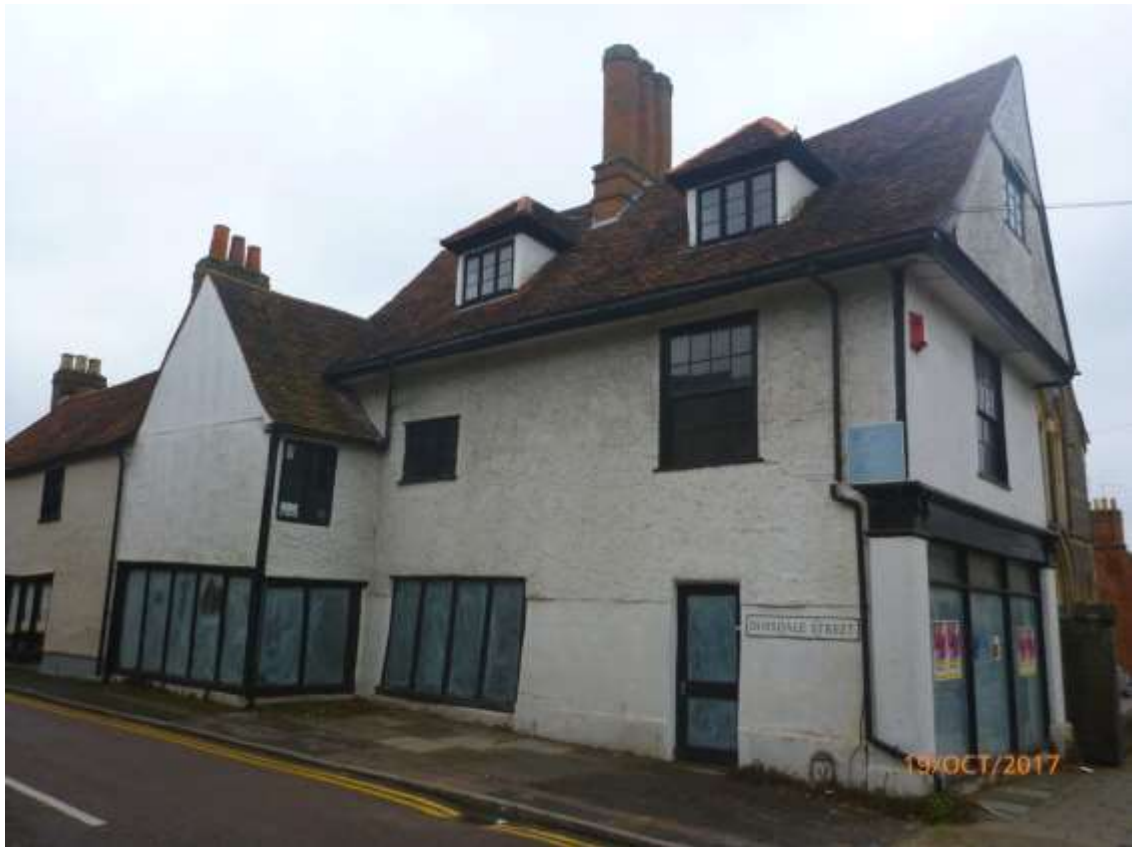
Date of photograph: 19/10/2017

Description: C17th, timber-framed, 2 storeys and attics. Originally had lobby entry plan, with large 2-bay room at front to left. Has jettied gable facing street, deep eaves cornice, and 2 three-light casement dormers. Central red brick chimneystack with 3 octagonal shafts above brick base with bands (restored 1970s). Early C20th shopfront to ground floor. Front ground floor showroom to No.7 has rebuilt segmentally-arched (originally 4 centre arched) red brick fireplace with chamfered cheeks and intrados, and heavy timber bressumer above. Exposed beams with chamfer and tongue stops. Roof has peg jointed purlin and rafter construction. Basement beneath No.7 has arched vault through to main cellar beneath front room.

- General renovation to be habitable
- Assessment of damp / rot throughout
- Repairs to roof and guttering

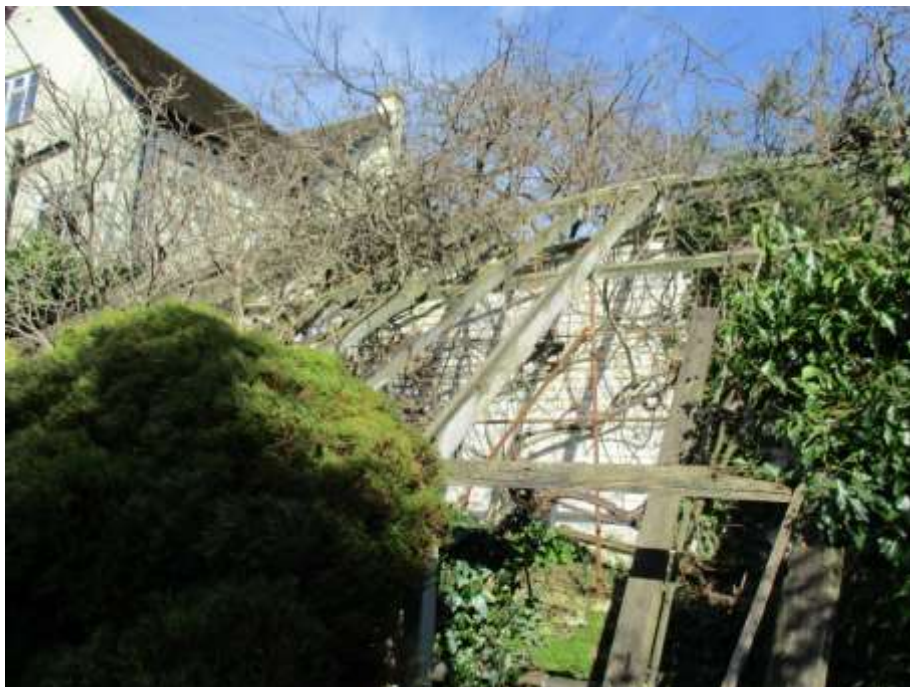
Date of photograph: 14/03/2016

Description: A late-C19th to early-C20th century greenhouse.

Works required: Overall objective to repair and restore if viable as a garden feature. Can another purpose be found for it if it is not viable as a greenhouse? Restore/replace elements of frame as necessary.

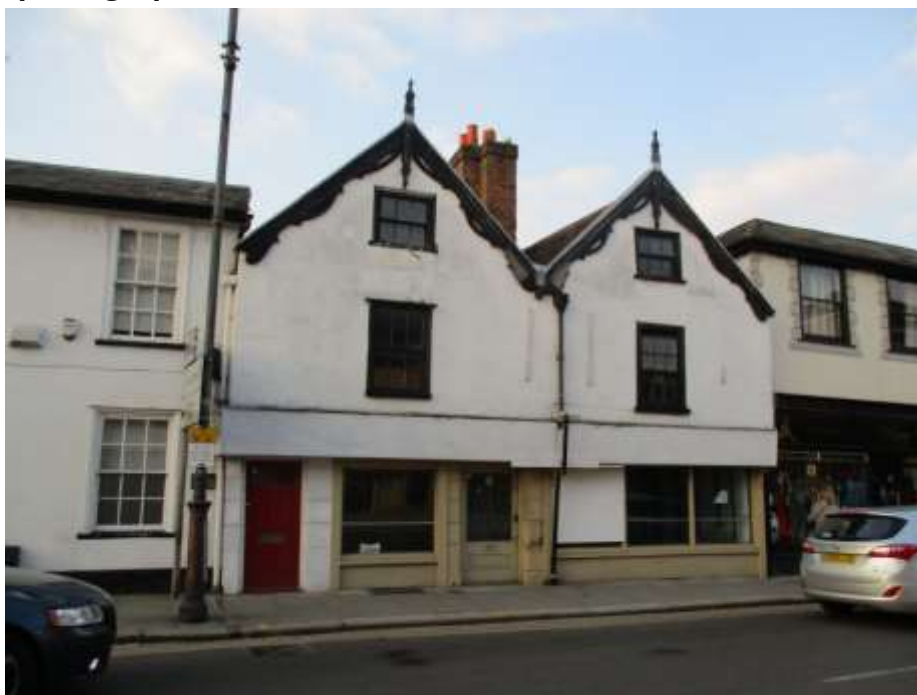
Date of photograph: 17/03/2016

Description: Grade II House, now shops and offices, early C17th, altered C19th and extended C20th. Timber-framed and stuccoed, double gabled old tiled roofs, with early C19th Gothick moulded and traceried barge boards and cut pinnacle finials and pendants, facing street, Welsh slated, C19th raised infill between gables at rear. Red brick chimneystack of 2 back-to-back shafts with oversailing band and orange clay pots centre right. Double-depth plan with 2 bay jettied front.

- Assessment of general condition throughout
- General renovation to be habitable
- Repairs to roof and rainwater goods
- Repairs or replacement of shopfront

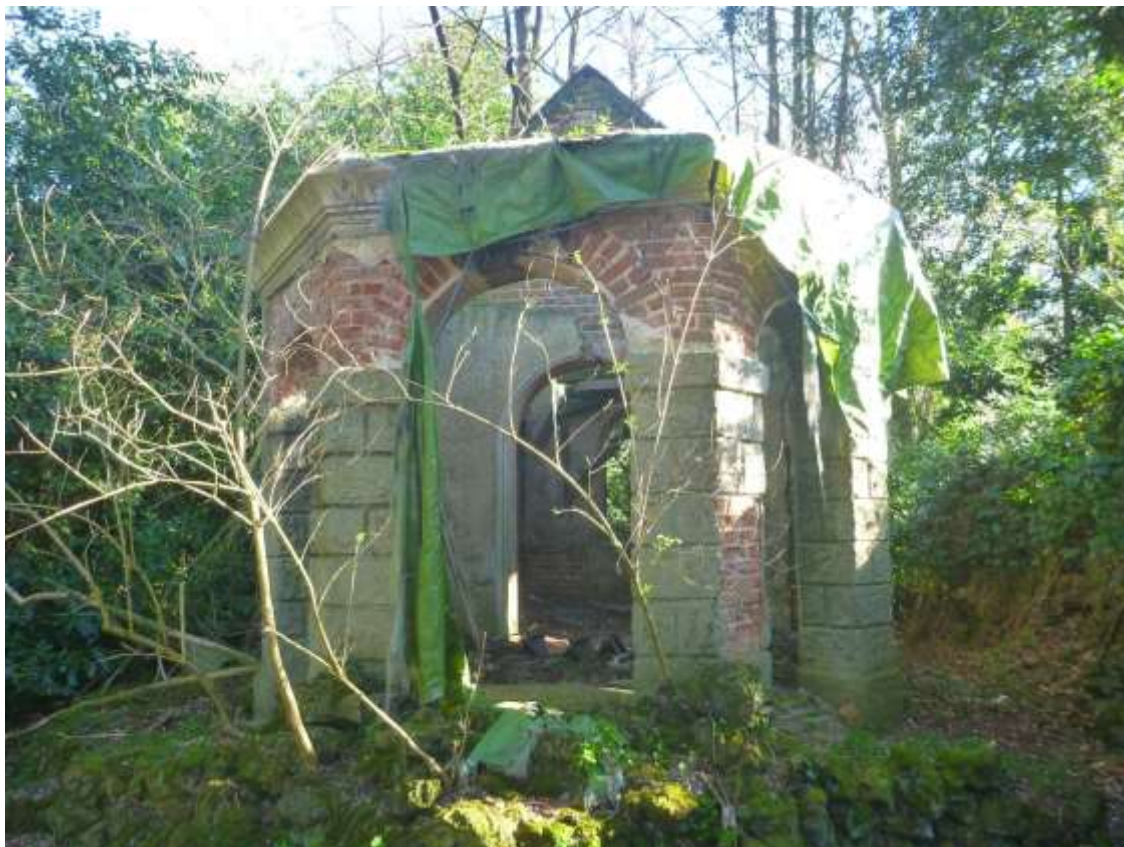
Date of photograph: 26/02/2019

Description: Grade II. Hermitage with grotto gardens dating from C17th. Various structures. Now in ruinous condition (and as described at time of listing). Remote location in woodland setting removed from house.

Works required: Overall objective to consolidate and prevent slow but inevitable and continuous decline unless minimal action taken. No economic use with future of unusual structure dependant on owner's guardianship. Remove vegetation.

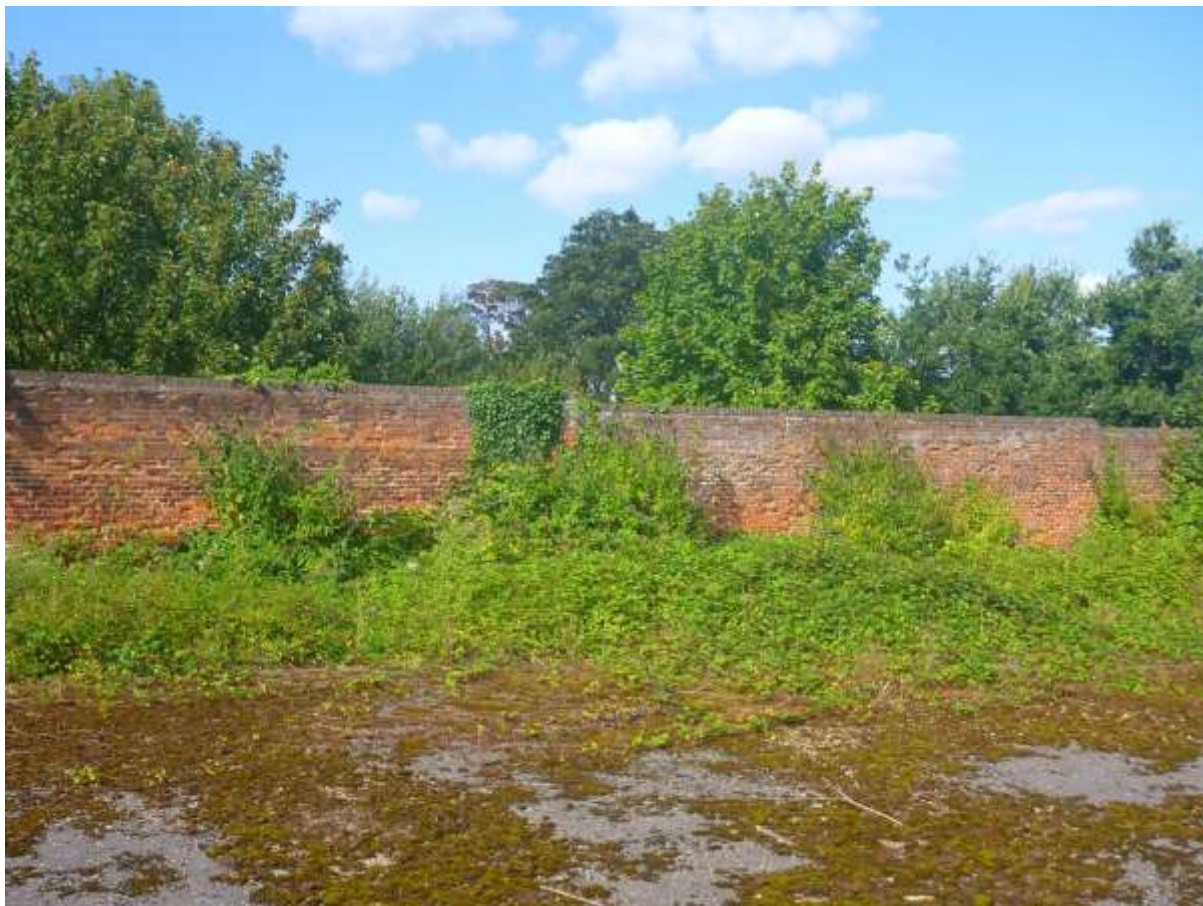
Date of photograph: 15/08/2019

Description: Grade II. Two walled gardens. Former Kitchen Garden Walls for Balls Park. Early C18, with C19 and C20 alterations and repairs. Red brick laid to Flemish bond, with Portland stone copings and finials to piers.

Works required: To restore the walled garden and architectural detailing as described in LB description following removal of vegetation.

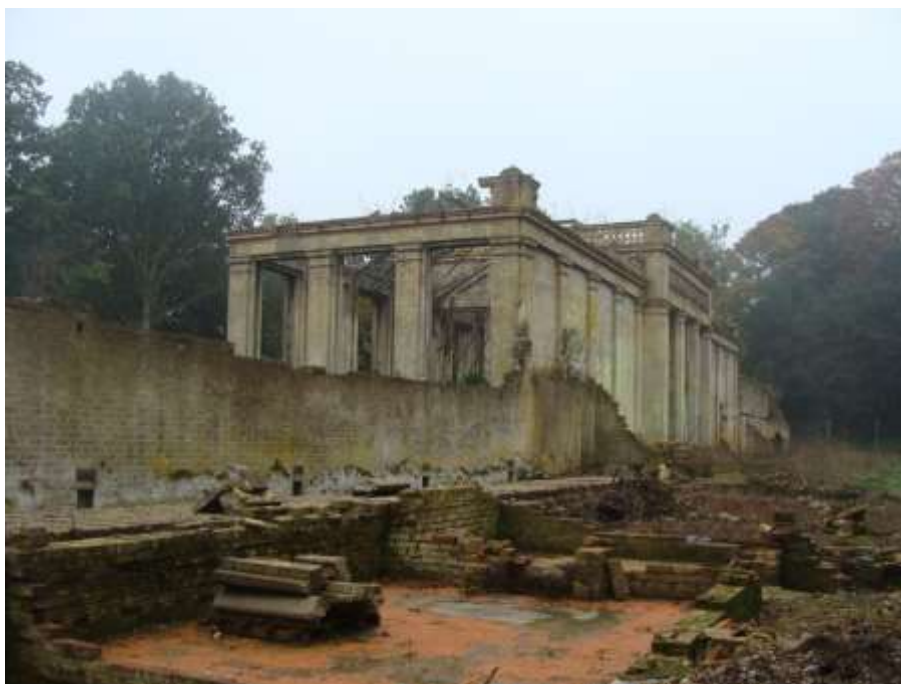
Date of photograph: 23/10/2012

Description: Grade II. Mid-C19th former Orangery and Conservatory to Panshanger House for the 7th Earl Cowper in classical style with rich distinctive detailing. Formal gardens once lay south of Orangery leading on to landscaped grounds and Mimram valley laid out by H. Repton, 1799-1801. Panshanger House demolished mid-C20th; footprint still exists nearby.

Works required: A clear vision for the future of this unique building is needed. Should be returned to its original use. A potential candidate for consideration of associated 'enabling development' possibly involving replacement of Panshanger House. Further strategic discussions needed.

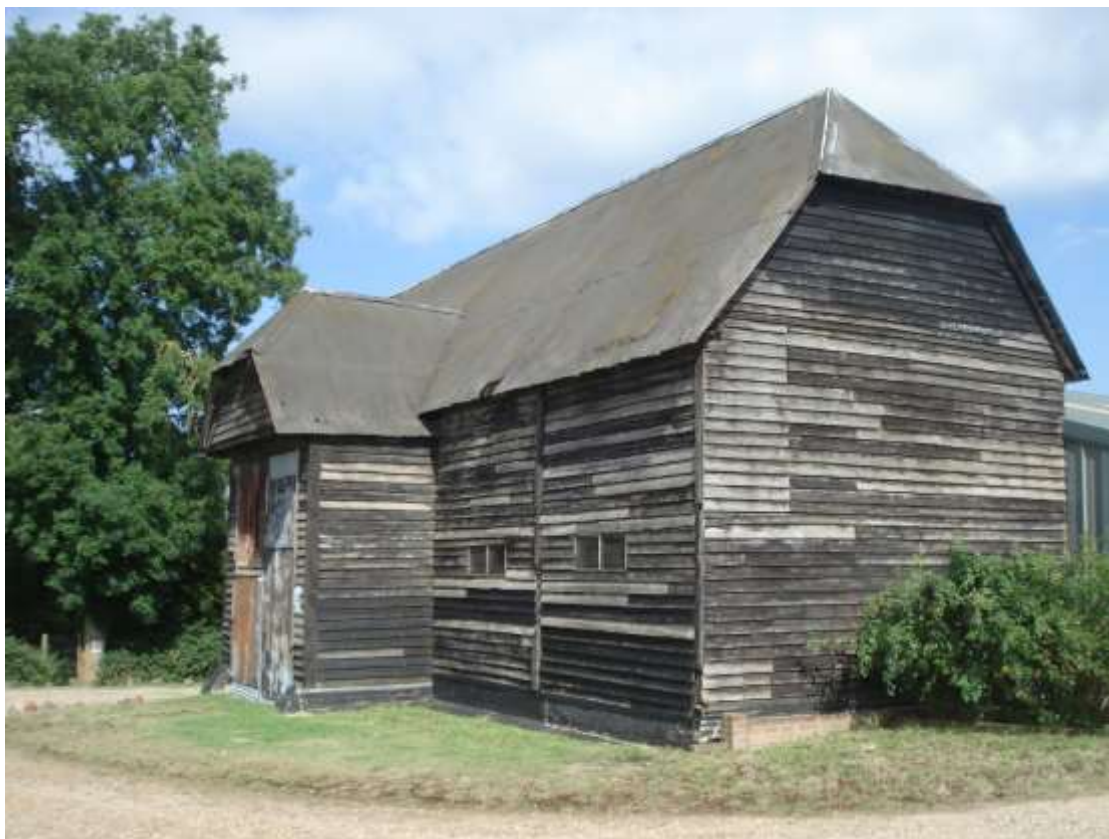
Date of photograph: 07/08/2014

Description: Grade II. Barn. C17th. Timber framed on a brick sill, weather-boarded. Steep pitched corrugated roof, half-hipped at ends. Projecting central porch with half-hipped roof and overhanging gable. Double doorway to porch currently without doors. Clapsed purlin roof structure with collars and inclined queen struts. Long curved braces from posts to tie beams.

- General renovation, or to be made watertight
- Assessment of damp / rot throughout
- Assessment to condition of timber frame
- Repair / replace weatherboarding and roof covering
- Repair / replace doors

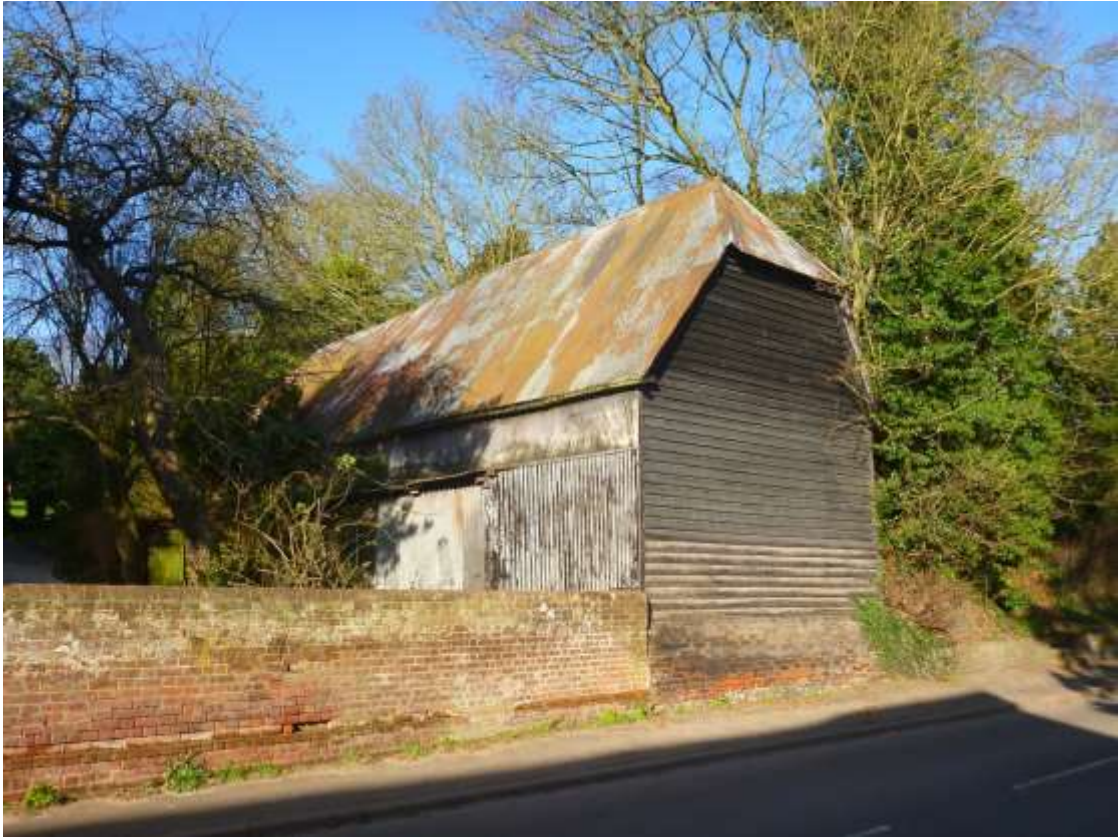
Date of photograph: 02/02/2016

Description: Grade II. Barn. C17th. 5-bay. Timber frame on tarred offset brick plinth. Part externally weather-boarded, part corrugated iron walls. Steep half-hipped corrugated iron roof. Central bay rear outshot opposite the central double doors. Jowled posts, long curved braces to tie-beams, clasped purlin roof with thin rafters. Mid height rail staggered with straight tension braces above and below. Face-halved bladed scarf joint in wall plates. Owned by Little Meadow.

- General renovation
- Assessment of damp / rot to timber frame and roof structure
- Repair / replace weatherboarding including some reinstatement
- Replace roof covering
- Repair / replace door

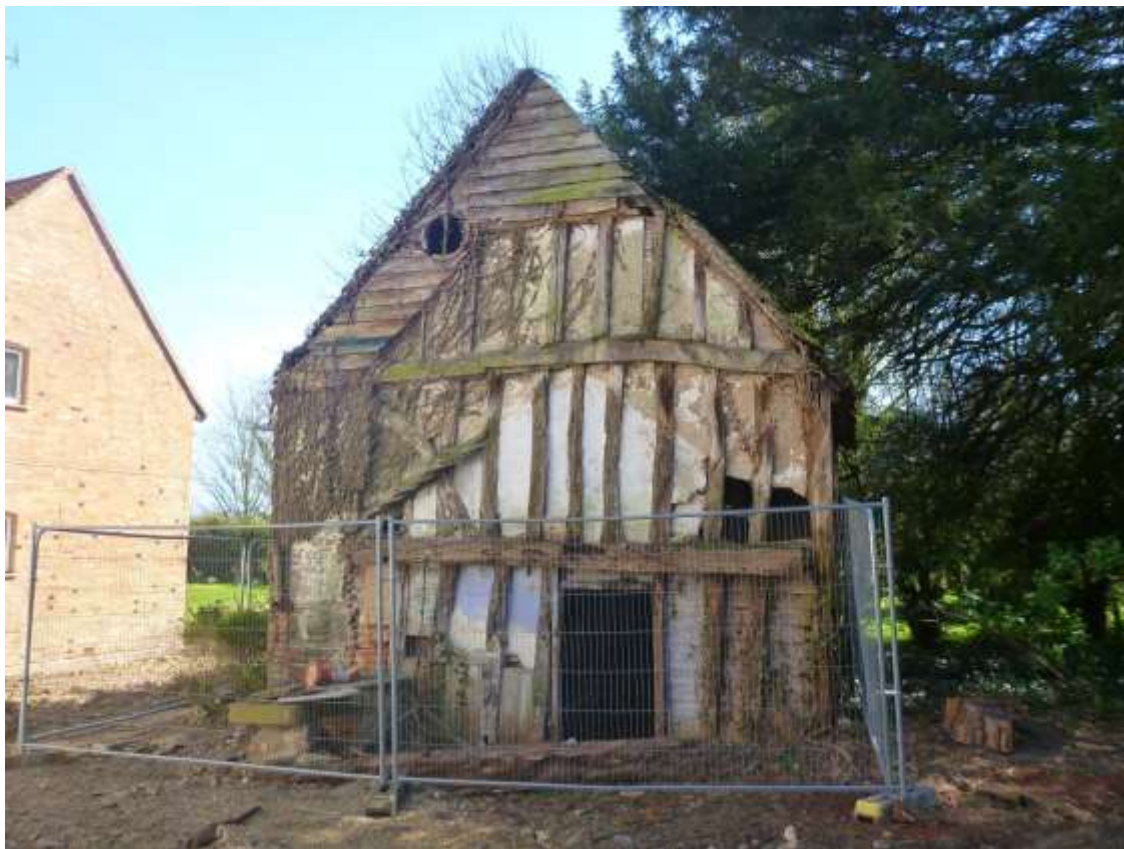
Date of photograph: 22/04/2021

Description: Grade II Brew House from C17th. Timber frame with steep old red tile roof. Converted to an RC chapel for R.H. Benson (1871-1914) between 1903 and 1914 but eventually abandoned when a new chapel was built in 1917.

Latest update: Discussed repairs with new owner in April 2021.

Works required: Overall objective to restore building without loss of small scale and historic interest. Ideally as an ancillary use to main building. In extremely poor condition.

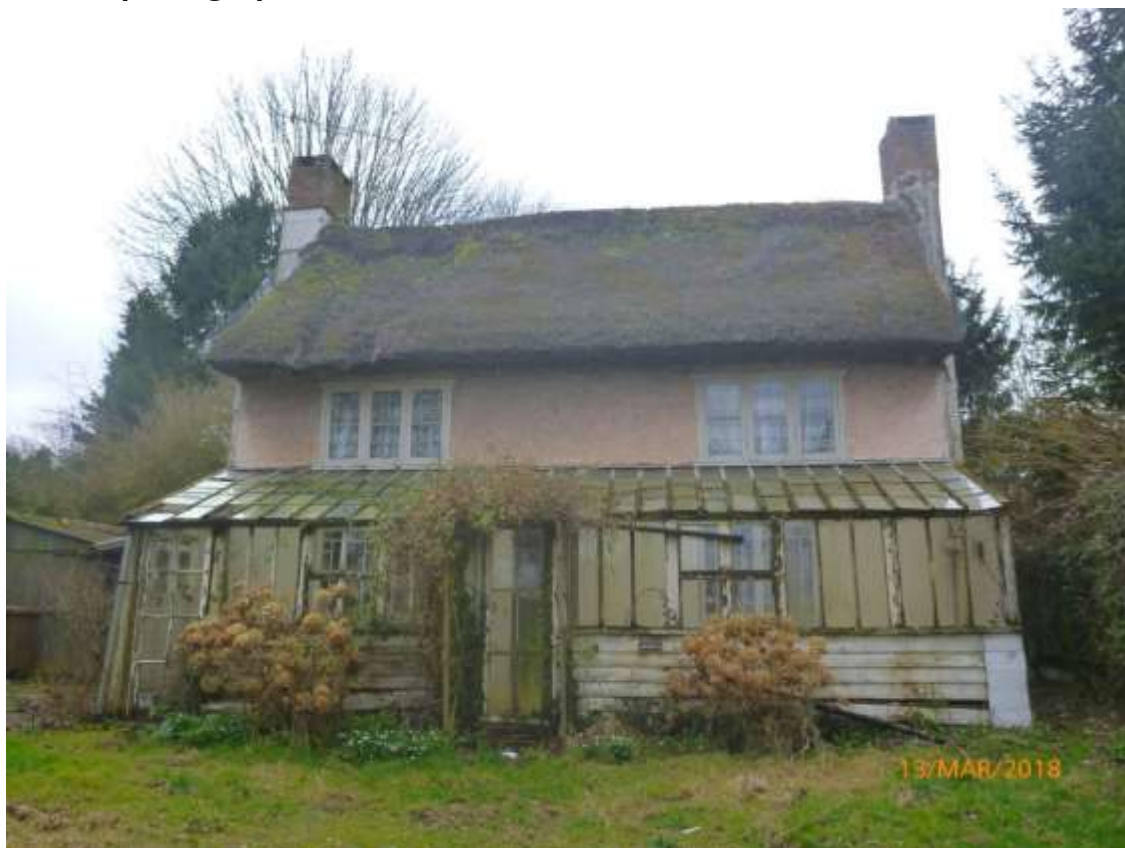
Date of photograph: 13/03/2018

Description: House. Between 1806 and 1823. Timber frame roughcast with steep thatched roof. Symmetrical, 2-storeys, 2 windows wide house facing E with end chimneys and central door with margin lights. 3-light flush casement windows. Glazed conservatory across Ground Floor front.

- General renovation to be habitable
- Assessment of damp / rot throughout
- Rethatching or repairs to thatch as necessary

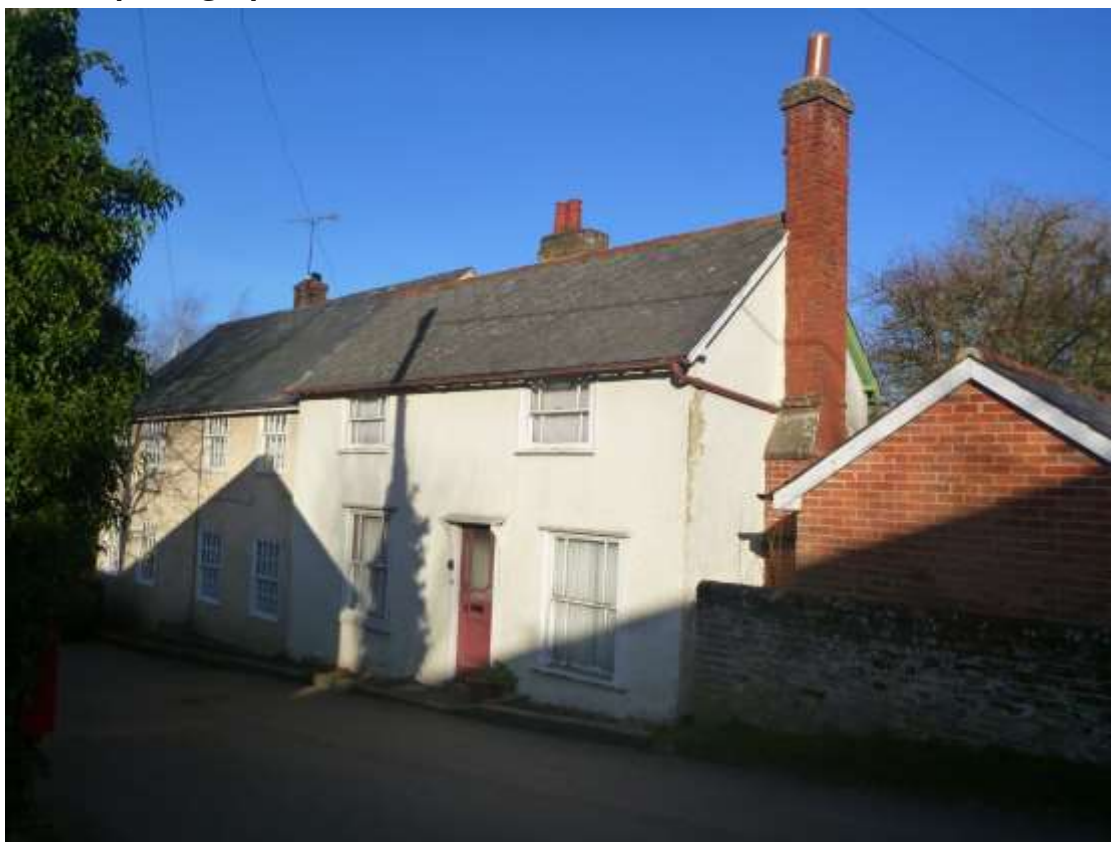
Date of photograph: 02/02/2016

Description: Grade II. House. C17th or earlier. Raised to two storeys in early C19th. Timber frame on brick sill, plastered. Roof of asbestos slates, some currently missing. 2-cell plan. Entrance into S part between two windows. External gable chimney to S part: rear wall chimney to N part. Ground floor front windows tall margin-light sashes with smaller sash windows close under eaves to first floor. Panelled margin-light front door with weather-hood on brackets. Owned by adjoining house.

- General renovation to be habitable
- Assessment of damp / rot throughout
- Assessment to condition roof structure
- Repairs to roof and guttering
- Repair / replace windows and doors

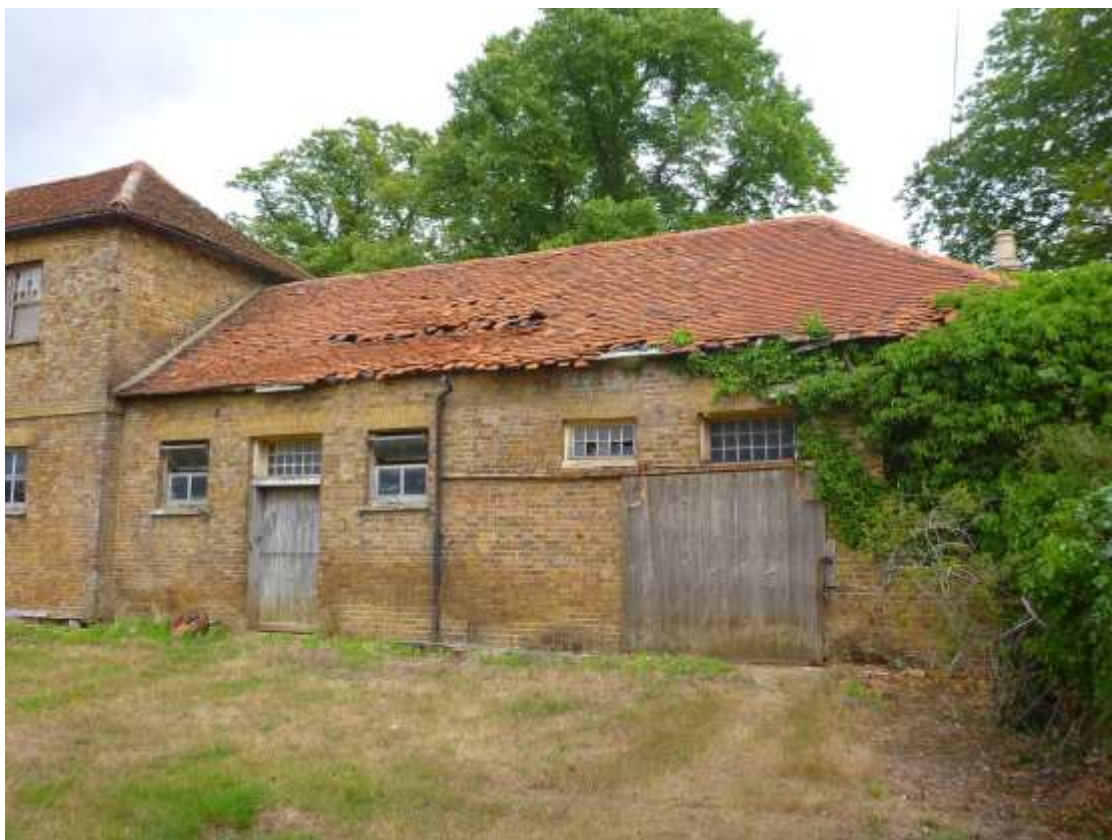
Date of photograph: 23/07/2015

Description: Grade II. Stables attached to separately listed central granary and further stables. Early C19th. Brick stable range with hipped red tile roof. Four boarded stable doors with multi-light fanlights under a yellow brick gauged arch. Flanked by small high-set windows, each under a yellow brick gauged arch.

- General renovation, or to be made watertight
- Assessment of damp / rot to roof structure
- Repair / replace roof covering
- Repair / replace doors and windows

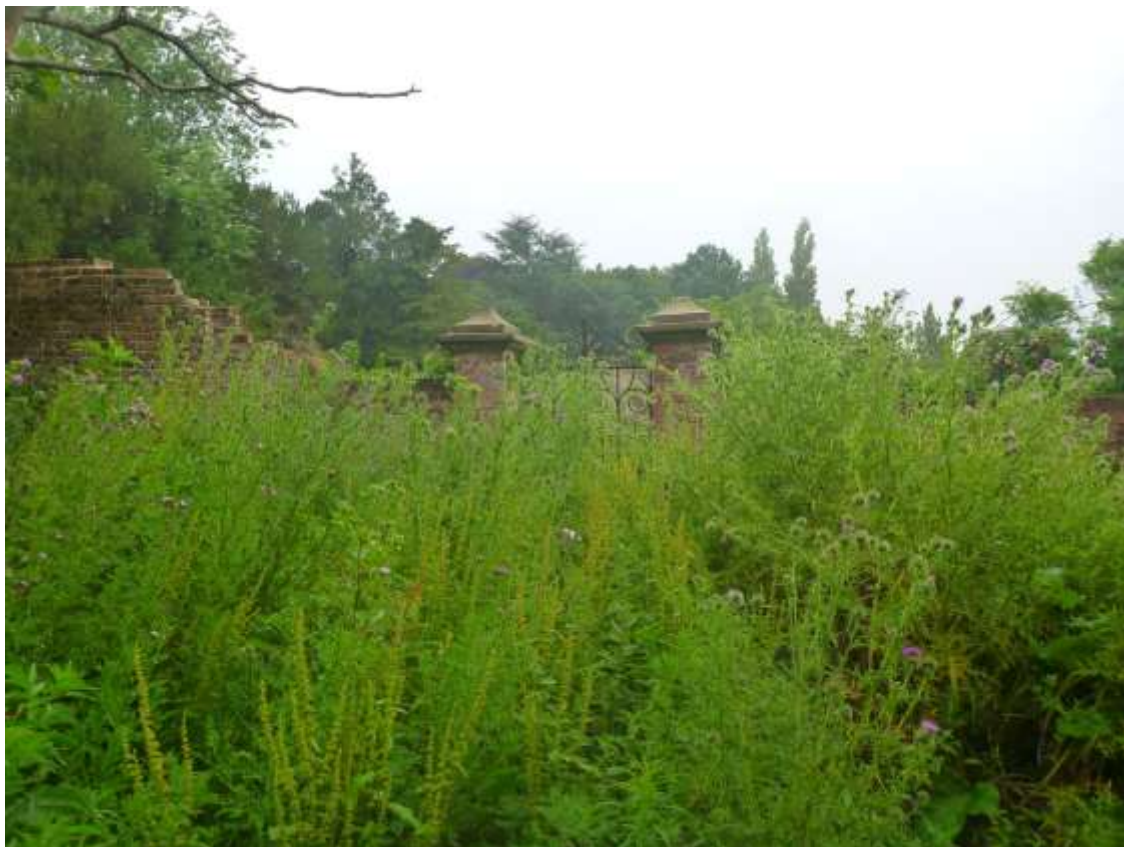
Date of photograph: 09/07/2020

Description: Grade II. Kitchen garden walls, sundial, and 2 gates, dating from C18th. Probably part of the extensive works at Briggens c1770 by the Blackmore family. Gates probably for H C Gibbs c1908. An historic C18 walled garden.

Works required: To restore the walled garden and architectural detailing as described in LB description following removal of vegetation.

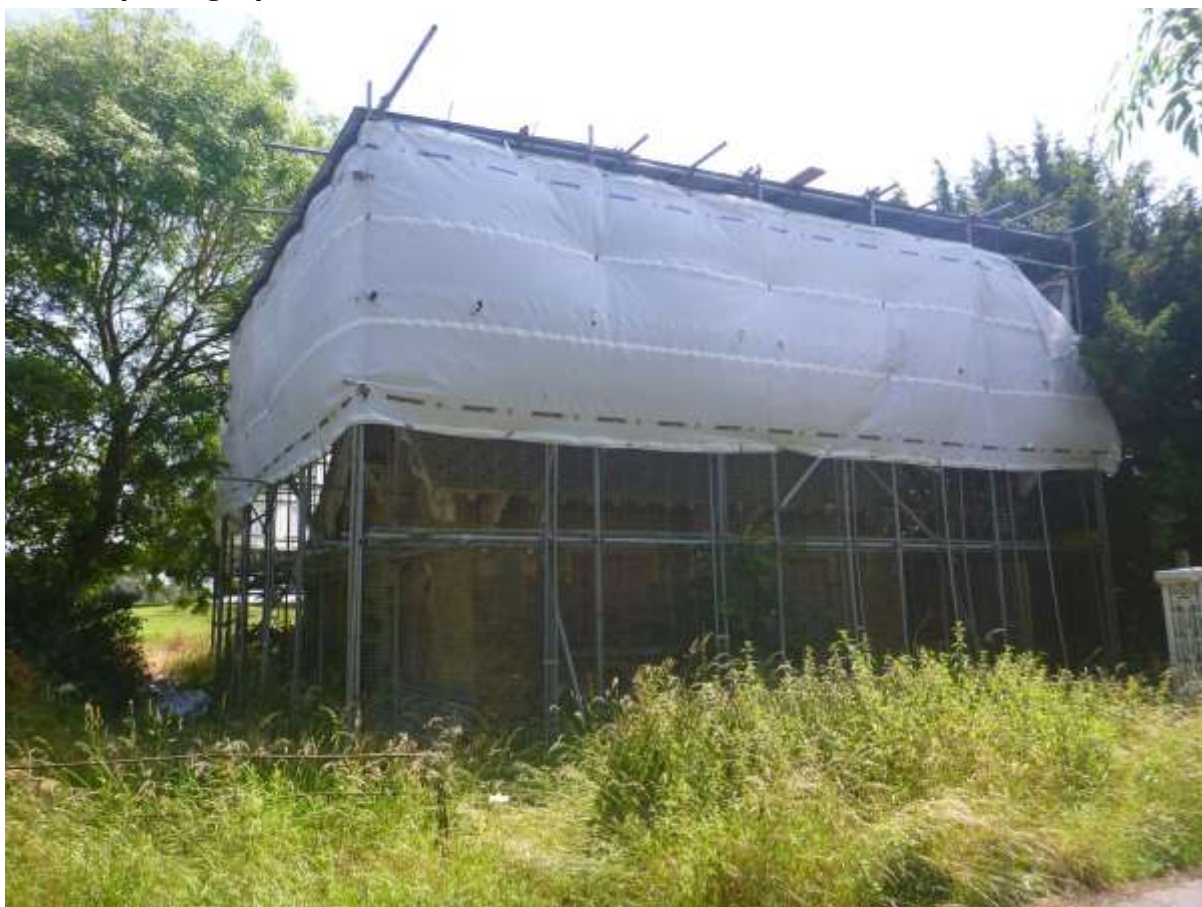
Date of photograph: 28/06/2019

Description: Grade II. Lodge. Mid-C19th. Single storey grey brick Tudor style gate house at the entrance to the North Drive. Low pitched gabled roofs of large patent scalloped buff tiles. Stone coat of arms over the door with motto 'Pro Ars et Focis' and a serpentine, pierced wooden bargeboard with finial to the roof overhang. Tall brick central chimney with 2 square shafts. Similar details on lower gabled wing set back to E.

- Secure the site
- General renovation to be habitable
- Assessment of damp / rot throughout and condition roof structure
- Repairs to roof and guttering
- Repair / replace windows and doors

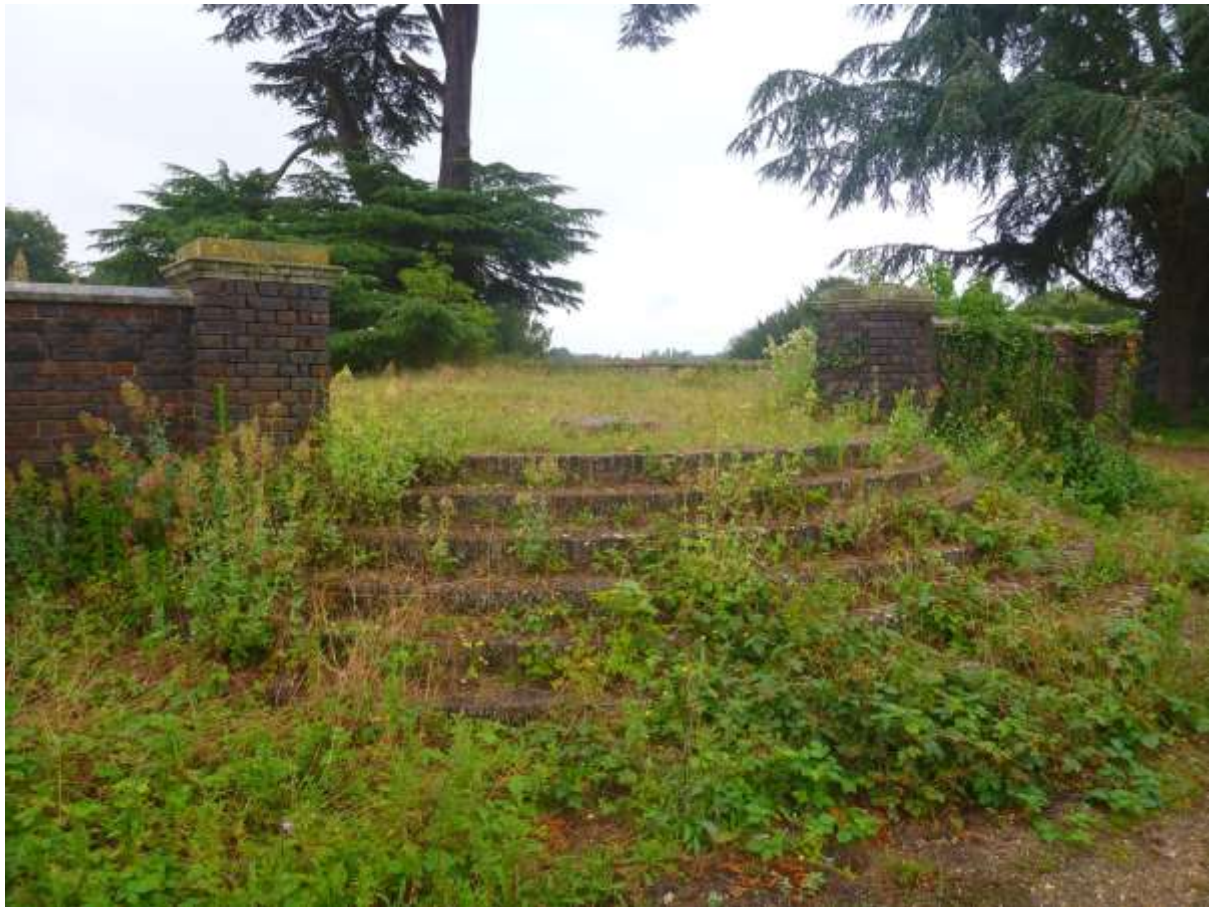
Date of photograph: 09/07/2020

Description: Grade II. Terrace walls and steps. Circa 1908 for H C Gibbs. Plum brick with recessed joints in walls, deeply chamfered stone copings, stone and moulded stucco seat, York stone paving. Formal lower terrace to S of house, 80 metres long with seat in recess at .W end at upper level. 2 flights of 7 semi-circular brick steps project southward, 1 near each end, flanked by low square brick piers with stone capping set in the long brick retaining wall with similar capping. Seat modelled in Florentine style with circular central achievement in the back with motto 'Tenax roposite'. An impressive architectural feature, essential to the setting of the house.

Works required: To restore the terrace and architectural detailing as described in LB description following removal of vegetation.
