EAST HERTS COUNCIL HERITAGE AT RISK REGISTER

Updated July 2021

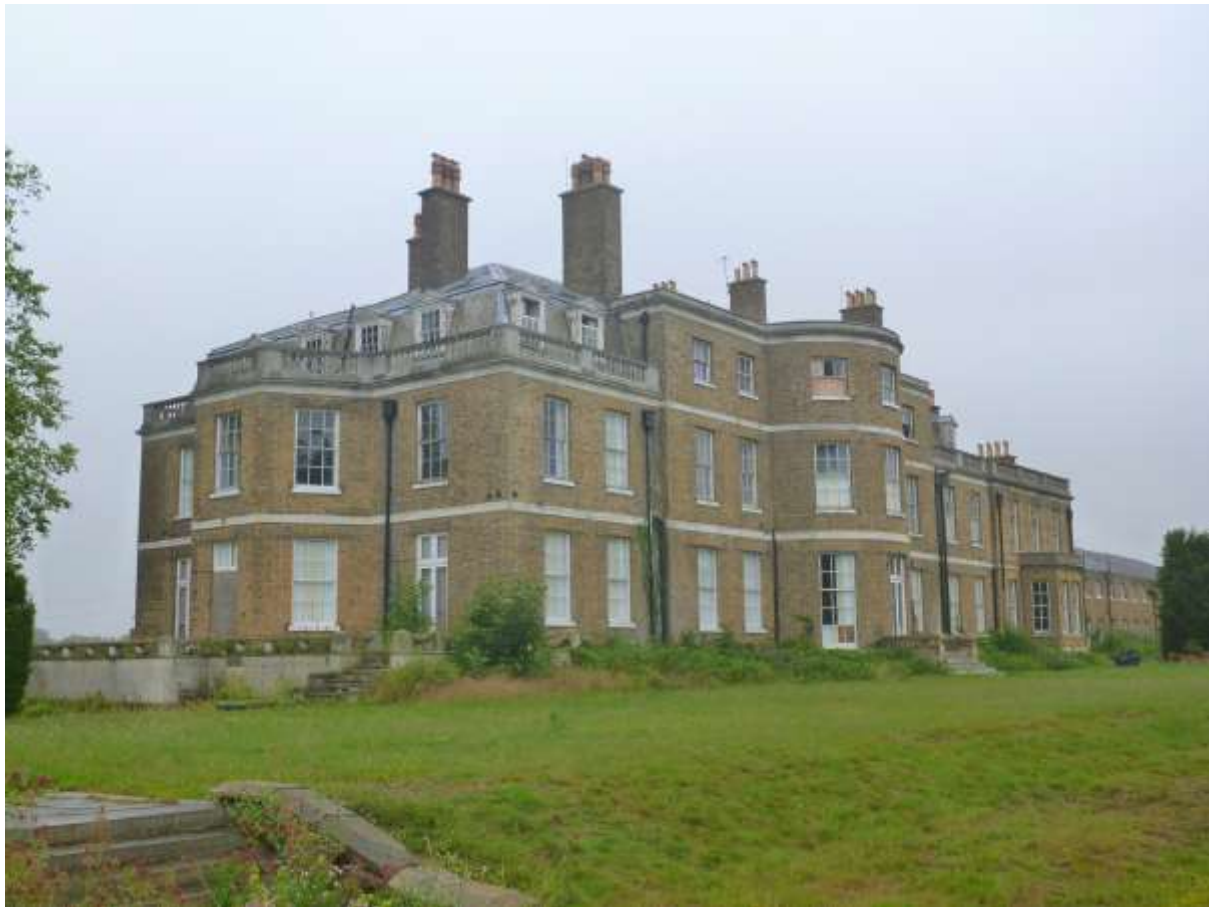
Date of photograph: 09/07/2020

Description: Grade II. Country House. Circa 1719 by the mason Christopher Cass (1678-1734) for Robert Chester, a director of South Sea Company: 2-bay N and S blocks and 2nd floor added for Thomas Blackmore probably c1770. N end and W side extensions in 1899: alterations 1908. On hilltop site facing W in a landscaped park designed by Charles Bridgeman in c.1720. Grey brick with stone dressings, hipped slate roof, Portland stone upper terrace on S end overlooking a tank of York stone. 3 storeys above basement, 7 windows front. Balustrade of low square piers with stone rails between supported on stone balls.

- General renovation to be habitable
- Assessment of damp / rot throughout
- Assessment to condition roof structure
- Repairs to roof and guttering
- Repair / replace windows and doors

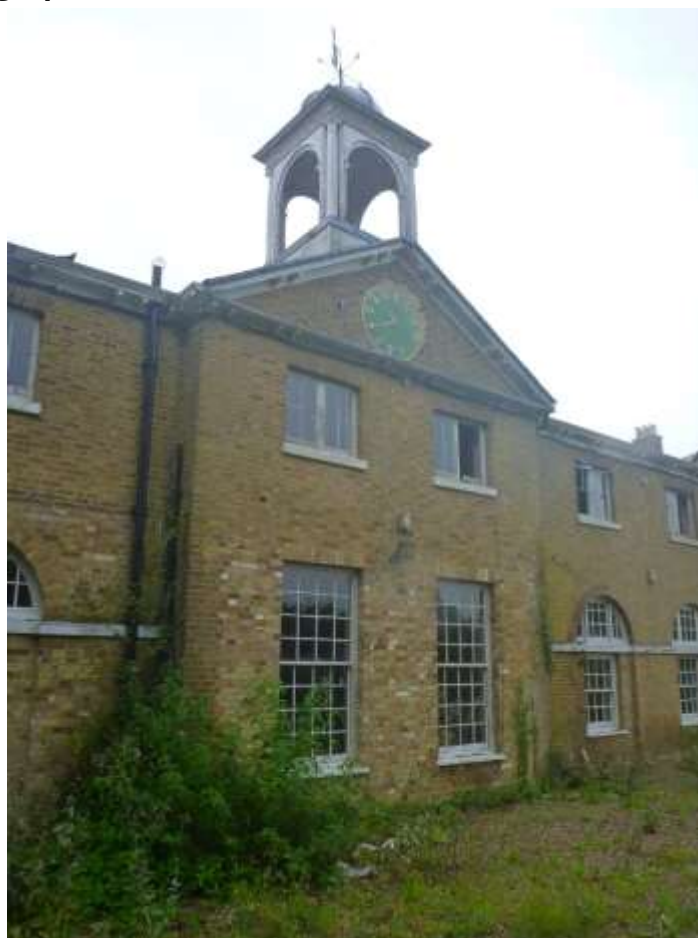
Date of photograph: 09/07/2020

Description: Grade II. Stable block. C18, probably 1770 for the Blackmore family. 2 storeys. Wooden cornice with paired brackets. Rectangular block with 2-window central projection on W with triangular pediment and clockface in tympanum. White wooden square cupola over, topped by low dome and windvane with a fox. Round-headed openings in each face, dentilled cornice and Tuscan columns recessed at each corner. Bell said to be cracked. Recessed sash windows with glazing bars. Front arches now blocked and large sash windows inserted.

- General renovation to be habitable
- Assessment of damp / rot throughout
- Assessment to condition roof structure
- Repairs to roof and guttering
- Repair / replace windows and doors

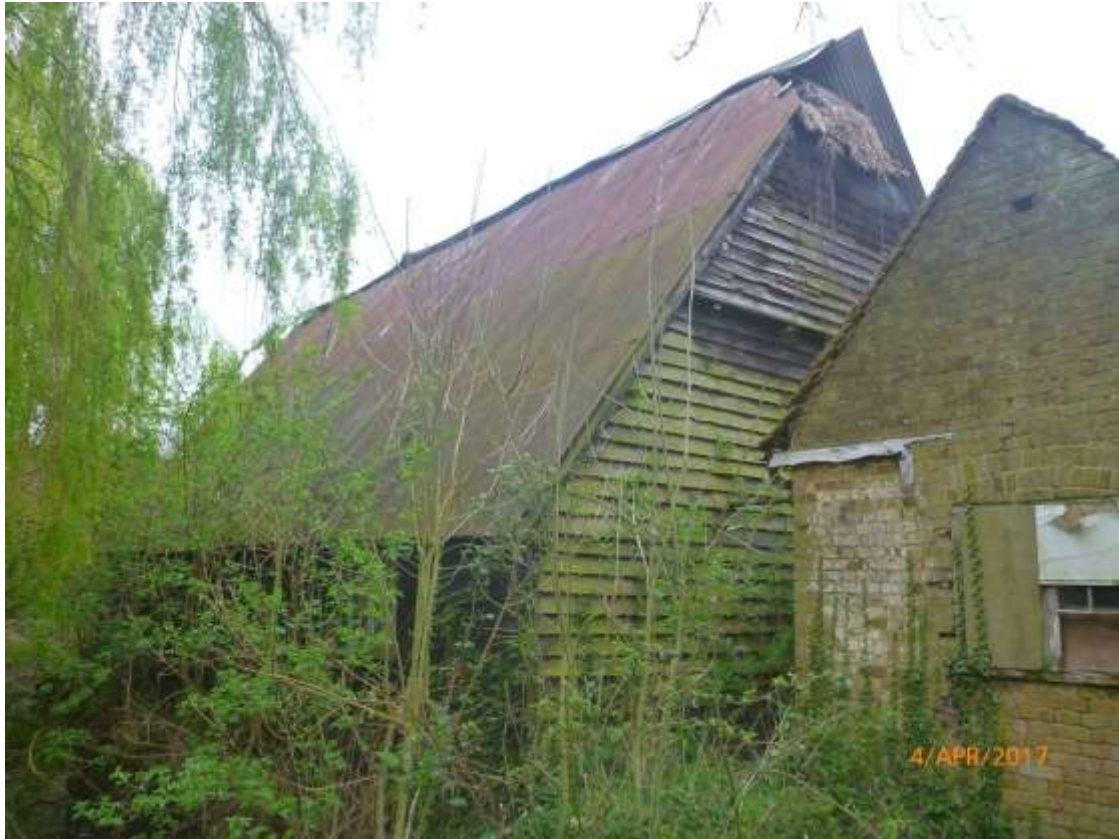
Date of photograph: 04/04/2017

Description: Grade II. Aisled barn. C17th or earlier. 4-bay. Timber framed on a red brick sill, external weatherboarding. Steep gabled roof thatched with red tiled valleys to thatched gabled porch in second bay from E. Rear slope now covered in corrugated iron. Shouldered jowled posts, curved braces to tie beams and arcade plates. Thin clasped purlin roof with curved wind braces and lap jointed collars. Arcade plate scarfed over entrance with face halved and bladed scarf. Wall plates have edge-halved scarf joints with bridled butts. Owned by The Old Farmhouse.

- General renovation
- Assessment of damp / rot to timber frame and roof structure
- Repair / replace weatherboarding
- Repair / replace thatched roof
- Repair / replace doors and windows

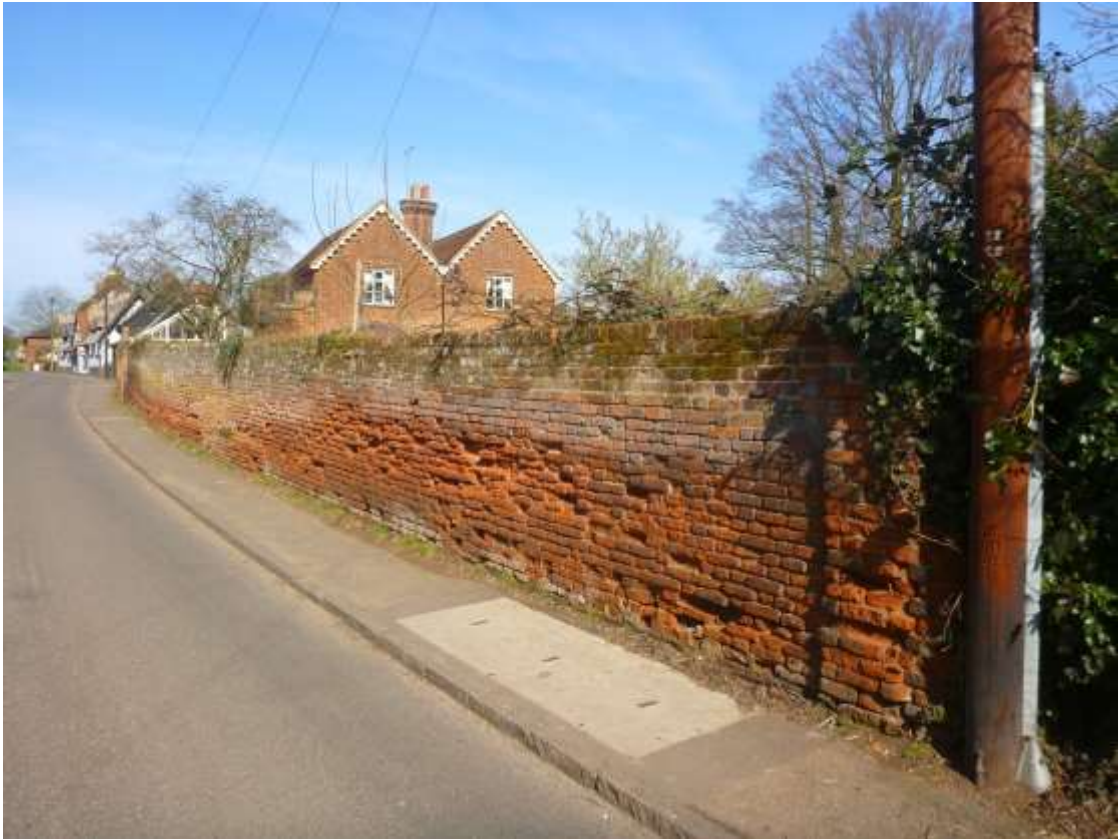
Date of photograph: 14/03/2016

Description: Grade II. Wall. C18th or earlier red brick wall, top rebuilt in C19th. C18th to early-C19th single storey, brewhouse adjoining N end of wall, facing E. Red brick W, N and E walls of brewhouse. Steep red tiled gabled roof. Long red brick wall fronting street. Old irregularly bonded brickwork with chamfered plinth offset stepping up at piers for wide and narrow gateways beside house. Now blocked and small gateway next to S pier of larger opening. Owned by Ford House.

Latest update: Repairs discussed with owner in May 2018, but not yet carried out.

- Repairs to wall / assess if need to rebuild in sections

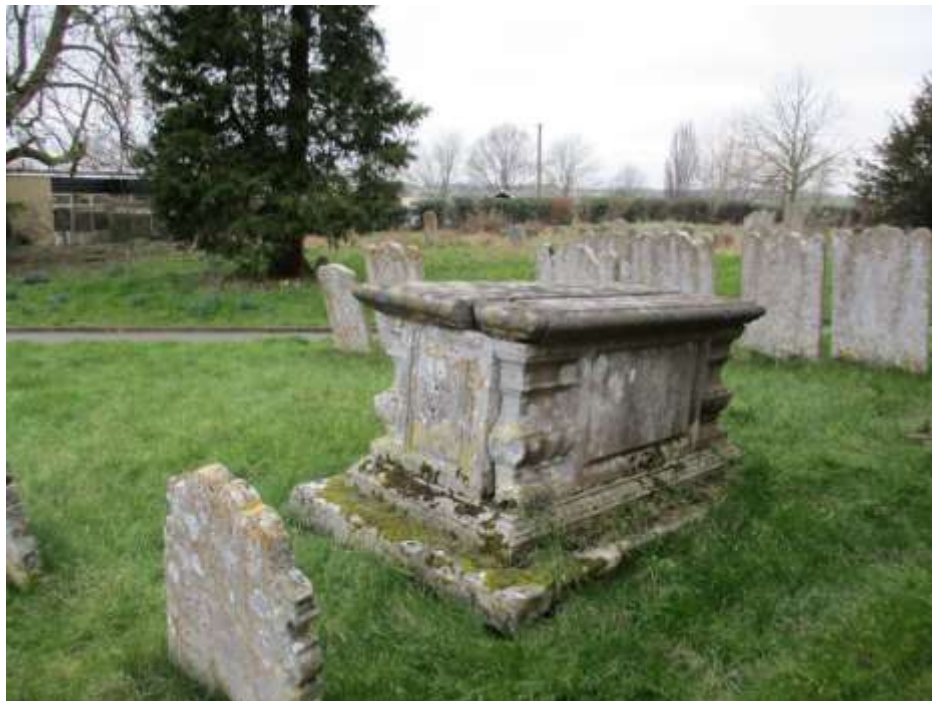
Date of photograph: 15/03/2016

Description: Grade II. Chest-tomb. C18th. White limestone with grey stone top slab. Rectangular chest-tomb with step, moulded base and moulded edges to outstanding top slab. Rectangular fielded panel in the middle of both sides and end with recessed moulded and gadrooned corners.

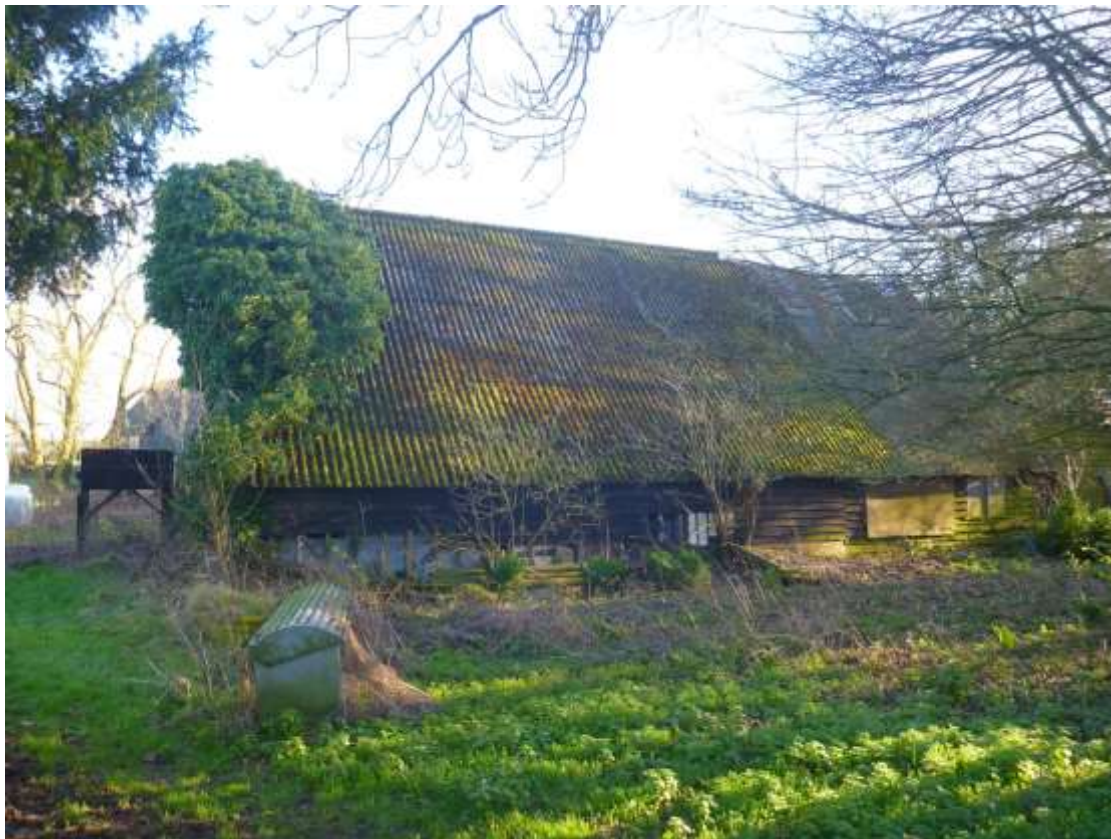
Date of photograph: 02/02/2016

Description: Barn. C18th to early-C19th. 5-bay with rear aisle. Probably post and truss construction. Timber frame on a brick sill with external weatherboarding and some corrugated iron walling. Corrugated iron gable ended roof. Large doorway to end facing the road, now covered with corrugated iron. Weather-boarded lean to at both the side and the rear. Owned by Meesdenbury Farm.

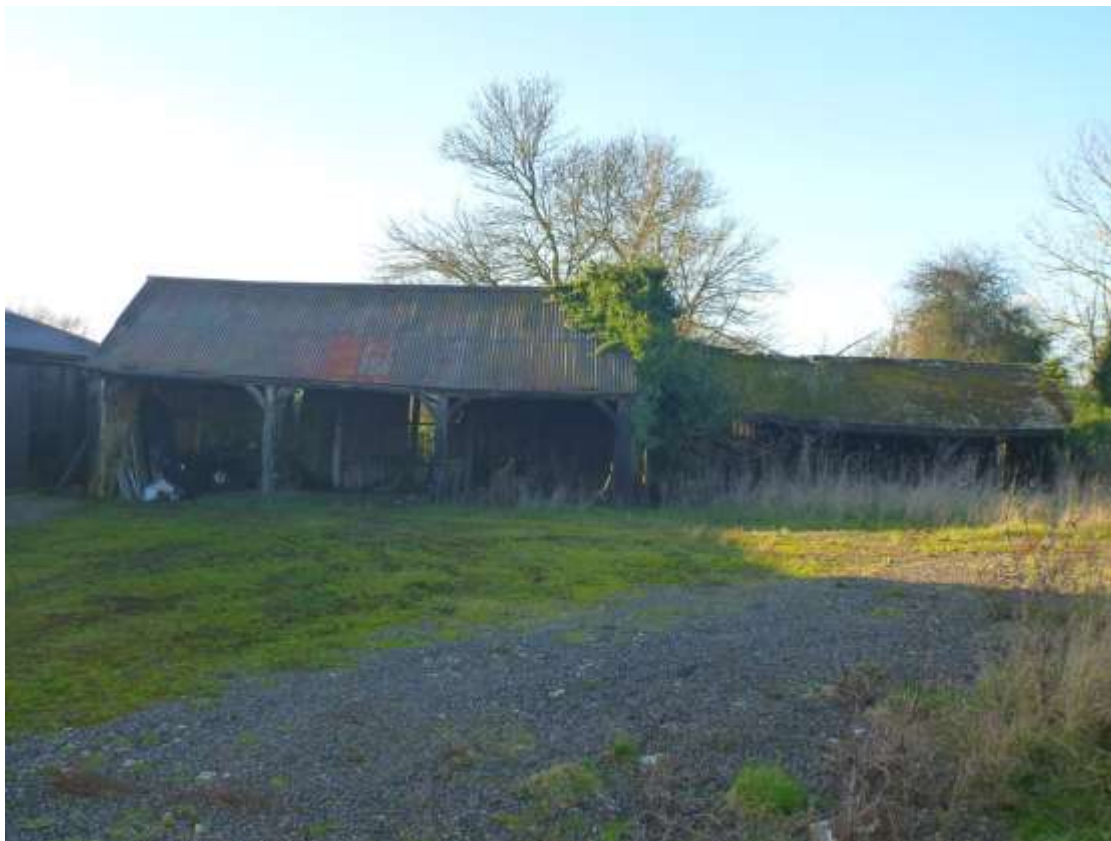
Heritage Asset Number: (1176988)

Description: Farm buildings. C18th to C19th. Two 3-bay cart-sheds. Post and truss construction. Timber frame on a brick sill with external weatherboarding. Corrugated iron gable ended roofs. Open sided into farmyard.

- General renovation
- Assessment of damp / rot to timber frame and roof structure
- Assessment of stability to tiled roof
- Repair / replace weatherboarding
- Repair / replace roof covering

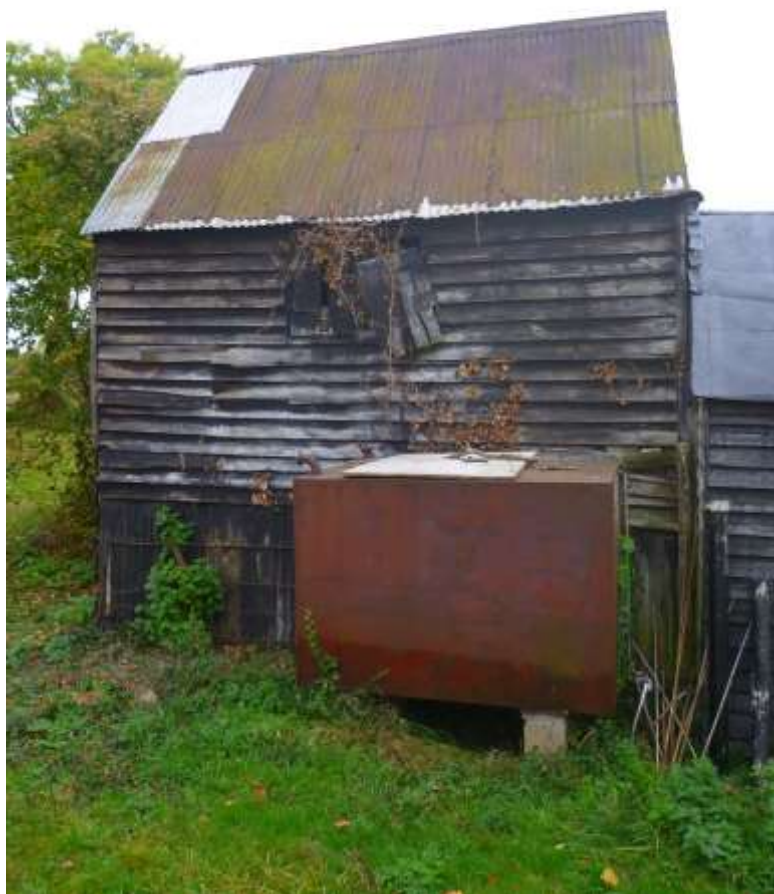
Heritage Asset Number: 1445216

Description: Grade II. C16th Granary. Two-storey two-bay timber-frame building. Weather-boarded. Corrugated iron roof. Owned by Camwell Hall Farm.

- Replace failing roof with tiled roof.
- Assessment of rot to timber-frame and repairs as necessary.
- General renovation

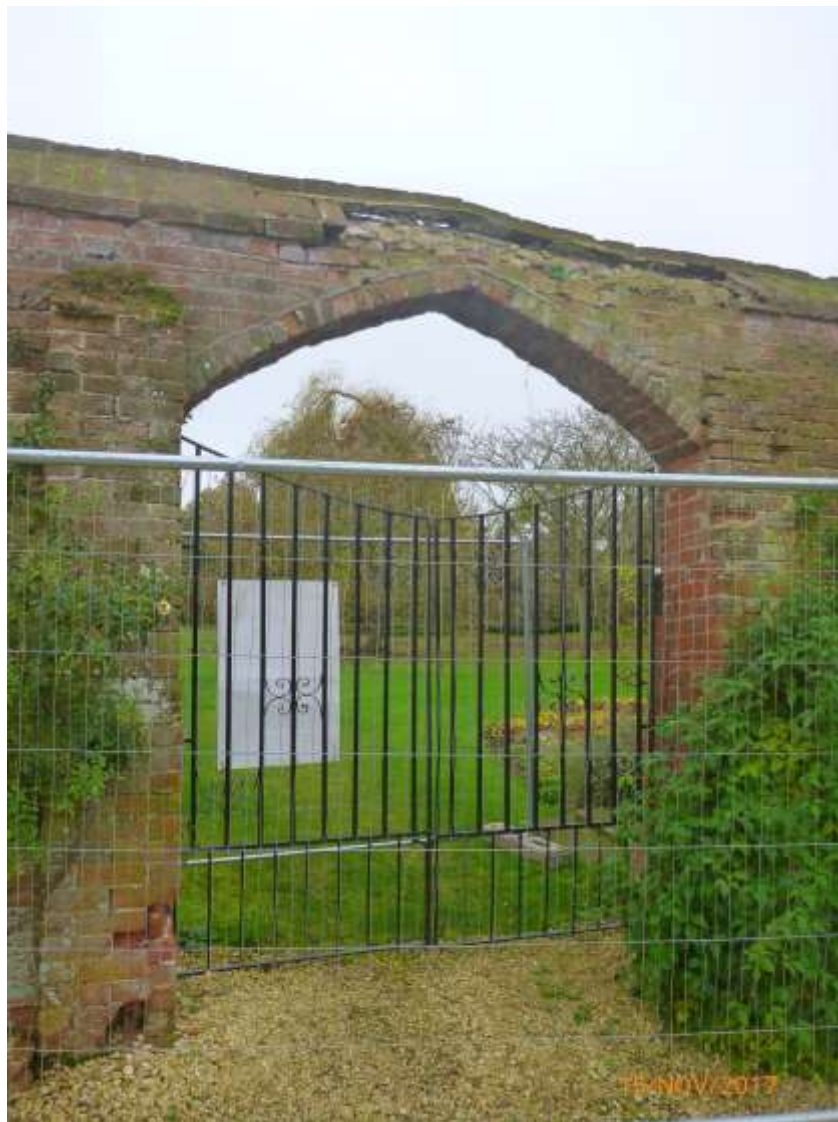
Heritage Asset Number: 1213384

Description: Grade II. Former Kitchen Garden Wall to Moor Place. C18th in red brick, and approximately 3 metres high. Owned by Montagu House.

Works required: South side of wall and archway are structurally unsound, and have leaned. Owner stated that until recently the wall and arch were covered in ivy that had masked the problem.

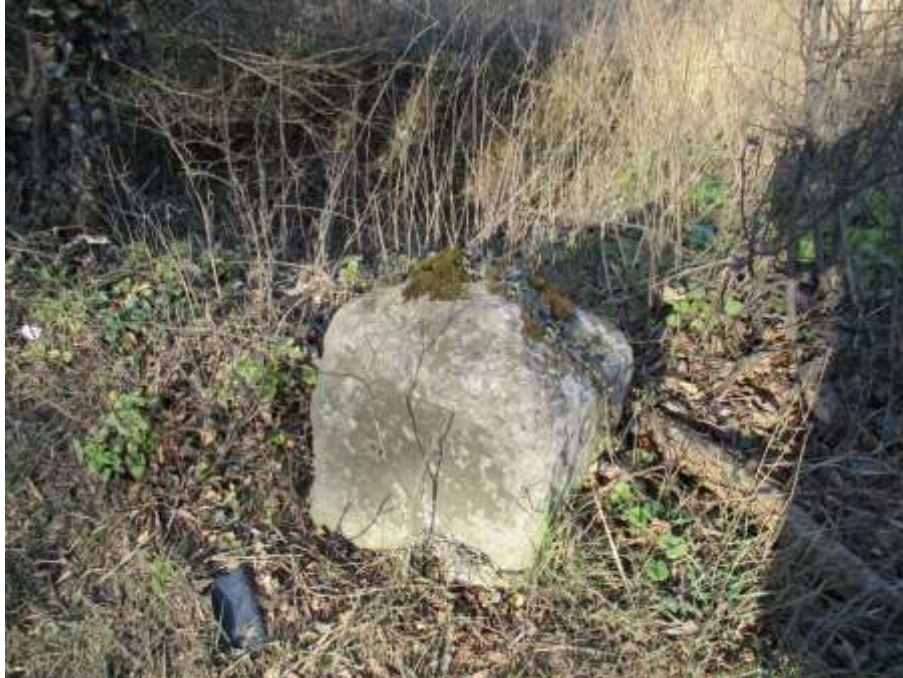
Heritage Asset Number: 1370061

Description: Grade II. Milestone. 1751 for Watton Turnpike Trust. White freestone. A low square pillar less than half a metre high, partly buried, pyramidal head. 24 on front face is distance to London in miles. To rear is an inscribed reference to the road, "Repaired by a Voluntary Subscription from the Inhabitants of Ware 1751".

Latest update: HCC now actively involved in commissioning repairs. This section of the A602 is being upgraded. Application 3/21/0842/LBC was submitted for the relocation of this milestone to fit the new road layout.

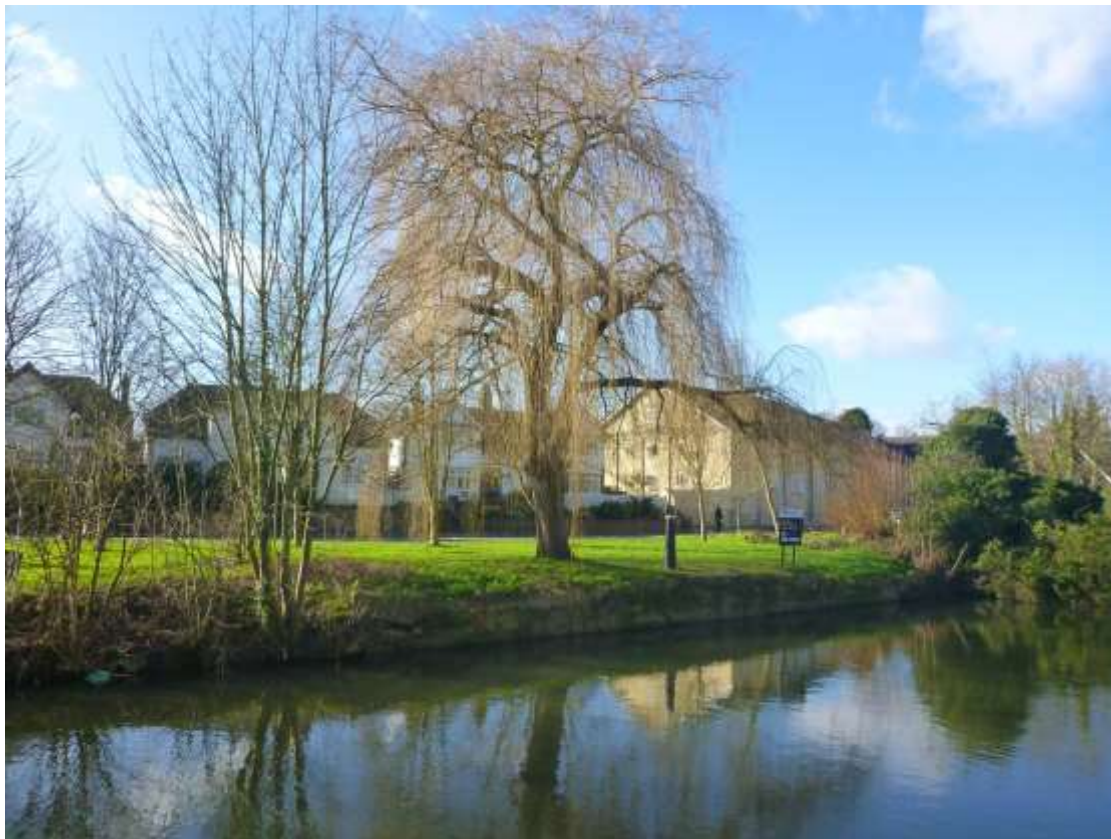
Heritage Asset Number: 1101629

Description: Grade II. Wall. C18th to C19th. 5 foot high solid iron pillar, tapering from 15 inch diameter at base. Expanded moulded head. Projecting central top pin. Base for crane at former wharf, about 5 feet from water edge where brick revetment is topped by large 9 foot long York stone slab. Owned by the Canal and River Trust.

- General restoration
- Assess stability of quay wall
- Repairs to wall and crane base
- Clean and paint cast iron

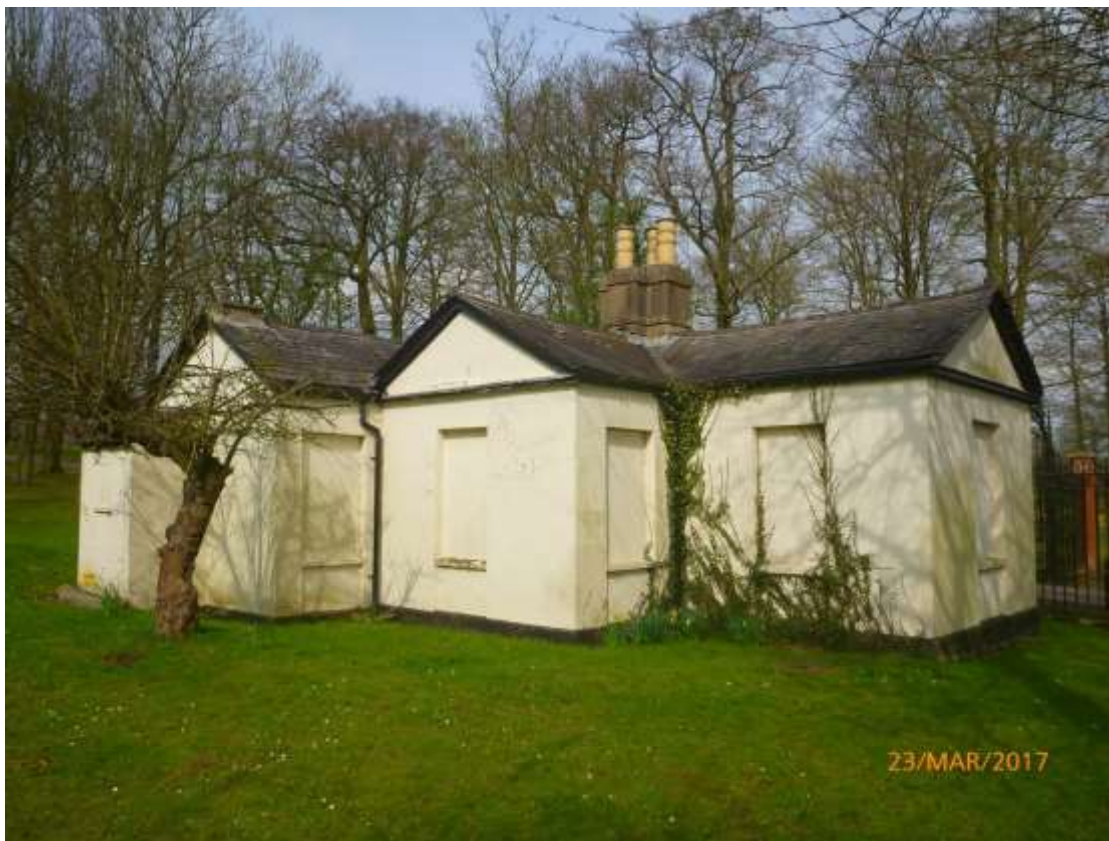
Heritage Asset Number: (1102394)

Description: Gatehouse. C19th. Single storey. Classic style building at front entrance of St Edmund's College next to gate and gate piers. White painted render over yellow brick scored to look like ashlar. Black painted render base sill. Slate gable ended roof. Simple pediment to ends. Two rendered yellow brick chimney stacks with pots. Blind and open windows. 6-over-6 sash windows with stone/concrete sills. Door to north side. Owned by St Edmund's College.

- General renovation
- Assessment of damp / rot throughout
- Repair / replace render
- Repairs to roof and guttering
- Repair / replace windows and doors

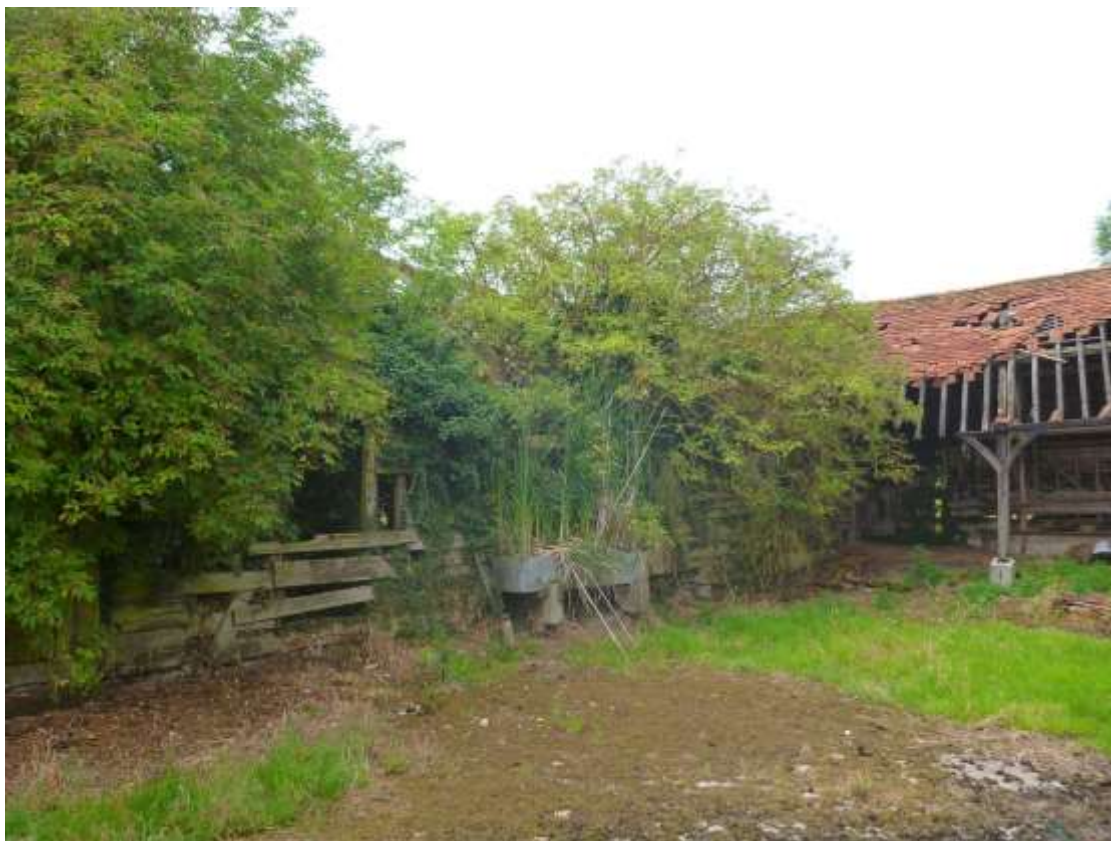
Heritage Asset Number: (1078743)

Description: Stables. C19th. Timber framed on a brick sill, weather-boarded with steep hipped roof exposed. Attached to large barn to W. Series of stable doors to N. Brick boundary wall to E. Further building to S completing U-plan with barn.

Latest update: Deteriorating. Potential for conversion should be encouraged in the near future to avoid further loss of historic material.

- Total renovation, or to be made watertight
- Assessment of damp / rot to timber frame and roof structure
- Repairs to brick base
- Repair / replace timber weatherboarding
- Replace roof covering
- Repair / replace doors

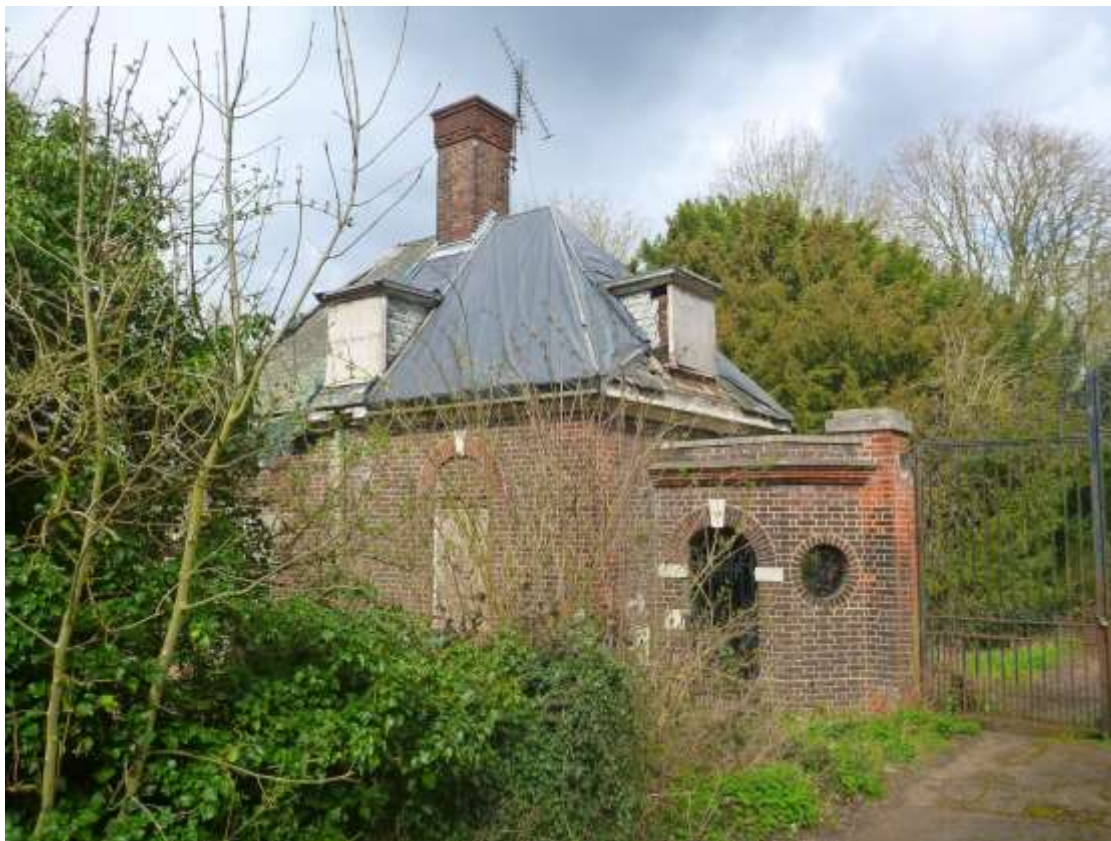
Heritage Asset Number: 1149361

Description: Grade II. Pair of gate-lodges 'HCG 1914' on approach bridge parapet. Plum brick with red brick dressings, steep Coniston slate hipped roofs. Tall single-storey and attics. Square central chimney and flat topped dormer with moulded cornice on each side. Two flush box sash windows with 6/6 panes, each set in round arched panel with keystone. Moulded wooden eaves cornice. Matching brick extensions at rear of each lodge. Parapeted flat roofed open porch links each lodge to a gate pier with wrought iron gates.

- Secure the site
- General renovation to be habitable
- Assessment of damp / rot throughout and condition roof structure
- Repairs to roof and guttering
- Repair / replace windows and doors

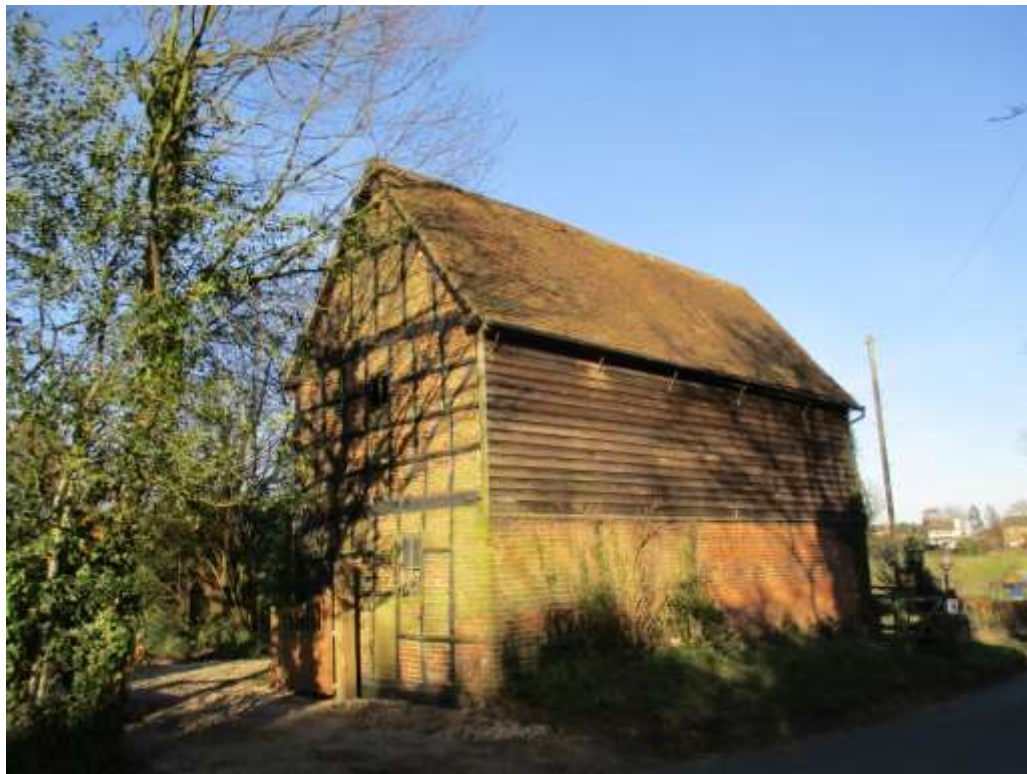
Heritage Asset Number: 1055846

Description: Grade II. Former stables with hay loft, now workshop and storage. Late C17 / early C18. Exposed timber frame with red brick, largely infill. Some weatherboarding. Steeply pitched tiled roof. 3 bays. Left gable end exposed small panel framing of thin scantling, mid rail with upper tension braces, cambered tie beam, struts to collar clasp purlins. Ground floor plank door and small pane casement. First floor 2 light window with a diagonal mullion. Right gable end all boarded. Rear catslide roof over a boarded and rendered lean-to. Central double doors with ground floor boarding. First floor 2 loft doors, exposed framing with a tension brace, 2 light window with a diagonal mullion. Owned by the Old Rectory.

- General renovation
- Assessment of damp / rot to timber frame and roof structure
- Repairs to brick base and brick in-filling
- Repair / replace render to lean-to and timber weatherboarding
- Repair roof covering and guttering
- Repair / replace doors and windows

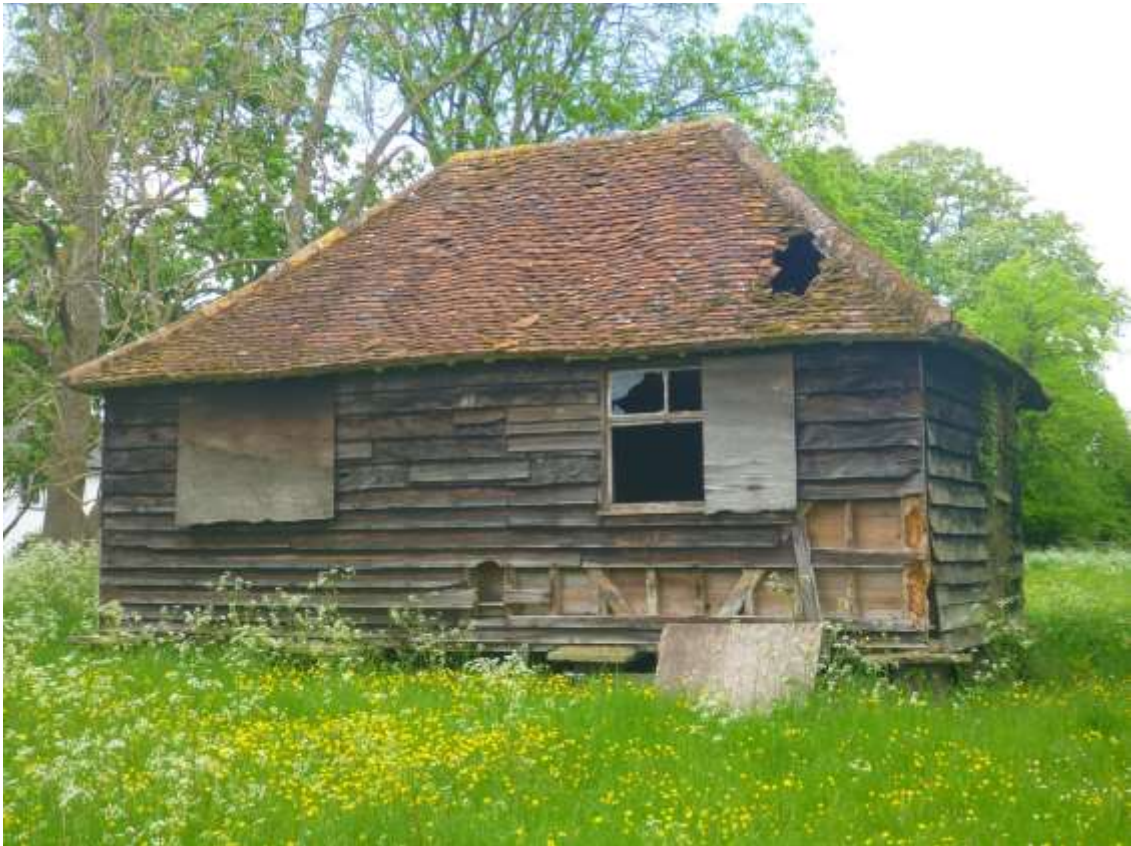
Heritage Asset Number: 1101393

Description: Grade II. Granary. C18th. Timber frame on red brick piers with projecting stone caps. Weather-boarded. Steep hipped tiled roof. Stuccoed brick stair at E end. Single storey rectangular granary raised on three rows of four piers. Plank door in middle of E end, now boarded up. Two windows have been inserted in S face, now boarded up. Only remaining building of College Farm, burned down in early-C20th. Owned by The Old Rectory.

- General renovation, or to be made watertight
- Assessment of damp / rot to timber frame and roof structure
- Repairs to brick piers
- Repair / replace timber weatherboarding
- Repair / replace roof covering
- Repair / replace doors and windows

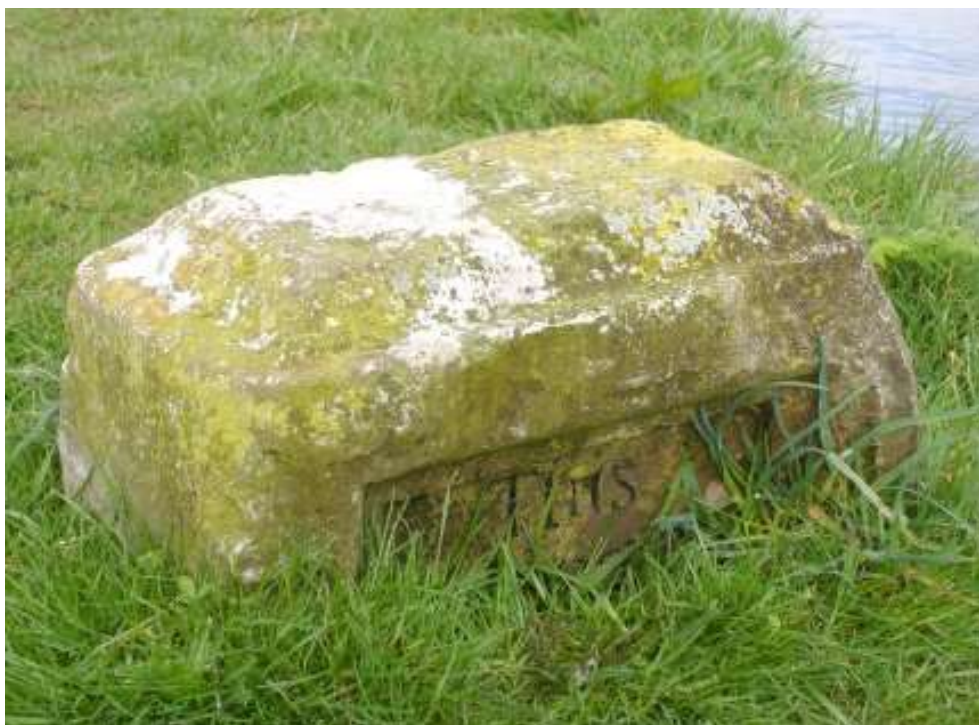
Heritage Asset Number: 1221275

Description: Grade II. Marker stone. Mid-C18. Limestone block with recessed panel on face inscribed 'This belongs to New River Company', located approximately 100m west of the sluice gates on the cut joining The New River to the River Lea and set in the bank.

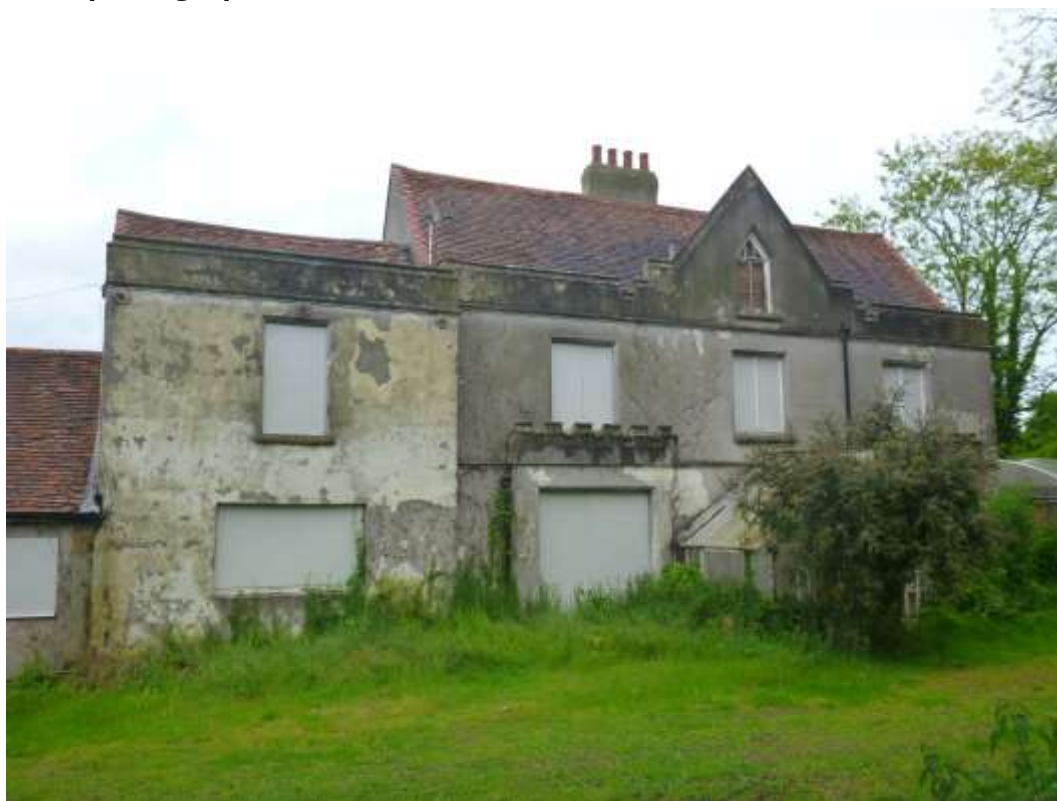
Heritage Asset Number: 1089152

Description: Grade II. Late C17th Farmhouse, re-fronted 1840-50 in Gothic Style. Largely brick built, now covered by stucco, with red tile roofs. A large L-shaped house of 2-storeys, attics, and cellar, facing south. Later low extensions.

- General renovations to be habitable
- Assessment of damp/rot throughout
- Repairs to roof and rainwater goods
- Repairs or replacement of windows and doors

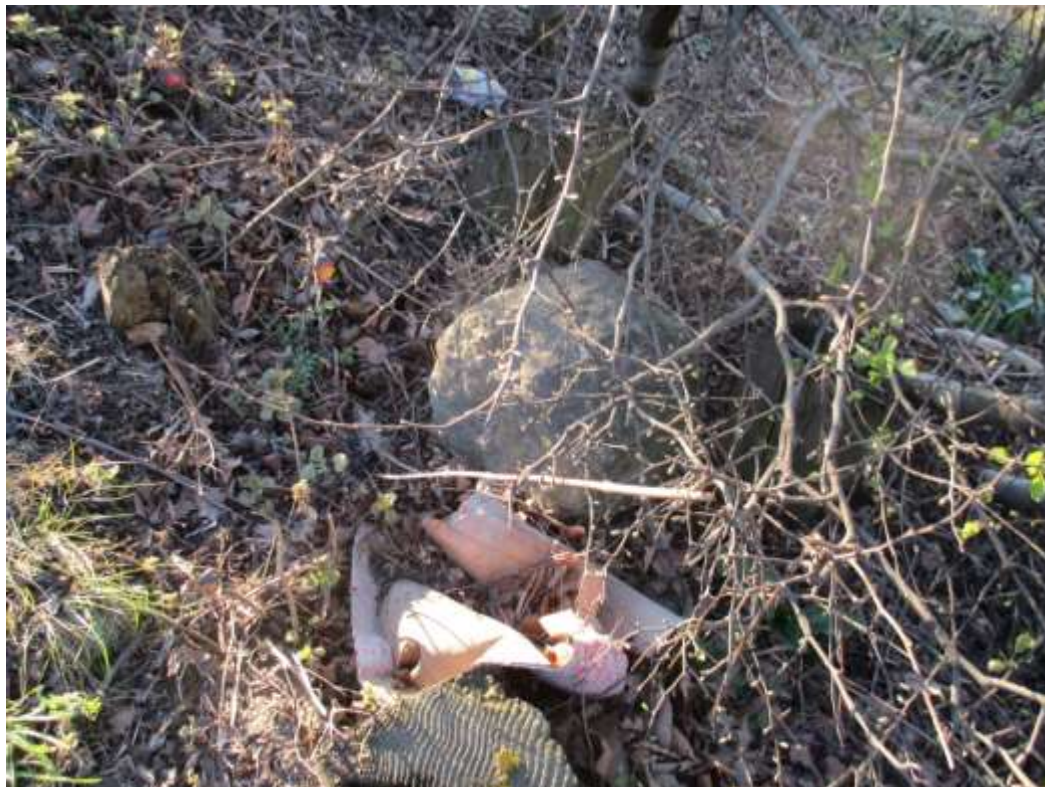
Heritage Asset Number: 1089076

Description: Grade II. Milestone. Mid-C18th. Erected by Watton Turnpike Trust. White freestone. A low square pillar about 3/4m high with a rounded head. No inscription legible. Marks 25 miles to London.

Latest update: HCC now actively involved in commissioning repairs. This section of the A602 is due to be upgraded. It has been agreed between HCC and EHDC that to avoid traffic disruption the restoration of this milestone should be undertaken at the time of the road improvements.

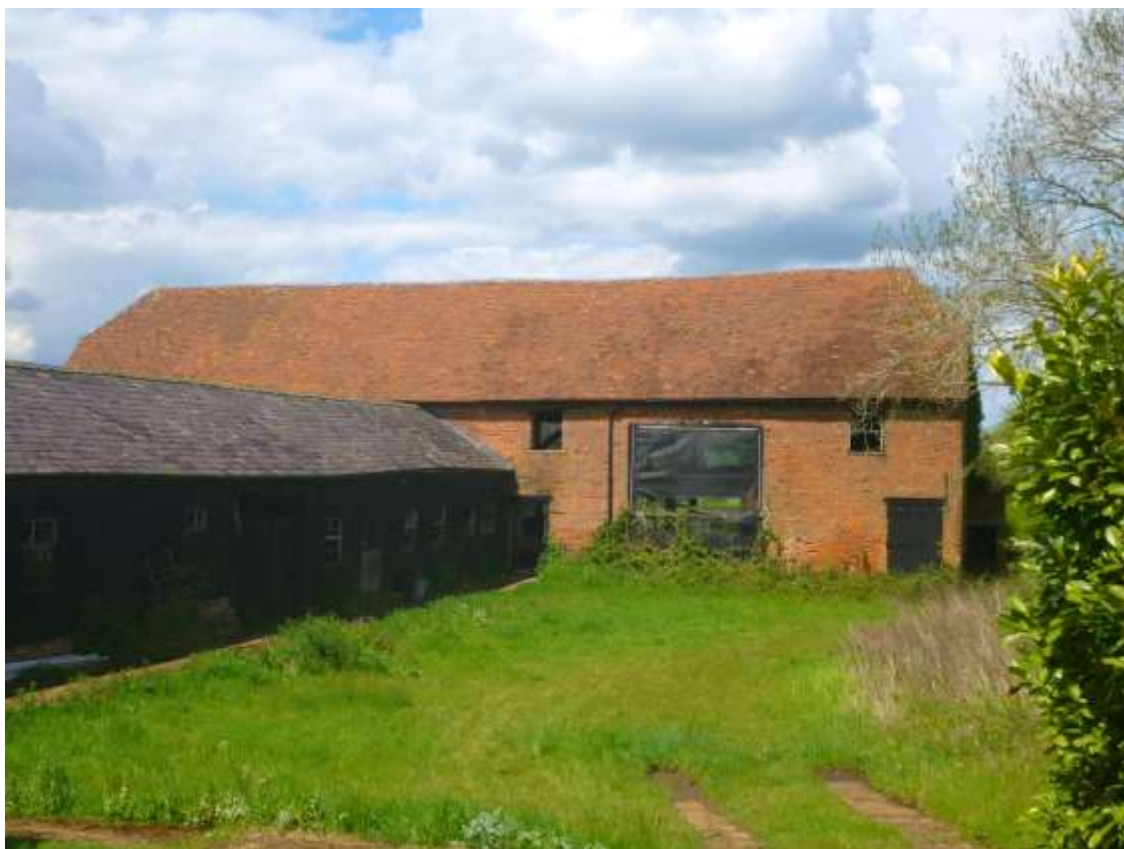
Heritage Asset Number: 1295904

Description: Grade II C17th barn, altered in late-C18th, North aisle removed late C20th. Timber frame now cased in red brick with steep half-hipped old red tile roof. 7-bay. Tall barn facing S with double doors in 2nd and 6th bays. West elevation bulging, openings not enclosed; brickwork in some locations poor.

Latest update: Roof has been repaired.

Works required: Overall objective to secure future of building, which after discussion with owner most likely to take place by incremental repairs. Following discussions it is understood that progress is being made in this respect. Monitor progress.

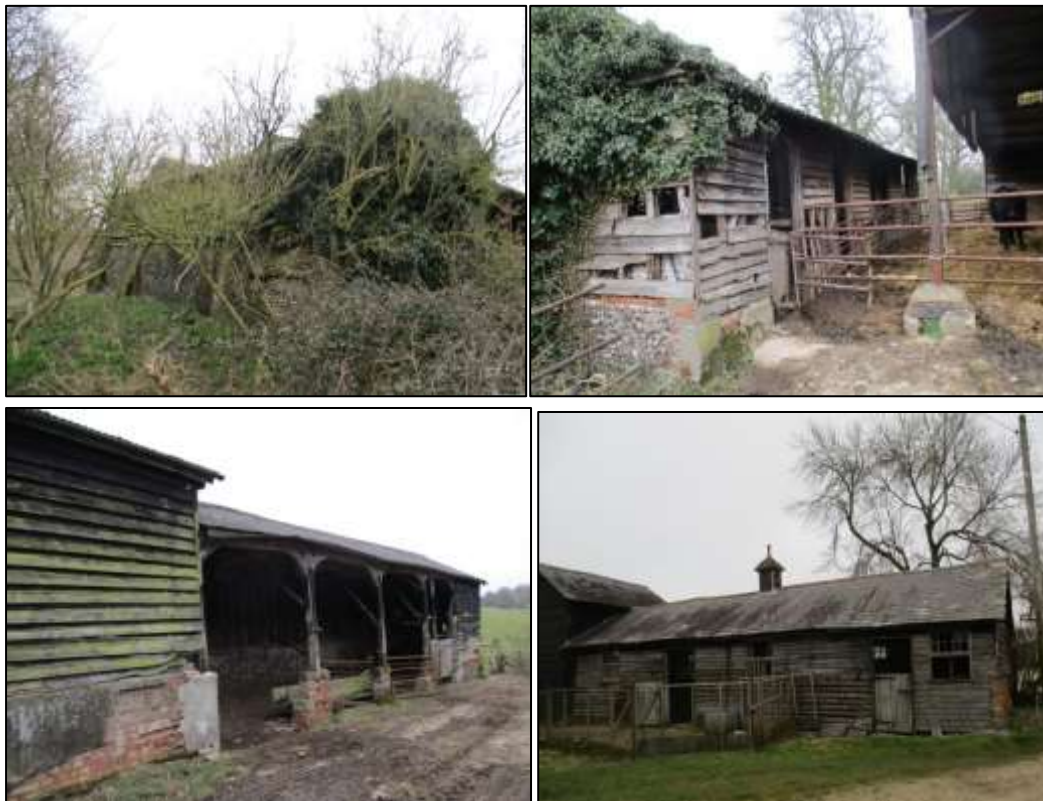
Heritage Asset Number: 1102246

Description: Grade II. Early-C19th barn. A tall un-aisled 6-bay barn facing E with 2 pairs of double doors. Un-jowled posts with long curved braces to tie-beams of king-post roof. Assortment of C19th and early-C20th curtilage barns and structures around the yard in very poor condition.

Works required: Areas of weather boarding missing. Roofs and masonry walls in poor condition. Overall objective to restore barns and improve yard by implementing consent and planning permission. Scheme approved for conversion of various barns to dwellings under 3/10/0448/LB, but has now lapsed.

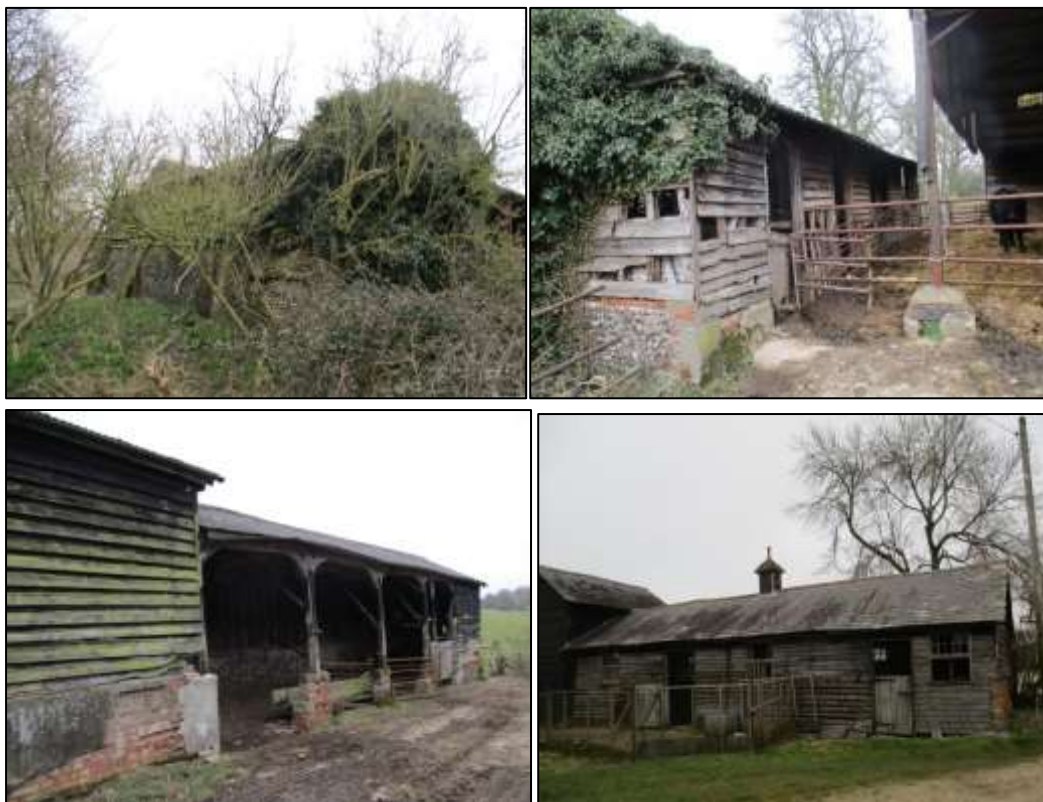
Heritage Asset Number: 1174084

Description: Grade II. Early-C18th granary. A tall 5-bay, 2-storeys structure with enclosed upper floor entered by ladder at S end, and open ground floor on ranges of posts on bases at each side and a later middle row of 6 props. Ground floor used as an implement shed. Arched braces to openings and cross-beams. 4 small openings along each side with adjustable wooden louvres. Door in centre of S gable with small hood. Bins survive in granary. A raised granary unusual in size and form. Assortment of C19th and early-C20th curtilage barns and structures around the yard in very poor condition.

Works required: Areas of weather boarding missing. Roofs and masonry walls in poor condition. Overall objective to restore barns and improve yard by implementing consent and planning permission. Scheme approved for conversion of various barns to dwellings under 3/10/0448/LB, but has now lapsed.
