EAST HERTS COUNCIL HERITAGE AT RISK REGISTER

Updated July 2021

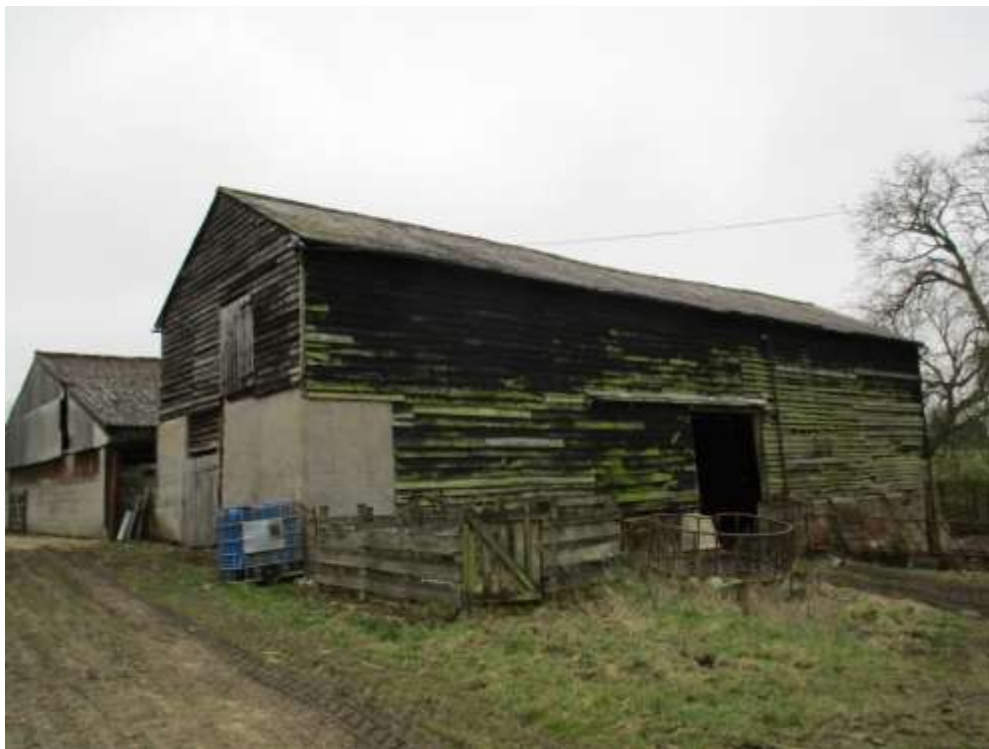
Heritage Asset Number: 1102245

Description: Grade II. Early-C18th barn. An unusually wide-span 7-bay tall un-aisled barn facing N. Opposed double doors in middle bay. Un-jowled posts and long curved braces to tie-beams. Mid-height rails tennoned in-line. Single purlin to each slope of queen-struts and collar roof. Undulating roof indicates present unstable condition; inadequate base showing some signs of movement; areas of weather-boarding missing. Other curtilage structures within yard also in very poor condition.

Works required: Overall objective to restore barn by implementing consent and planning permission. Scheme approved for conversion of this and other barns to dwellings under 3/10/0448/LB, but has now lapsed.

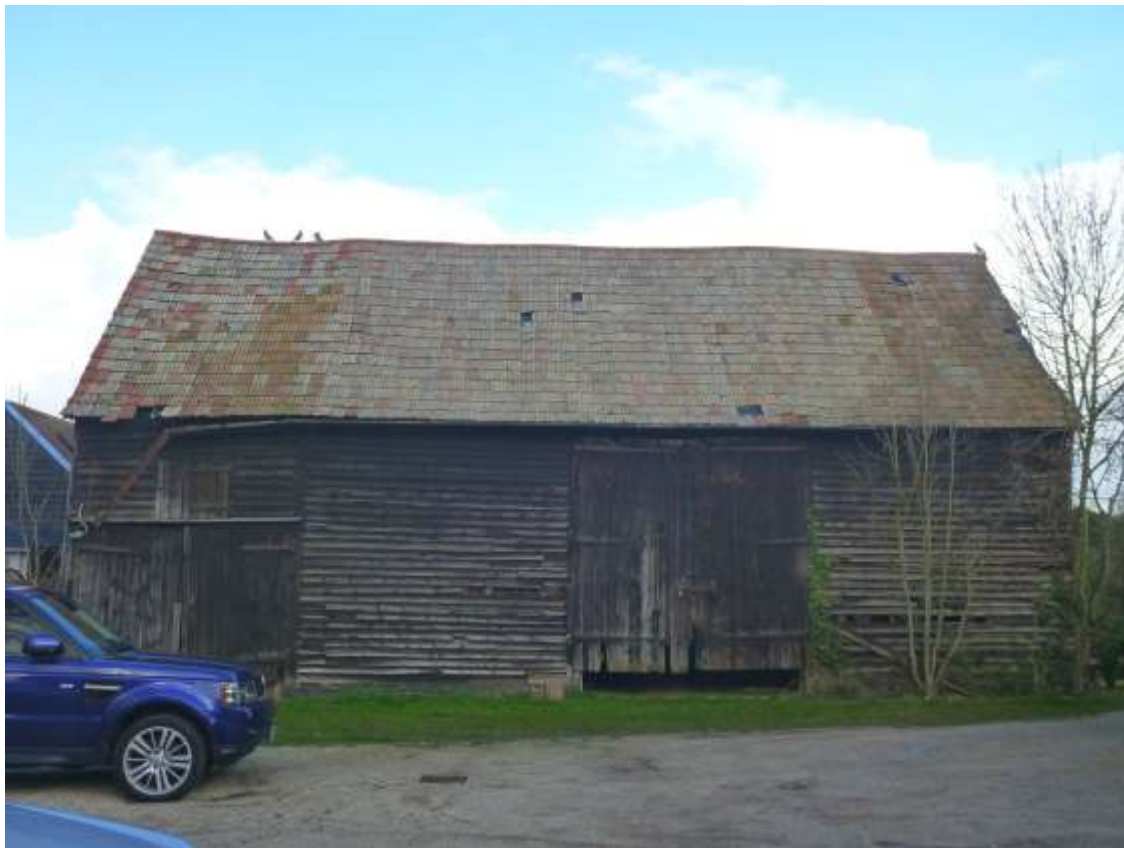
Heritage Asset Number: 1347718

Description: Grade II Barn, and stables. Early C18th extended and re-roofed in C19th. Timber-framed and black weather-boarded main barn on a low red brick sill. Steep roof now clad in corrugated grey tiles. Early C19th timber-framed and black weather-boarded low stable range with hipped slate roof encloses the yard. Historic timber-framed farm buildings forming part of a group with the West Barn and the house strategically located within the centre of the village and Conservation Area. General poor condition; slippage on main roof; areas of weather-boarding missing to stables.

- General renovation, or to be made watertight
- Assessment of damp / rot to timber-frame including roof structure
- Repairs to roof
- Repair / replace weatherboarding
- Repair / replace doors

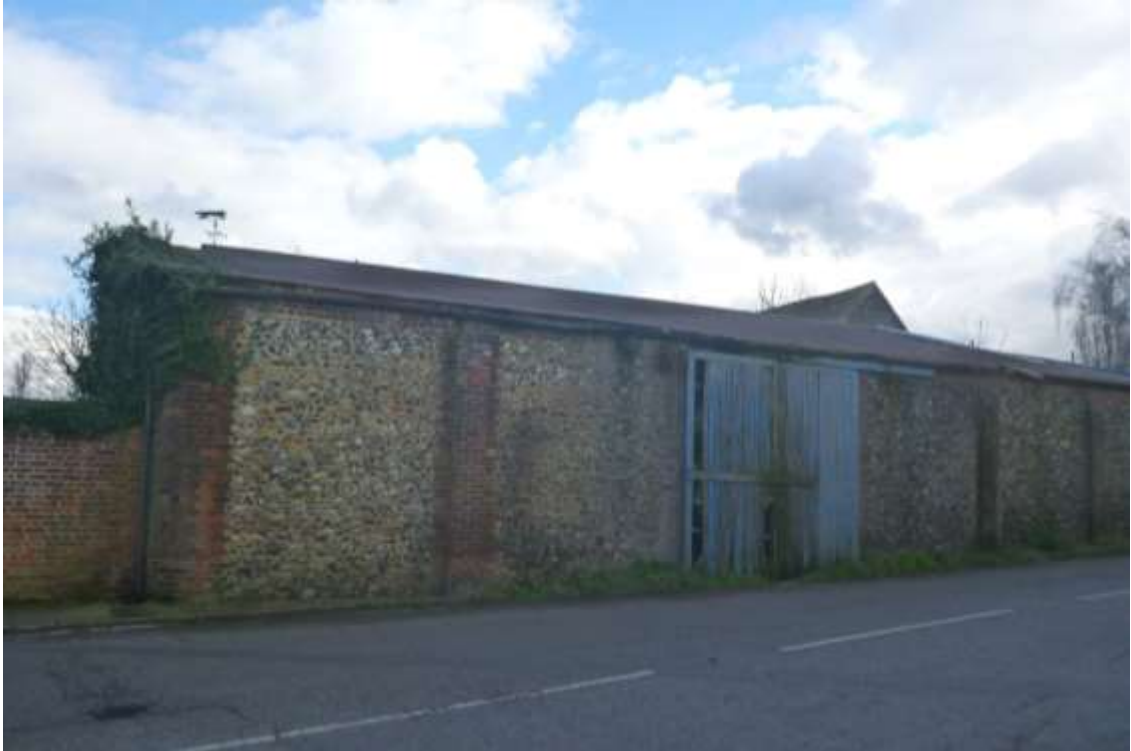
Heritage Asset Number: 1307755

Description: Grade II Barn. Early C19th, extended c1900. Un-coursed, un-knapped flints in lifts with plum brick pilastered piers, extended by shorter parallel timber-framed weather-boarded range on E side and reroofed in corrugated iron to a low pitch. A tall 1 storey barn with 11 bays fronting Hunsdon Road and extending about 40 metres along roadside. The building is of special interest for its unusual construction for the period. It adds visual interest to the village centre and is essential in maintaining the enclosure, in this part of the Conservation Area.

- General renovation, or to be made watertight
- Assessment of damp / rot to timber-frame including roof structure
- Repairs to roof
- Repair flint walls
- Repair / replace doors
