EAST HERTS COUNCIL HERITAGE AT RISK REGISTER

Updated October 2025

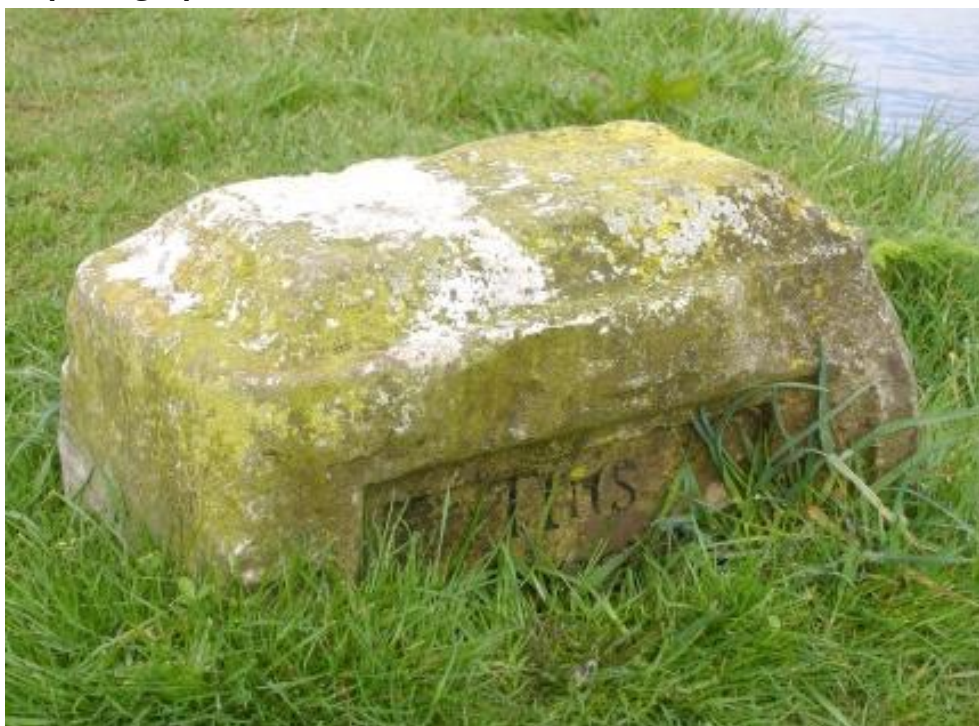
Heritage Asset Number: 1221275

Description: Grade II. Marker stone. Mid-C18. Limestone block with recessed panel on face inscribed 'This belongs to New River Company', located approximately 100m west of the sluice gates on the cut joining The New River to the River Lea and set in the bank.

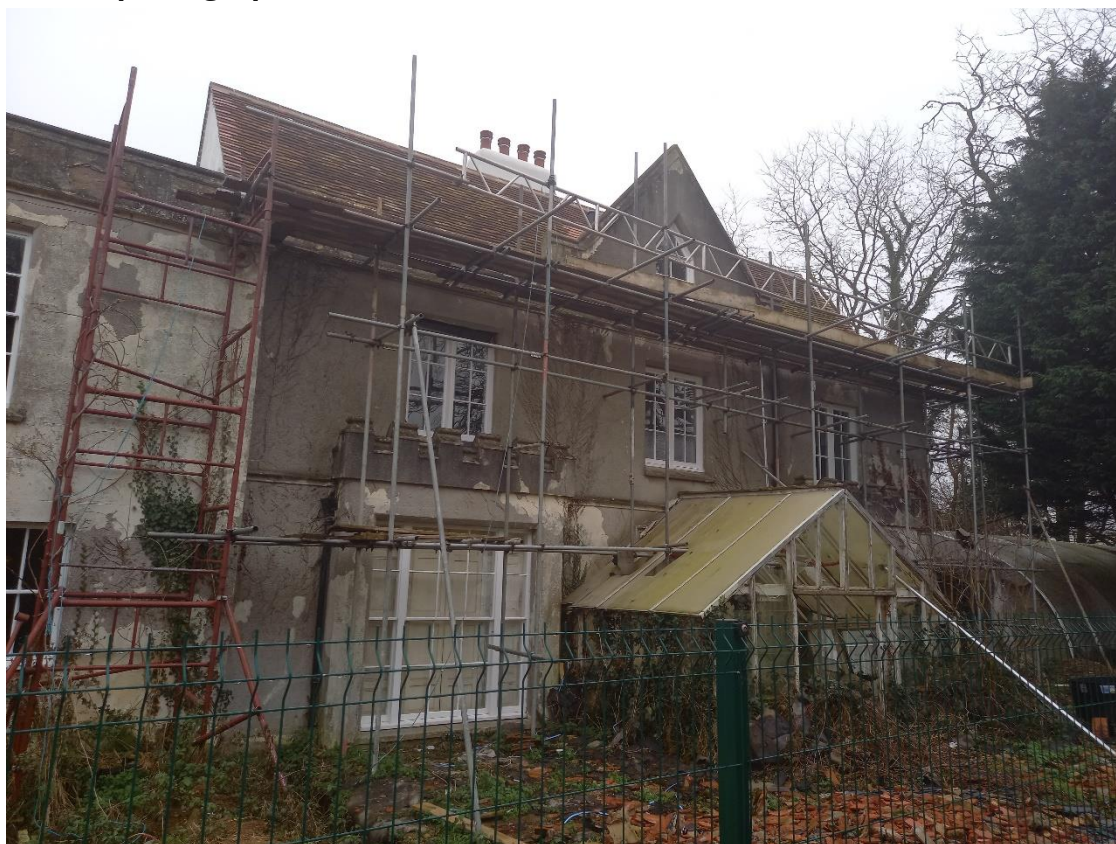
Heritage Asset Number: 1089152

Description: Grade II. Late C17th Farmhouse, re-fronted 1840-50 in Gothic Style. Largely brick built, now covered by stucco, with red tile roofs. A large L-shaped house of 2-storeys, attics, and cellar, facing south. Later low extensions.

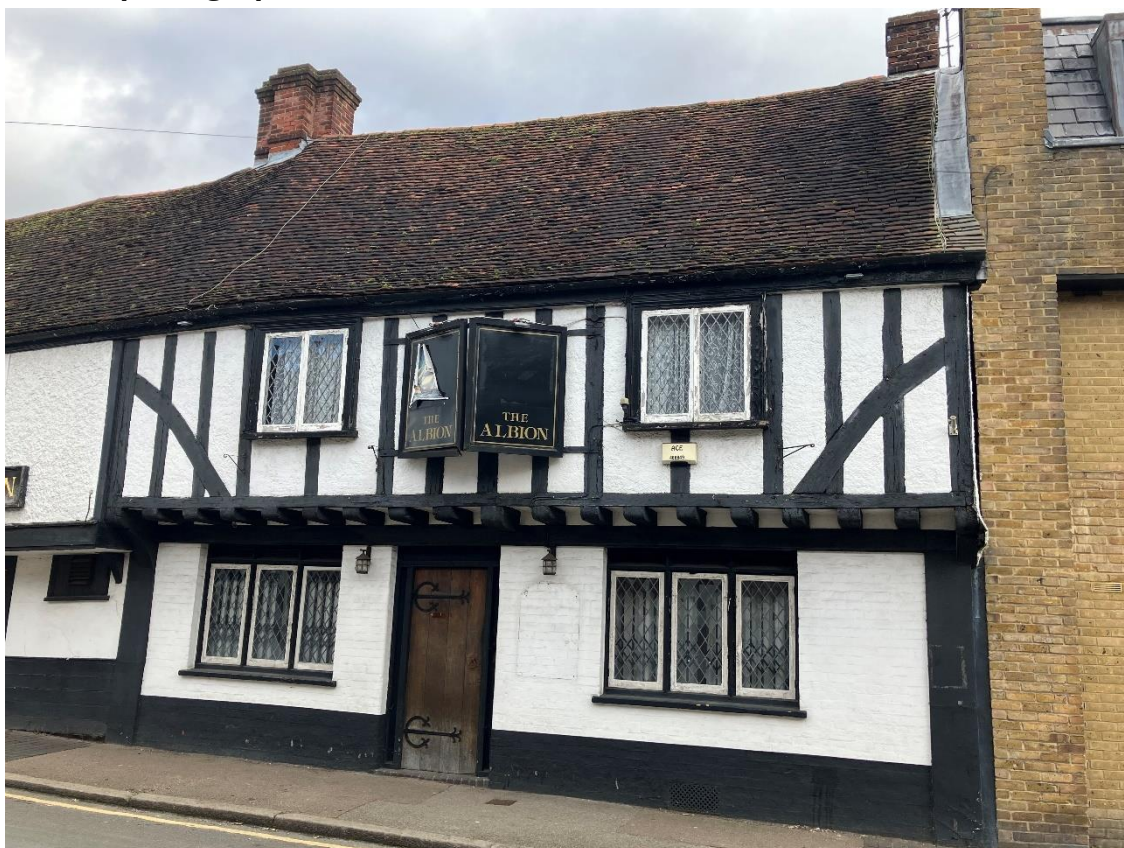
Heritage Asset Number: 1222116

Description: Grade II listed building, built as a house, later a public house with living accommodation above, currently unoccupied. Dates from C15th, altered C17th, and early-C20th.

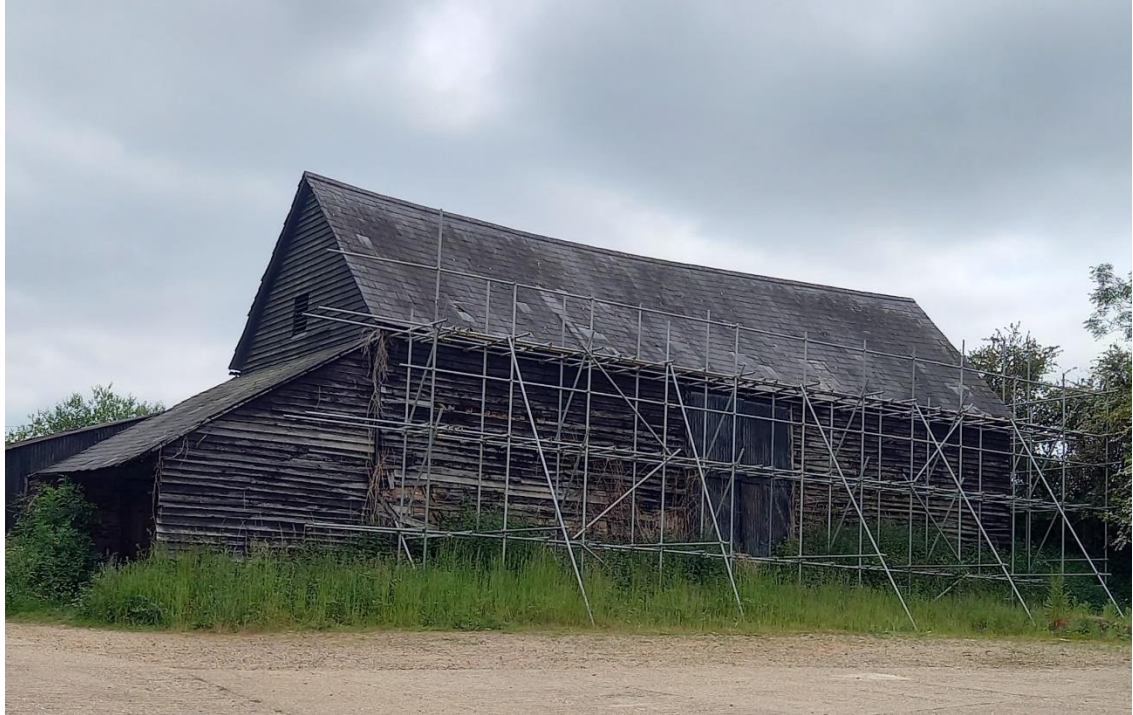
Heritage Asset Number: 1204940

Description: Grade II early-C18th 5-bay barn, re-roofed in early-C19th. Timber frame weatherboarded on tarred red brick sill wall in English-bond. Steep roof now slated. Lean-to at north (lower) end. Interior has long curved braces to heavy tie-beams and boarded walls. The West Barn is a 5-bay box-framed timber threshing barn cut into the sloping ground to the south with a brick plinth and pitched slate roof. Brick threshing floor with compacted earth to the north and south. The doors – which are stored within the building – are a later replacement.

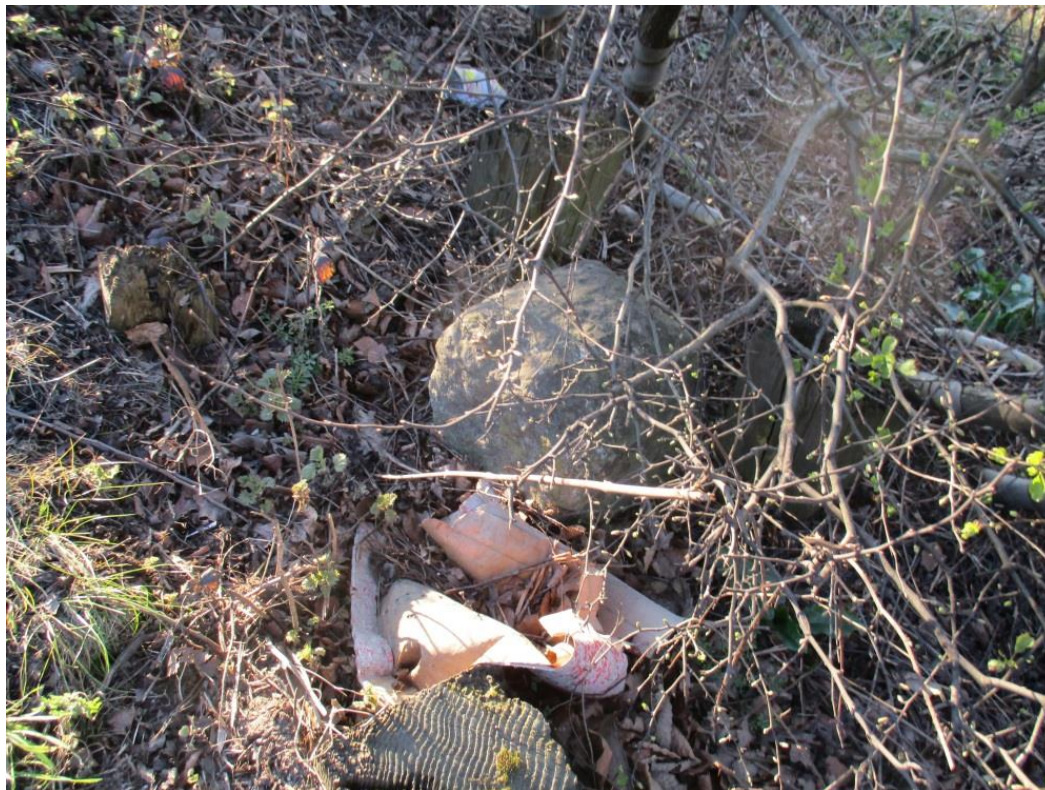
Heritage Asset Number: 1089076

Description: Grade II. Milestone. Mid-C18th. Erected by Watton Turnpike Trust. White freestone. A low square pillar about 3/4m high with a rounded head. No inscription legible. Marks 25 miles to London.

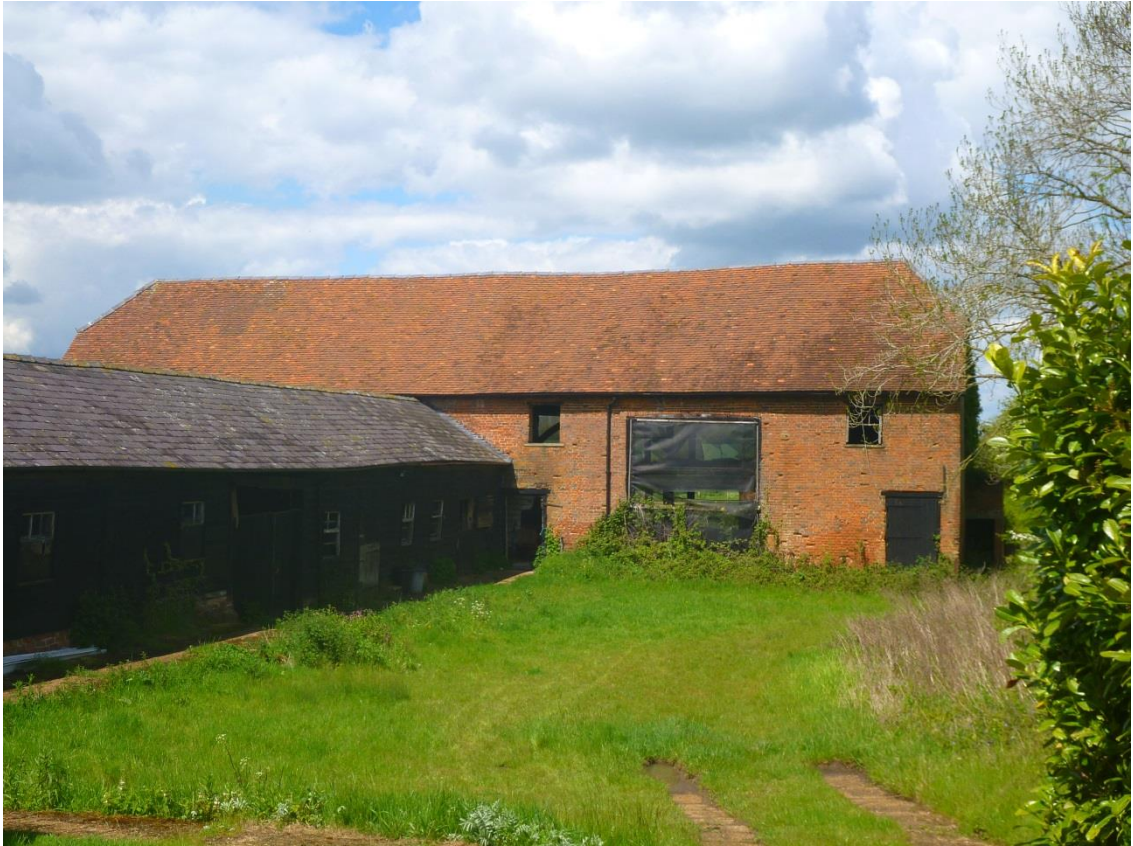
Heritage Asset Number: 1295904

Description: Grade II C17th barn, altered in late-C18th, North aisle removed late C20th. Timber frame now cased in red brick with steep half-hipped old red tile roof. 7-bay. Tall barn facing S with double doors in 2nd and 6th bays. West elevation bulging, openings not enclosed, and in some locations the condition of the brickwork is poor.

Works required: Overall objective to secure future of building, which after discussion with owner most likely to take place by incremental repairs. Following discussions, it is understood that progress is being made in this respect. Monitor progress. Seek securing and infilling of opening.

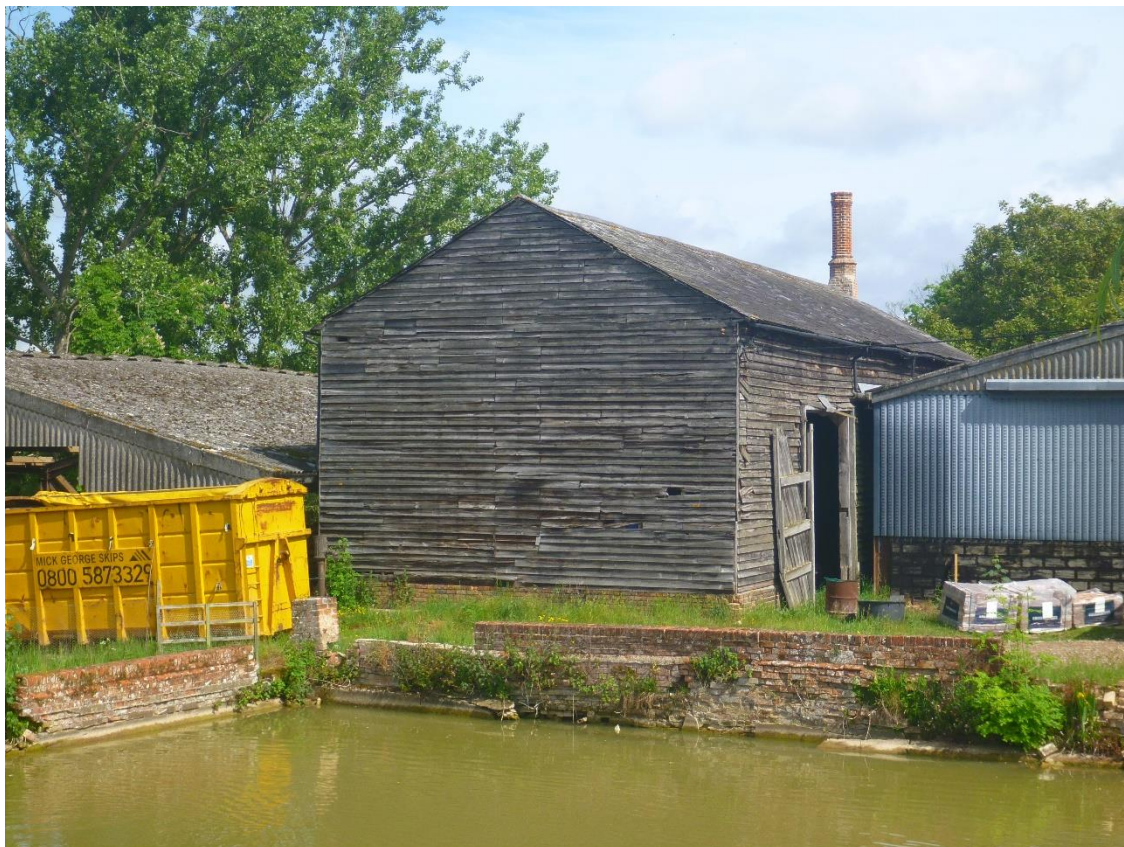
Heritage Asset Number: 1102246

Description: Grade II. Early-C19th barn. A tall un-aisled 6-bay barn facing E with 2 pairs of double doors. Un-jowled posts with long curved braces to tie-beams of king-post roof. Assortment of C19th and early-C20th curtilage barns and structures around the yard in very poor condition.

Works required: Overall objective to restore barns and improve yard by implementing consent and planning permission.

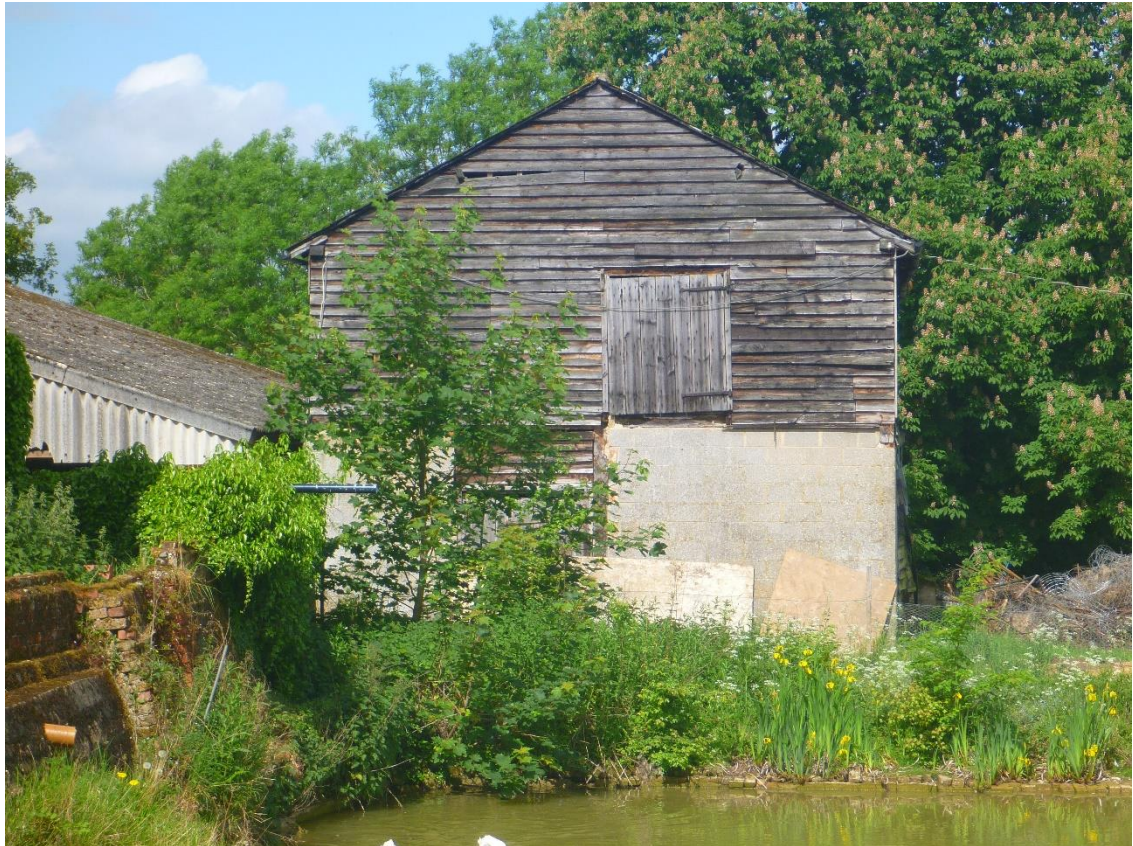
Heritage Asset Number: 1102245

Description: Grade II. Early-C18th barn. An unusually wide-span 7-bay tall un-aisled barn facing N. Opposed double doors in middle bay. Un-jowled posts and long curved braces to tie-beams. Mid-height rails tennoned in-line. Single purlin to each slope of queen-struts and collar roof. Undulating roof indicates present unstable condition; inadequate base showing some signs of movement; areas of weather-boarding missing. Other curtilage structures within yard also in very poor condition.

Works required: Overall objective to restore barn by implementing consent and planning permission.

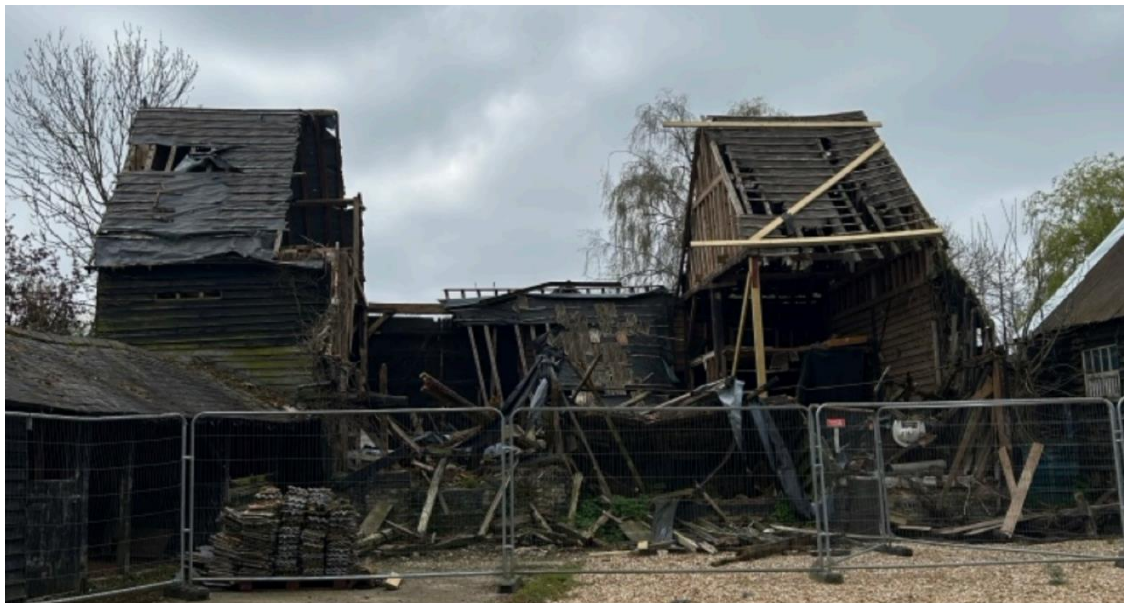
Heritage Asset Number: 1347718

Description: Grade II Barn, and stables. Early C18th extended and re-roofed in C19th. Timber-framed and black weather-boarded main barn on a low red brick sill. Steep roof now clad in corrugated grey tiles. Early C19th timber-framed and black weather-boarded low stable range with hipped slate roof encloses the yard. Historic timber-framed farm buildings forming part of a group with the West Barn and the house strategically located within the centre of the village and Widford Conservation Area. General poor condition. Areas of weather-boarding missing to stables and roof collapse in northern-most bay.

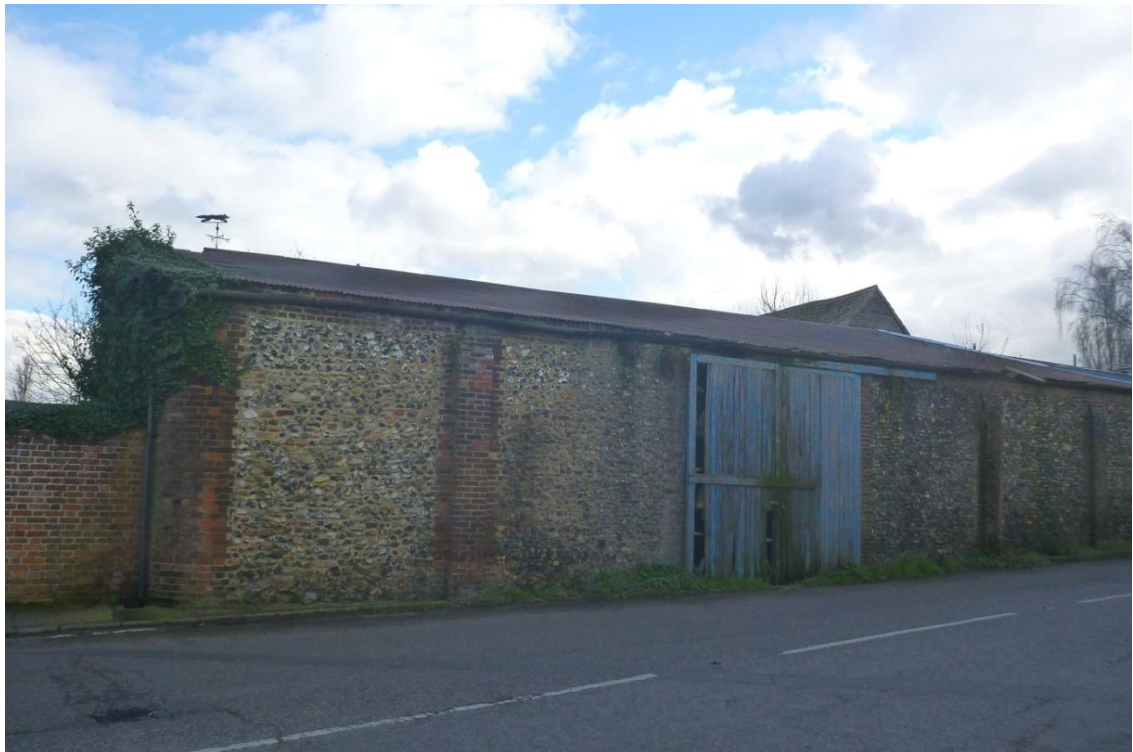
Heritage Asset Number: 1307755

Description: Grade II Barn. Early C19th, extended c1900. Un-coursed, un-knapped flints in lifts with plum brick pilastered piers, extended by shorter parallel timber-framed weather-boarded range on E side and reroofed in corrugated iron to a low pitch. A tall 1 storey barn with 11 bays fronting Hunsdon Road and extending about 40 metres along roadside. The building is of special interest for its unusual construction for the period. It adds visual interest to the village centre and is essential in maintaining the enclosure, in this part of the Conservation Area.
