## *Hunsdon Airfield Heritage Assets Feasibility Study*

# Gilston Park Estate Strategic Landscape Masterplan (SLMP)

## Hunsdon Airfield Feasibility Study

March 2025

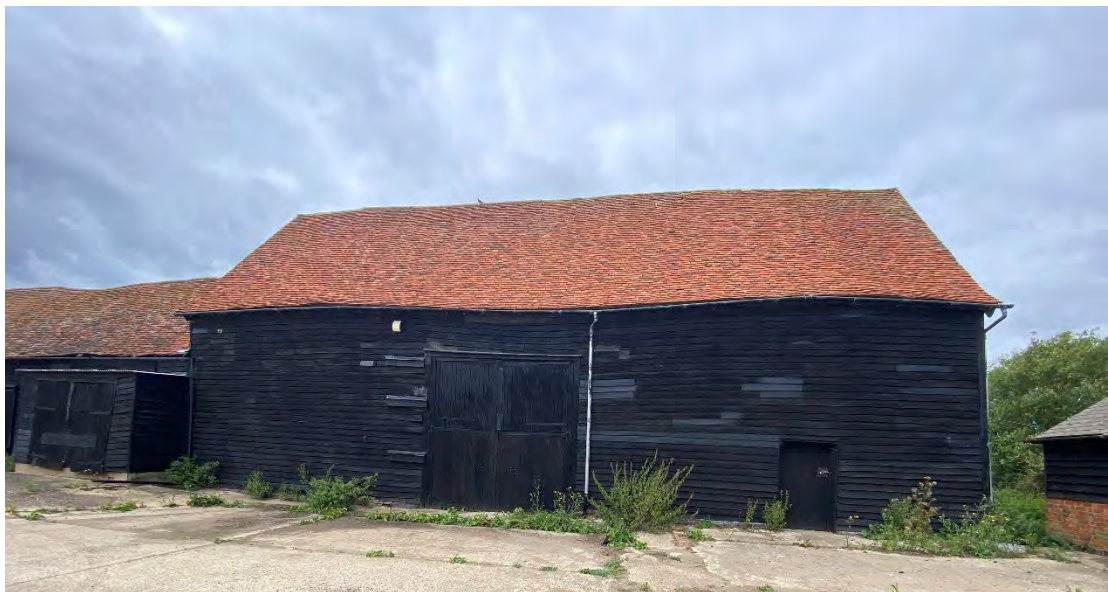
Figure 11: Photograph of the Big Black Barn looking west - 2024

3.5.8 The Big Black Barn is a Grade II\* listed former 16th century lodgings range, now barn, which was converted in the 18th century. The rectangular shaped barn runs northeast to southwest and is adjoined by a further barn to the southwest which is listed individually (see paragraph 3.5.13 onwards). The barn is an eight-bay timber framed structure, however two central bays on the northwest and southwest sides have been widened converting two bays into one, at which large double cart doors have been inserted on the southeast side. The barn is of a double height and open plan internally.

- 3.5.9 Externally the barn is covered by horizontal weatherboarding, most of which appears to have been replaced in the late 20th century-early 21st century, with most recent replacement occurring in 2020 with elm wood boards painted in wood stain. The roof is of red clay tile, under which is a queen post roof structure with two butt purlins, in poor condition. Internally there is evidence of the former window openings with defined rebated studs in the internal timber framing, however replacement timber to some bays leaves some former openings with single notches. Temporary timber propping was installed in 2019 to structurally brace the southeast elevation, just south of the double height doors, and to brace the northwest elevation on the second bay from the south.

- 4.2.1 The Big Black Barn has experienced significant structural movement which may be ongoing, with visible bowing in the front and rear elevations. Temporary structural support has been installed internally within the barn, and the brick plinth and sole plate are disintegrating in places. The building was assessed as being at serious risk of major failure.
- 4.2.2 It is recommended that the building be monitored to determine if it is necessary to carry out works to arrest any ongoing movement. Generally, the condition of the fabric does not warrant any immediate works, but in the medium-term repairs to the plinth walls, sill beam, main post bases, walls plates and weatherboarding may be required. Any works to repair the fabric of the barn must form part of a considered package.

- The Big Black Barn has experienced significant structural movement which may be ongoing. It is recommended that the movement be monitored to determine if it is necessary/justifiable to carry out works to arrest the movement. Generally, the condition of the fabric does not warrant immediate works, but in the medium-term repairs to the plinth walls, sill beam, main post bases, girding, wall plates and weatherboarding may all need to be carried out. This work must form part of a considered package of works and not be carried out piecemeal as several of these elements affect the issues around stability of the frame.

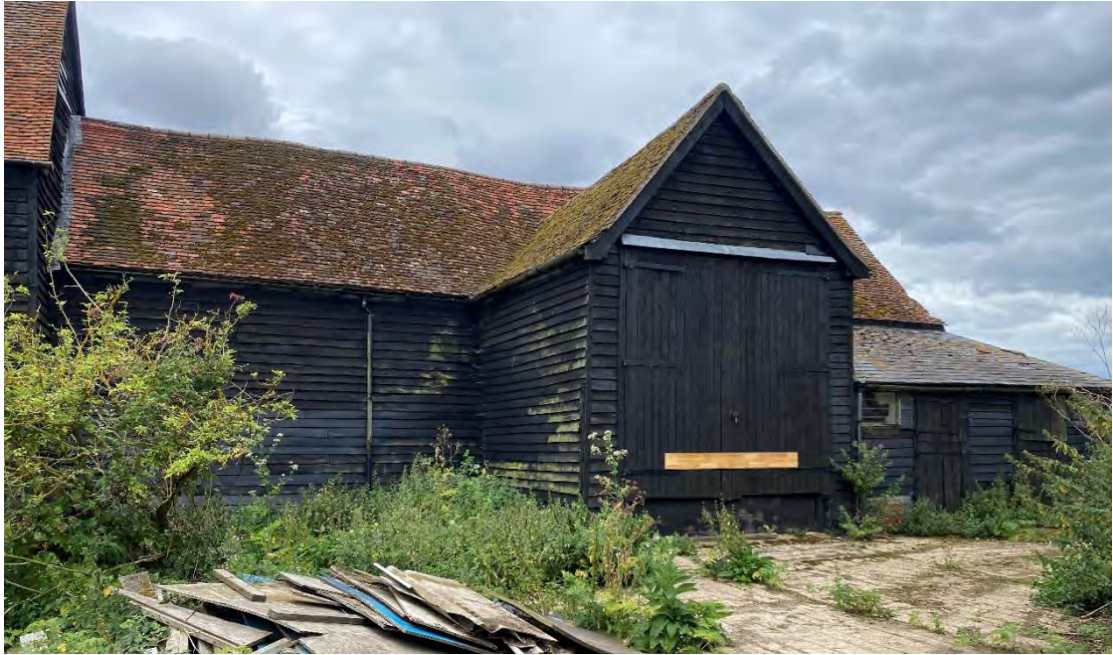
Figure 12: Photograph of the Barn at Hunsdon Lodge attached to the south end of the Big Black Barn looking east-2024

- 3.5.14 The barn to the south of the Big Black Barn, is a Grade II listed un-aisled, five-bay barn, which extends southward from the Big Black Barn. There is an internal opening connecting the two structures. The eaves and ridge of the barn sit approximately 1000mm lower than that of the adjoining Big Black Barn. To the west elevation is a double height gabled porch which extends approximately 3000mm to the west, with an infilled lean-to to the western corner, with a shallow lean to slate roof. The lean to is likely to have been used as two pens, each with individual stable doors. To the east elevation are two double door openings, the ones furthest north are positioned in projecting outshoot approximately 1000mm to the east with a flat roof comprised a concrete plinth and horizontal weatherboarding above under a corrugated metal sheeting flat roof.

- 4.3.1 Again, this barn shows signs of structural defects and there is evidence of localised damage to the frame. The ridge line of this structure is visible dipping, indicating some movement to the structure and there is shoring in place internally. Where visible, the timber frame shows evidence of decay, likely due to the introduction of concrete screed to the lower levels. There are also small areas identified which now contain asbestos after more recent modifications (mid-19th century).
- 4.3.2 The barn is considered to be at risk of major failure and structural repairs are considered necessary in the medium term to prevent further decay. The majority of the timber-frame does not warrant materials repairs in the short term, with the exception of some localised areas of deterioration. Any significant repairs should form part of a considered package for the building.

- The South Barn has experienced localised damage (such as the southwest gable) that require considered structural repair in the medium term potentially including works such as repair and replacement of structural members, sections of cladding, plinth walls and infill wall panels. The majority of the timber frame does not warrant material repairs in the short-term, with the exception of some localised areas of deterioration.

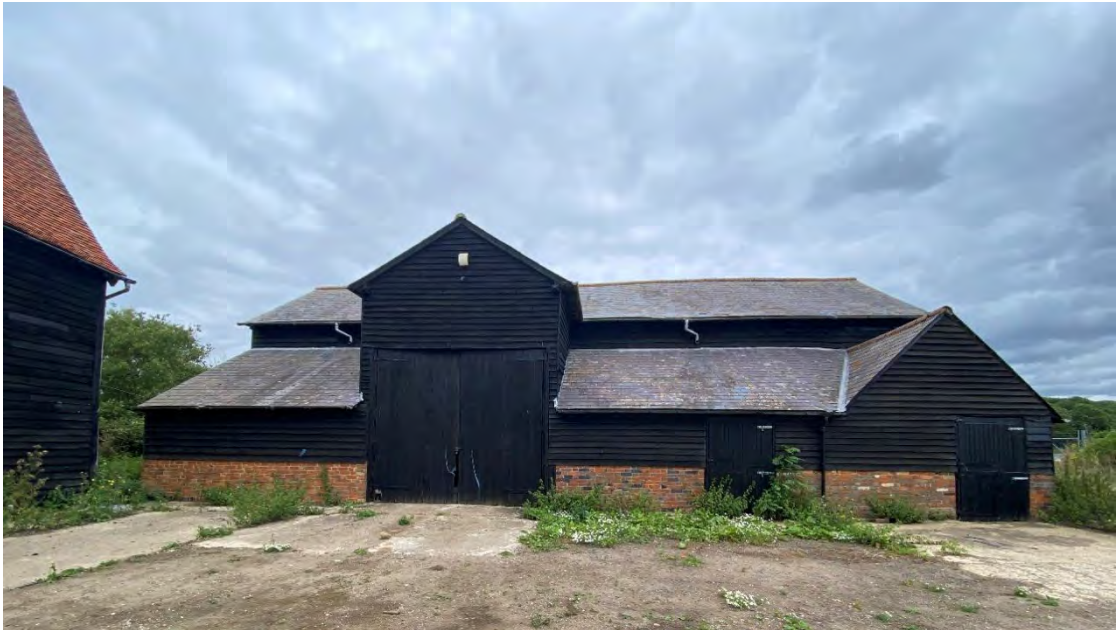
Figure 13: - Photograph of the Essex Barn looking north - 2024

3.5.19 The Essex Barn is a Grade II listed 18th century barn, which faces south. It is a double height timber framed structure of six bays orientated northwest to southeast, on a brick plinth of 12 course (approx. 780mm high) with a projecting double height gabled porch off centred to the west under a slate roof. The brick plinth to the north and west elevations looks to have been rebuilt in engineering bricks at some point. To the south elevation, either side of the porch are lean to structures terminating in a low gabled cross wing to the eastern corner. The barn formerly had an attached open sided shelter shed, which extended south from the eastern end of the south elevation that was demolished in the late 20th century and is likely to have extended from the cross wing.

- 4.4.1 The Essex Barn is currently in use as storage for light aircraft which restricted the ability to survey the property, and a full visual inspection was not possible. The extent of structure that was able to be viewed during the site visit appeared to be in reasonable condition, although there is some minor deviation in the ridge line. At this time only minor repairs are recommended, but a more detailed survey will be required when full access can be provided.

- The Essex Barn is generally in a good condition and requires only minor repairs, however these are not required immediately. Access points for pigeons should be addressed to reduce the health and safety risks associated with pigeon guano and detritus.

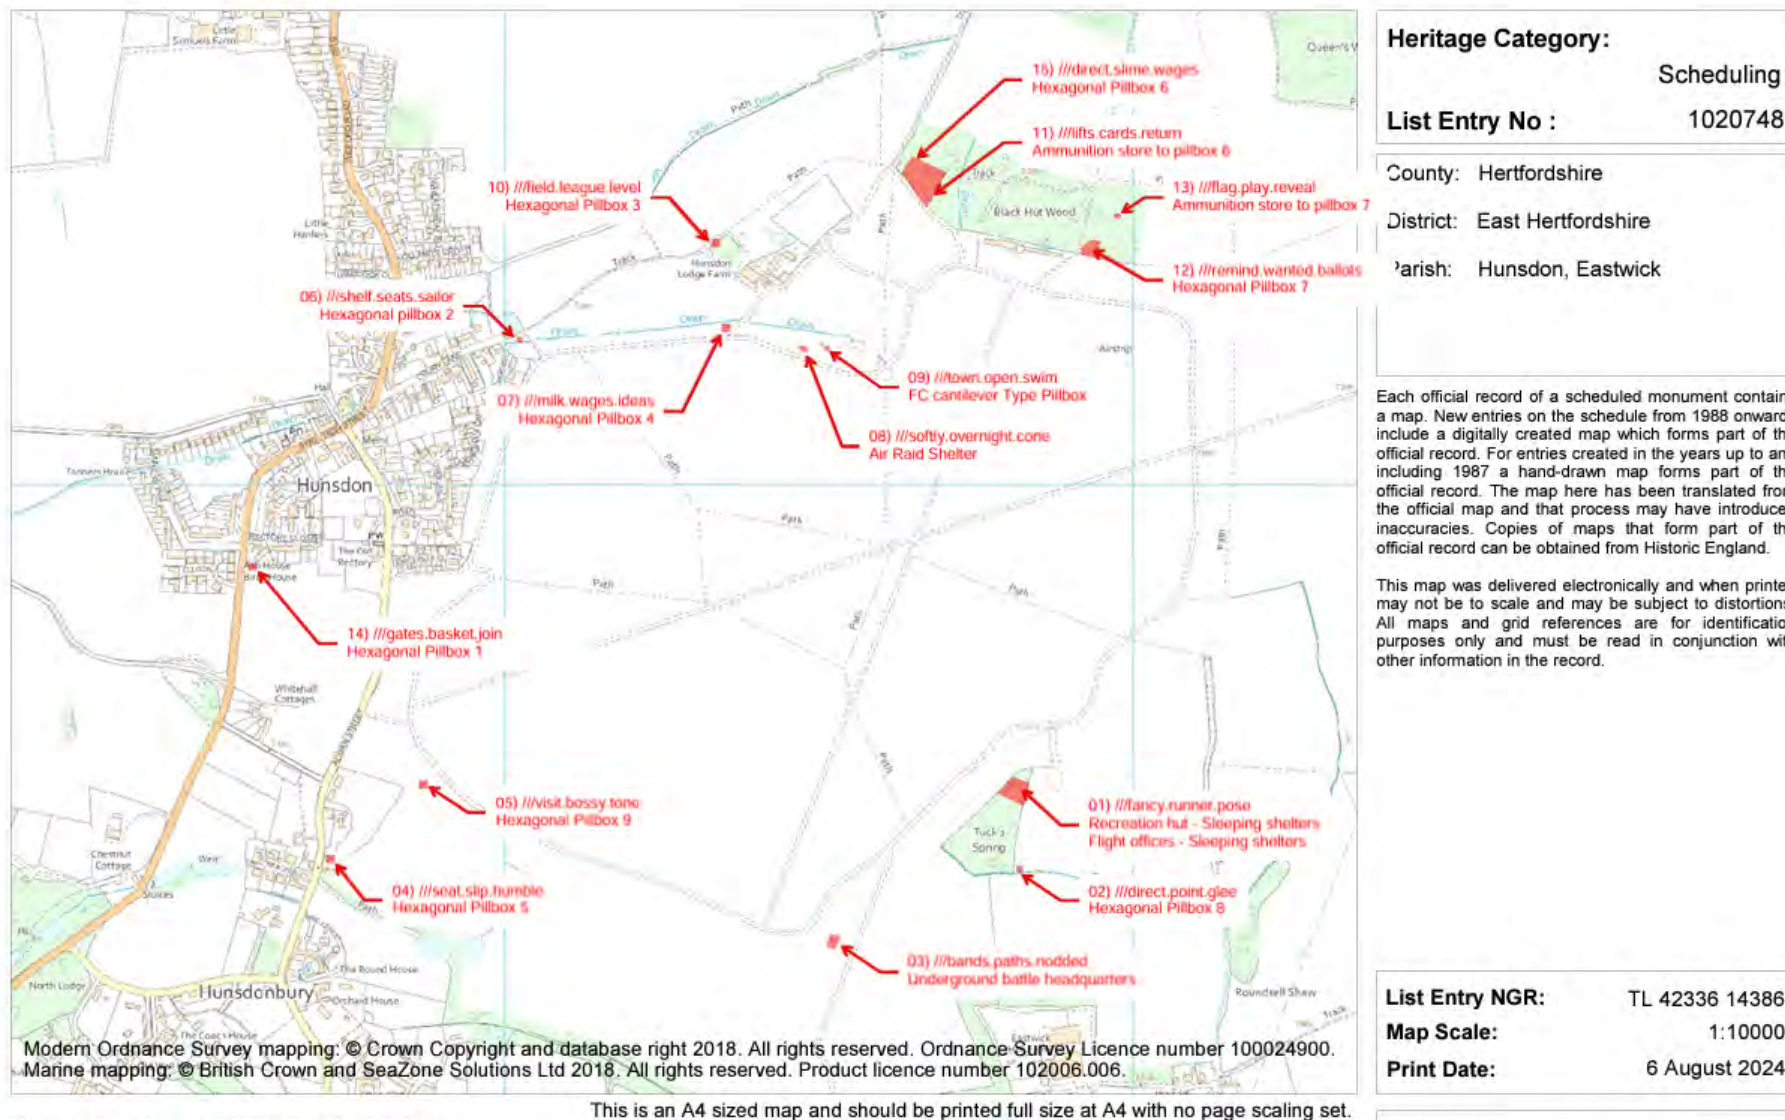
Figure 14: Location of monument components (numbers as per table 3.1 below)

- 4.5.1 Fourteen monuments at thirteen different locations were visually inspected. It was found that there is a wide mix of building types found on the site from concrete defence pillboxes, emergency sleeping quarters, command posts to shelters all of them are constructed from concrete and brick.
- 4.5.2 The condition survey found that all except two monuments are in a poor condition. The structures are not secure with evidence of people trespassing. Most of the monuments are heavily covered in vegetation and are being damaged by self-seeding trees growing within very close proximity of the structures, causing damage to both foundations and the build materials. The walls have already collapsed and will continue to deteriorate rapidly.

- 4.5.3 Generally, the heavy construction of the monuments and their relatively low age means they are structurally sound and require only minor structural works such as concrete and masonry repairs to allow safe access. The primary factor in potential future deterioration is likely vegetation growth and a considered plan to control this is recommended.

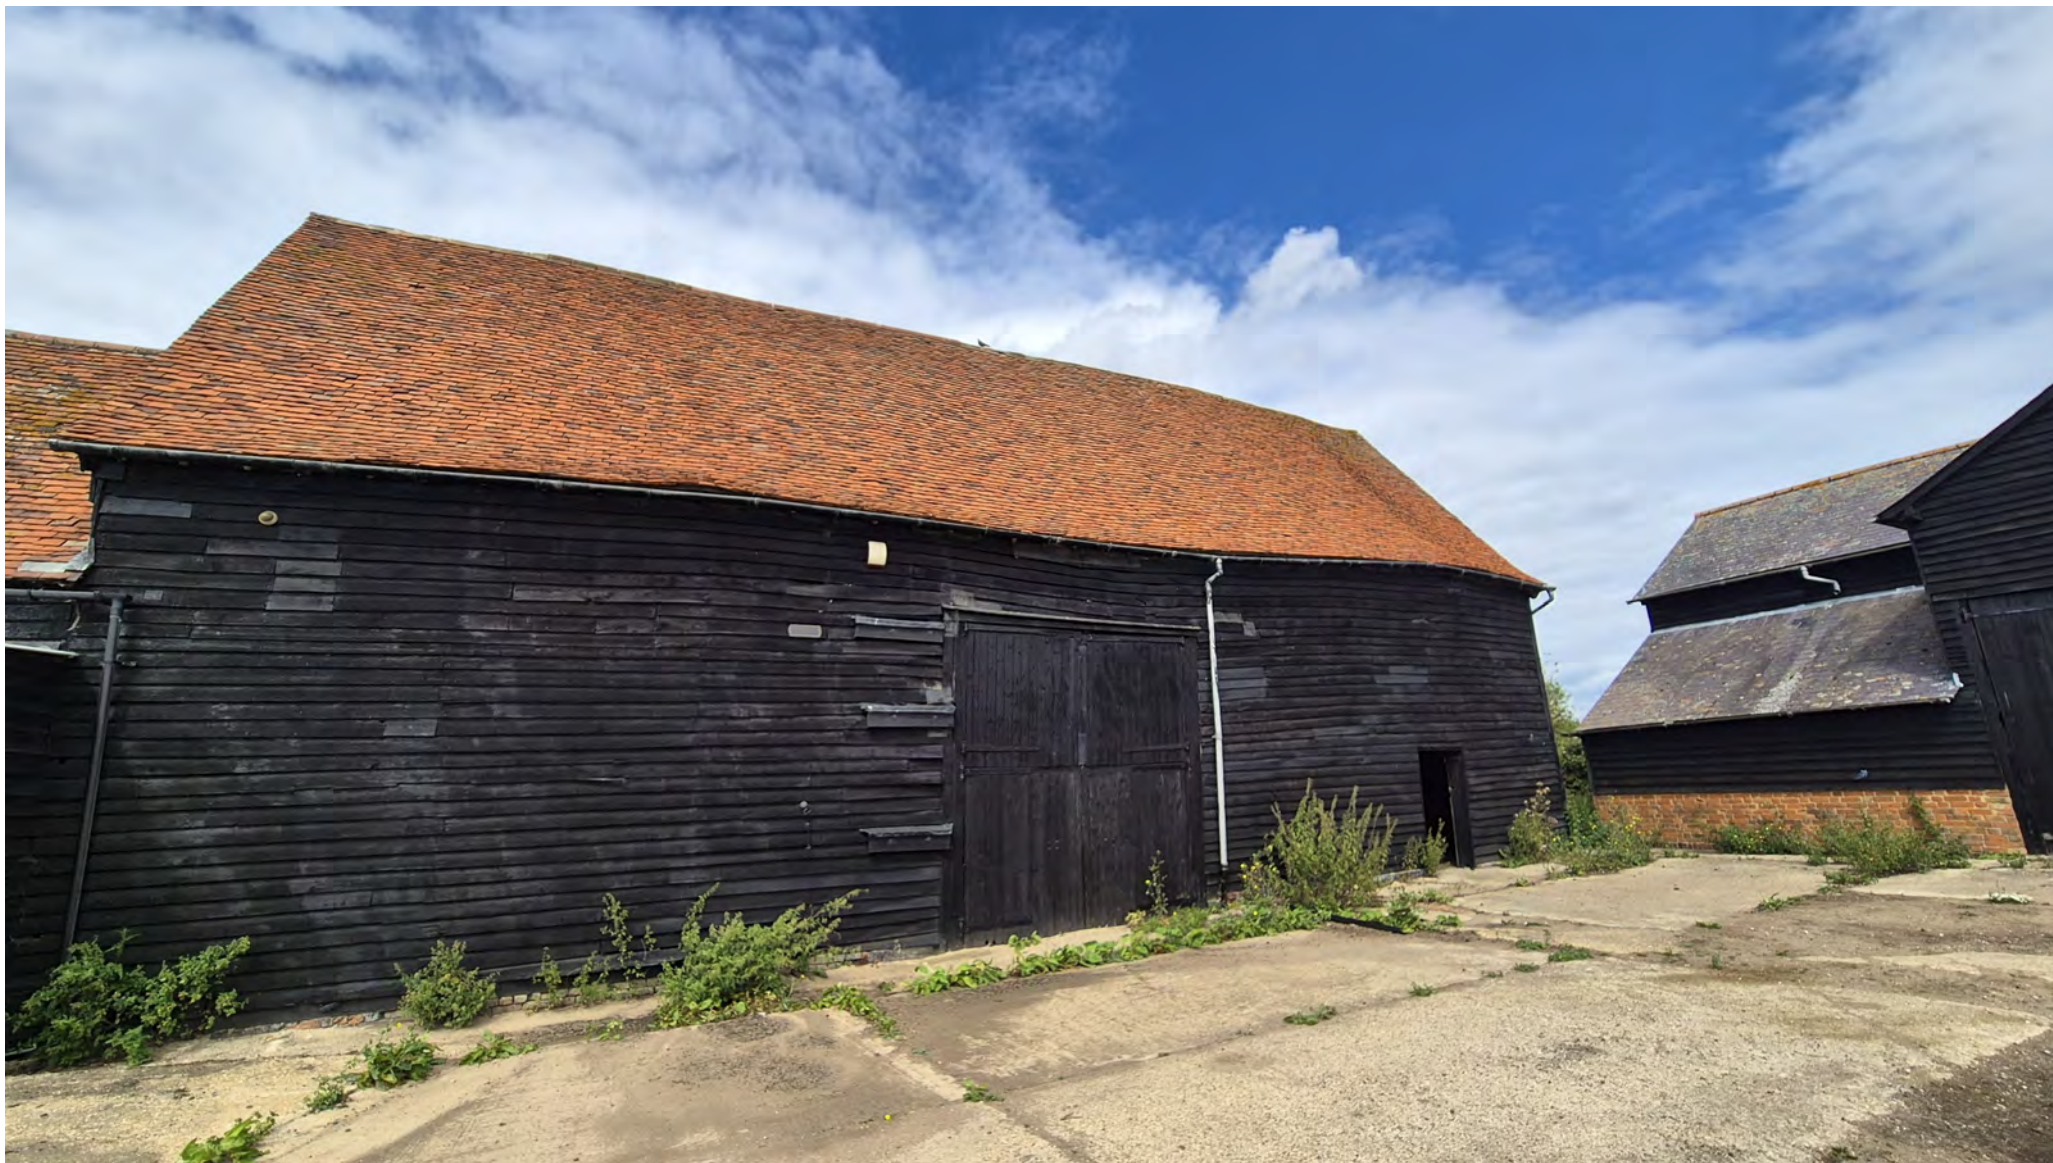
Eastern elevation of Big Black Barn

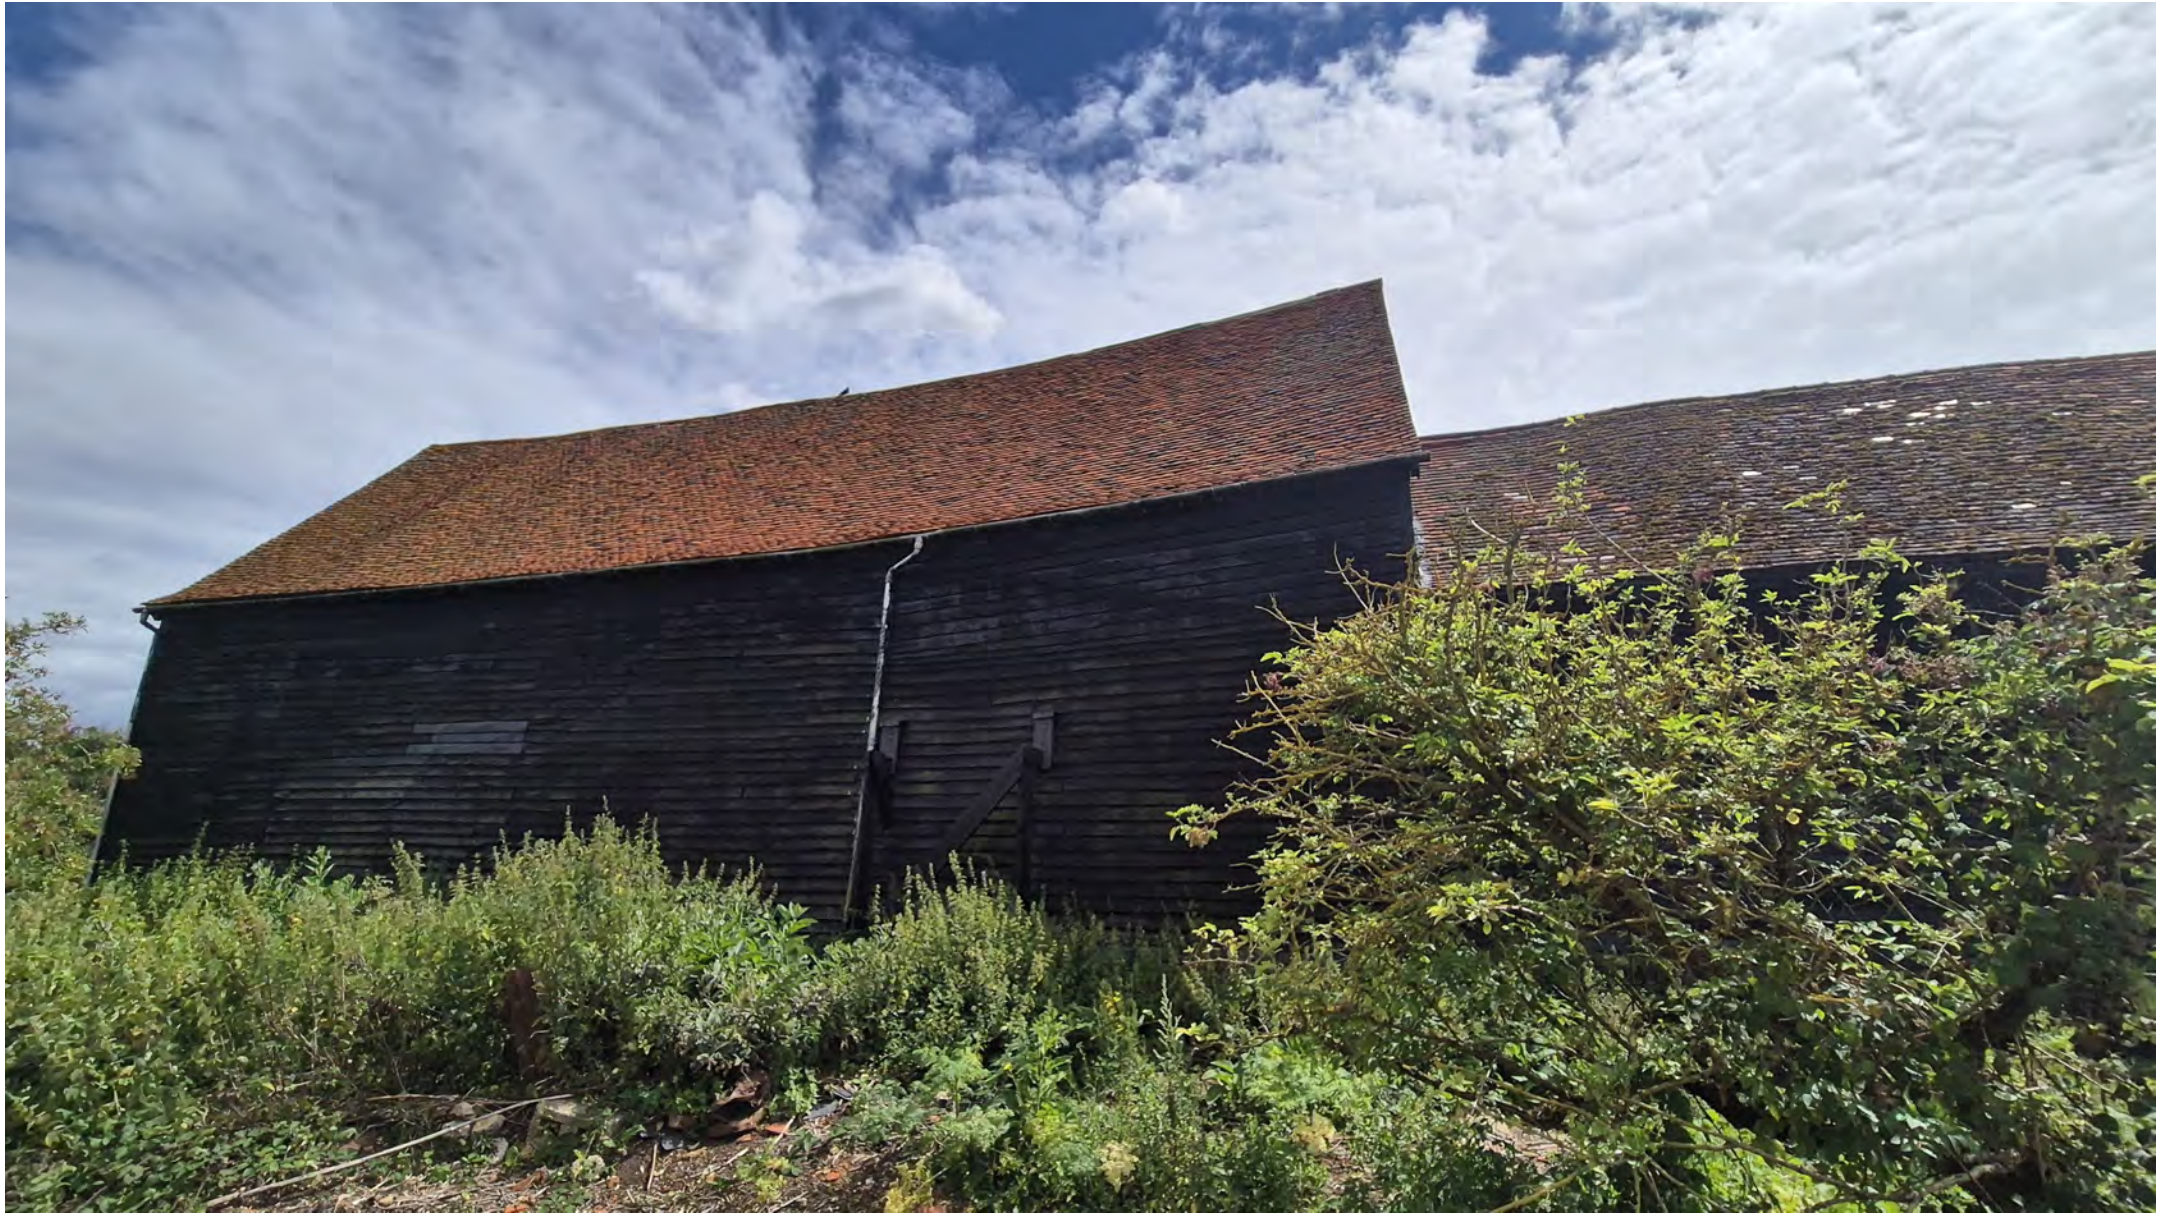
Western Elevation of Big Black Barn

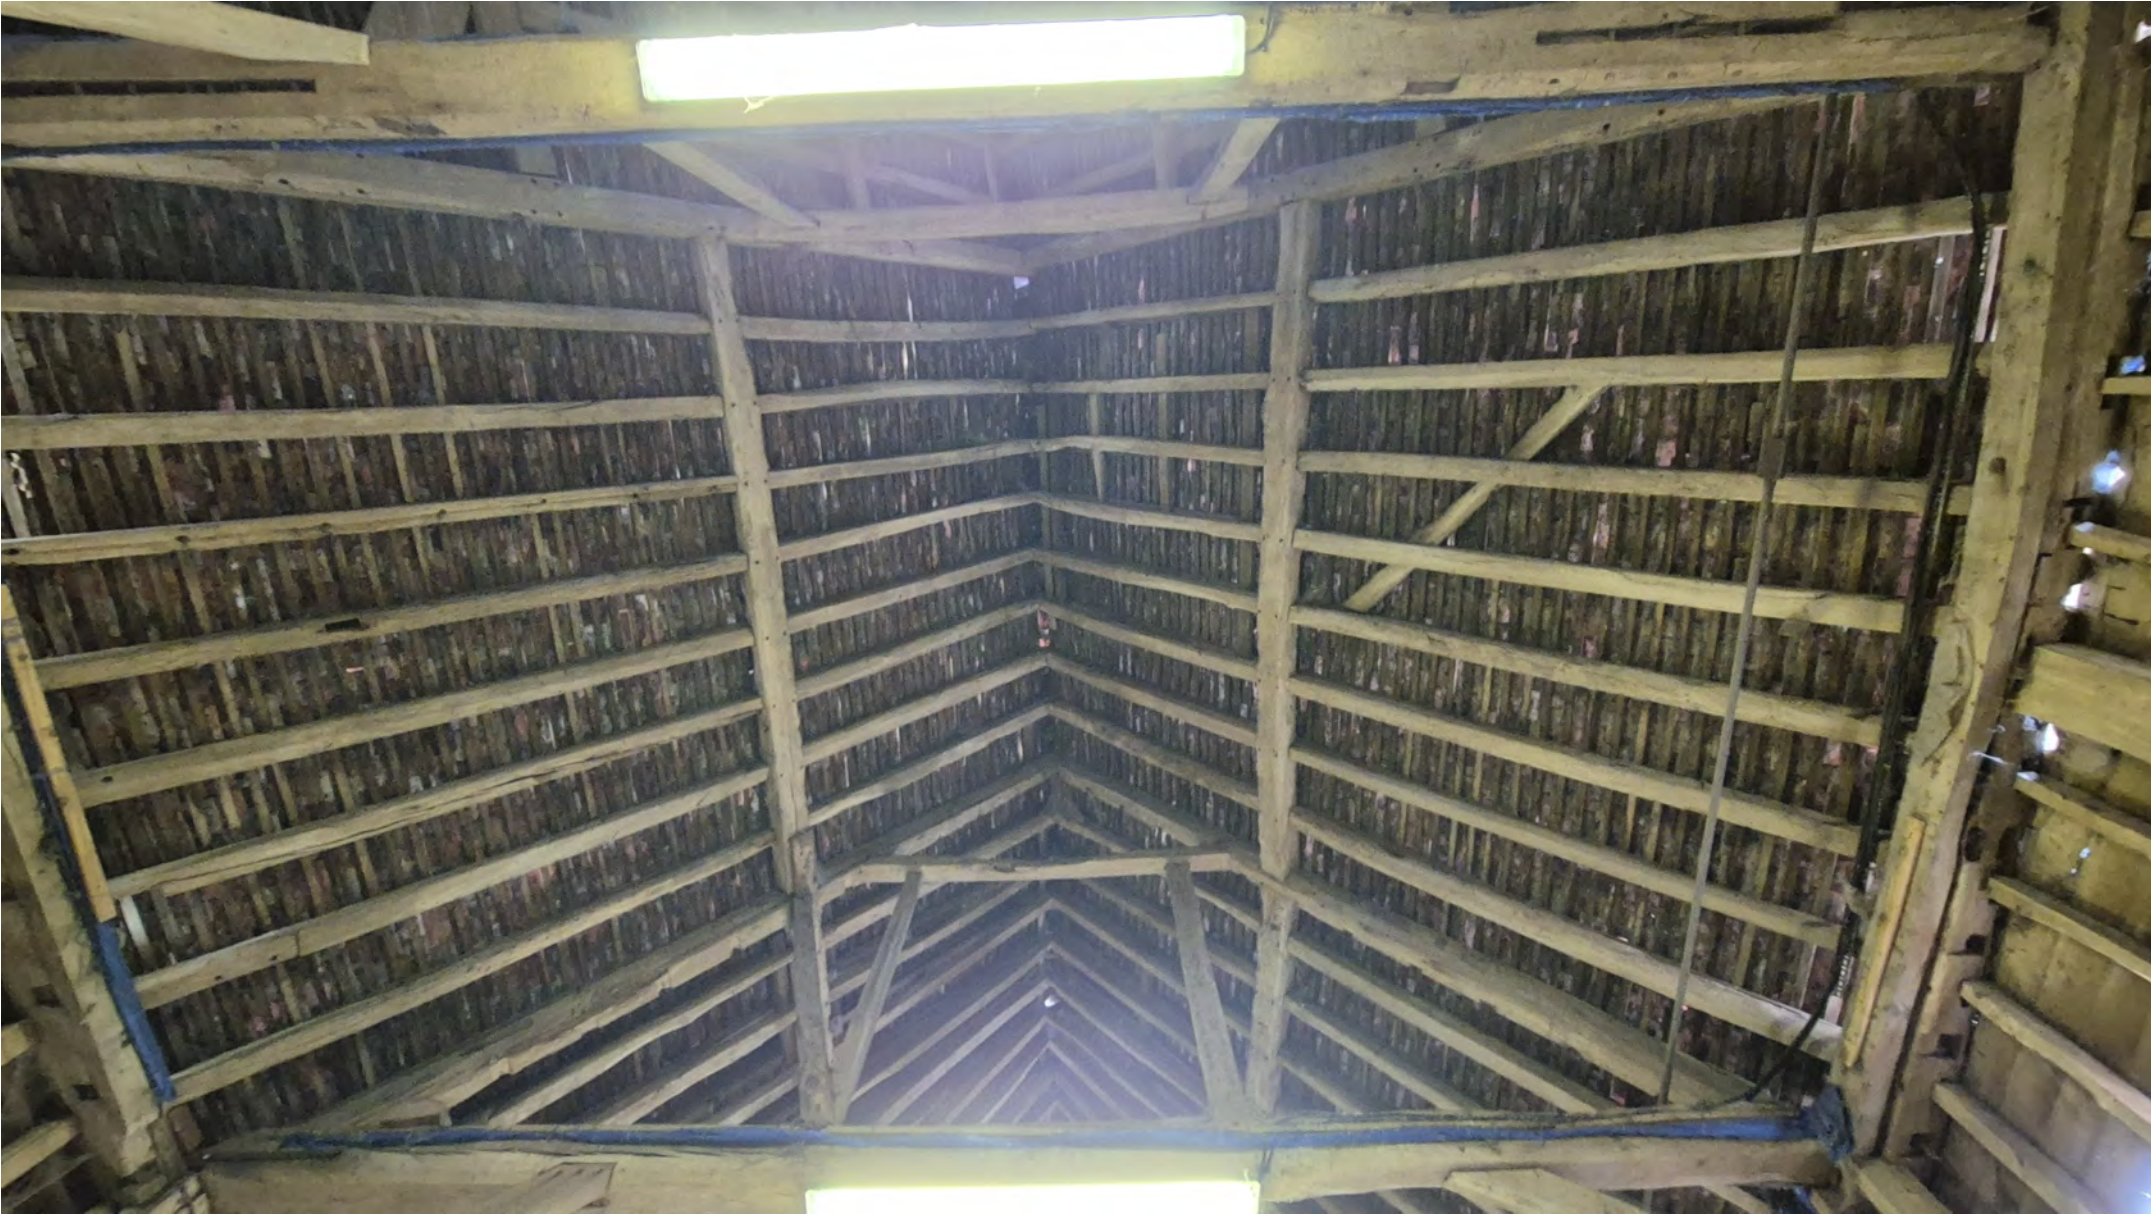
Big Black Barn - Bay 8 (Left: Eastern elevation / Middle: Western Elevation / Right: Roof Structure)

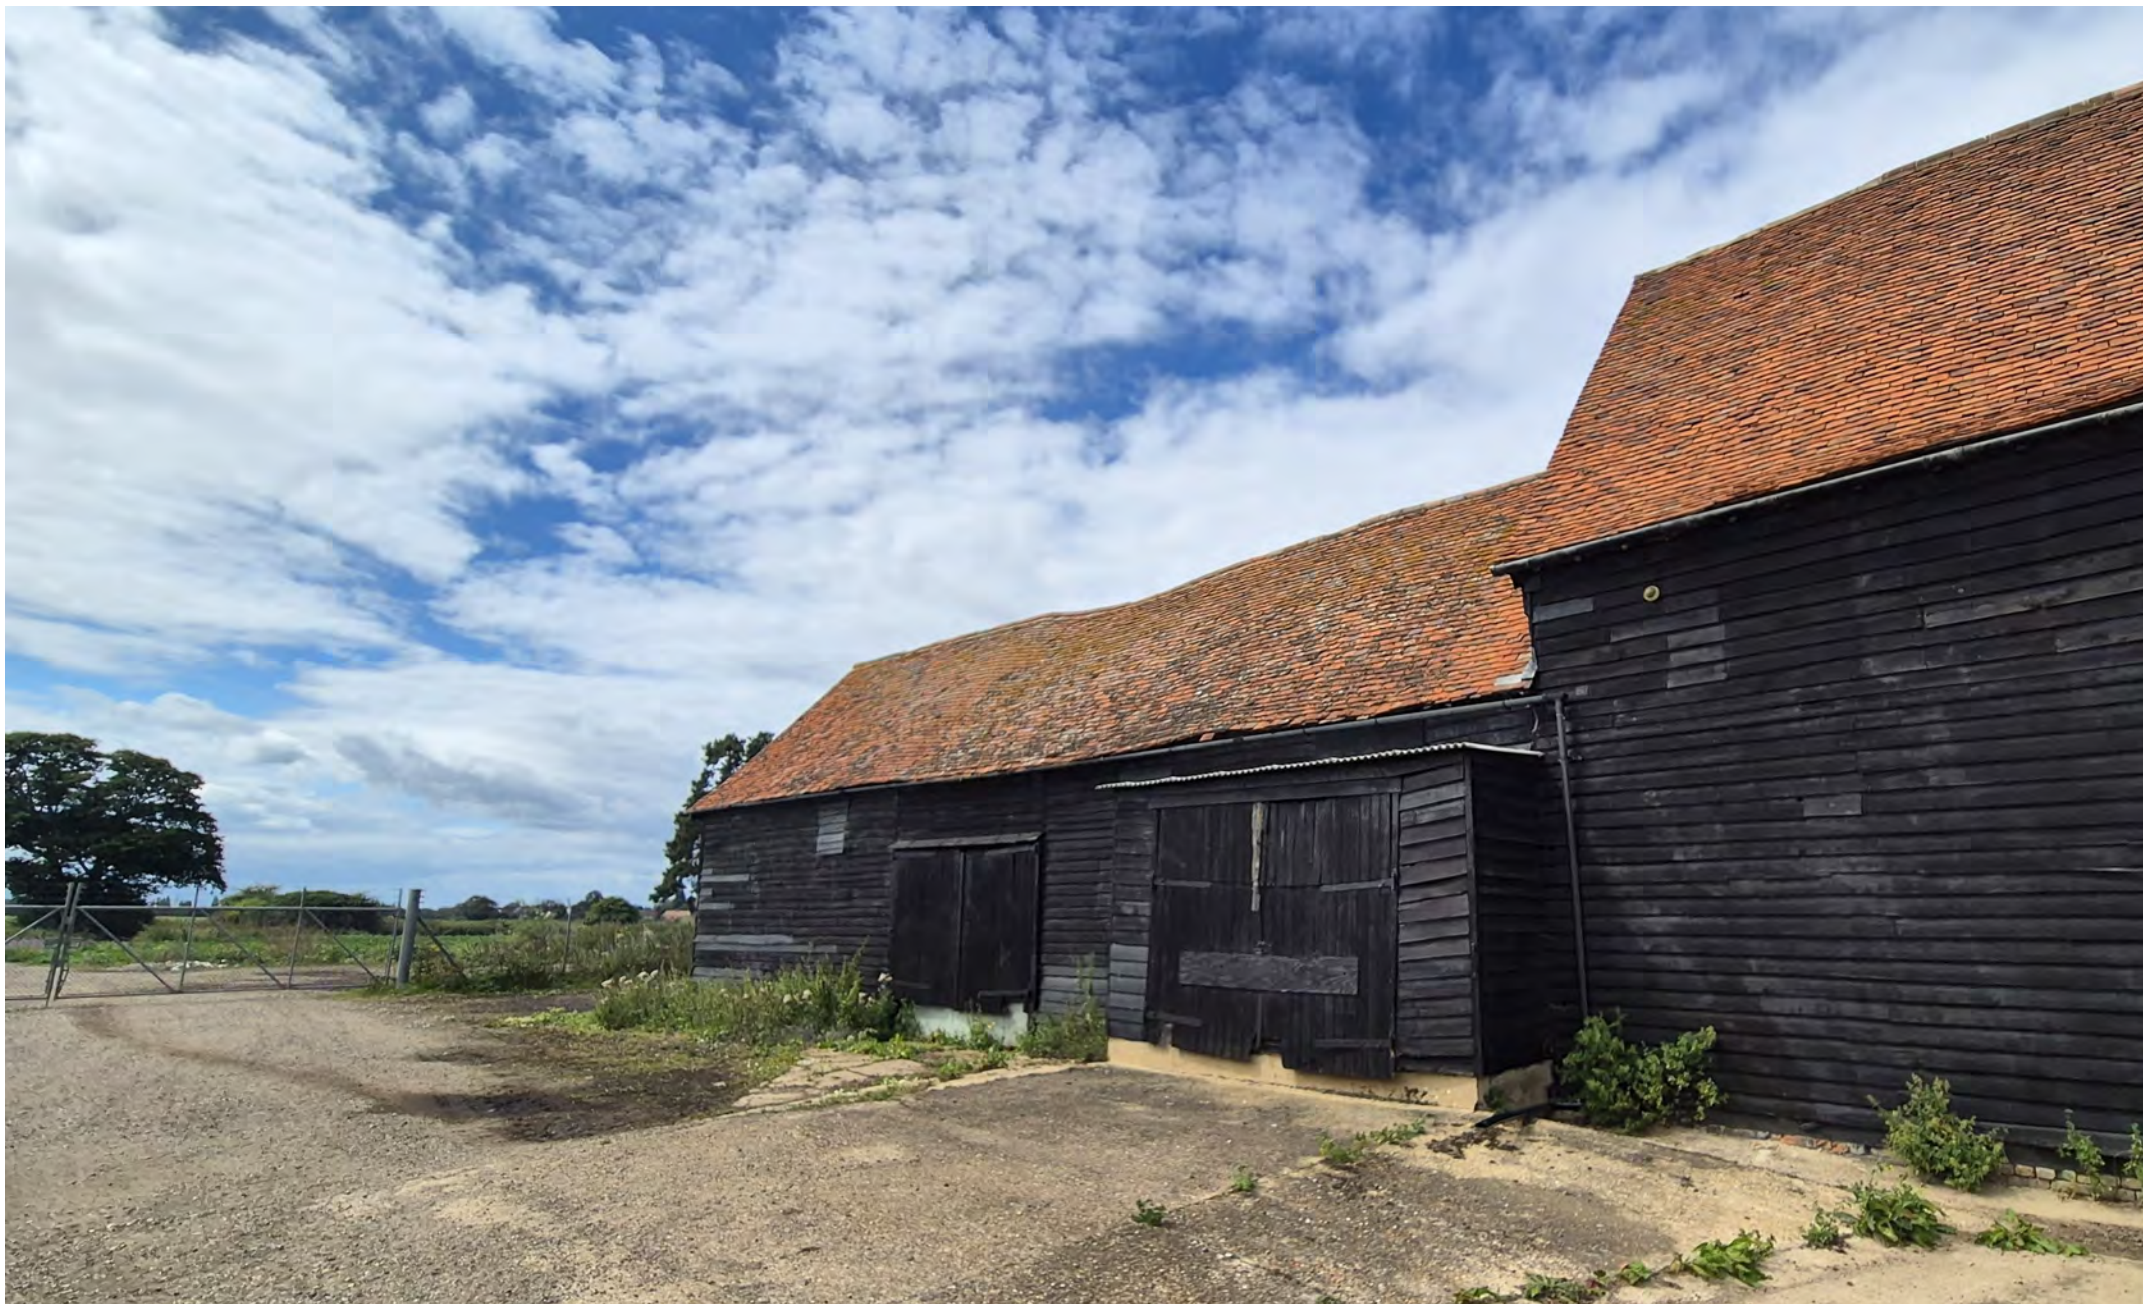
Eastern elevation of Big Black Barn

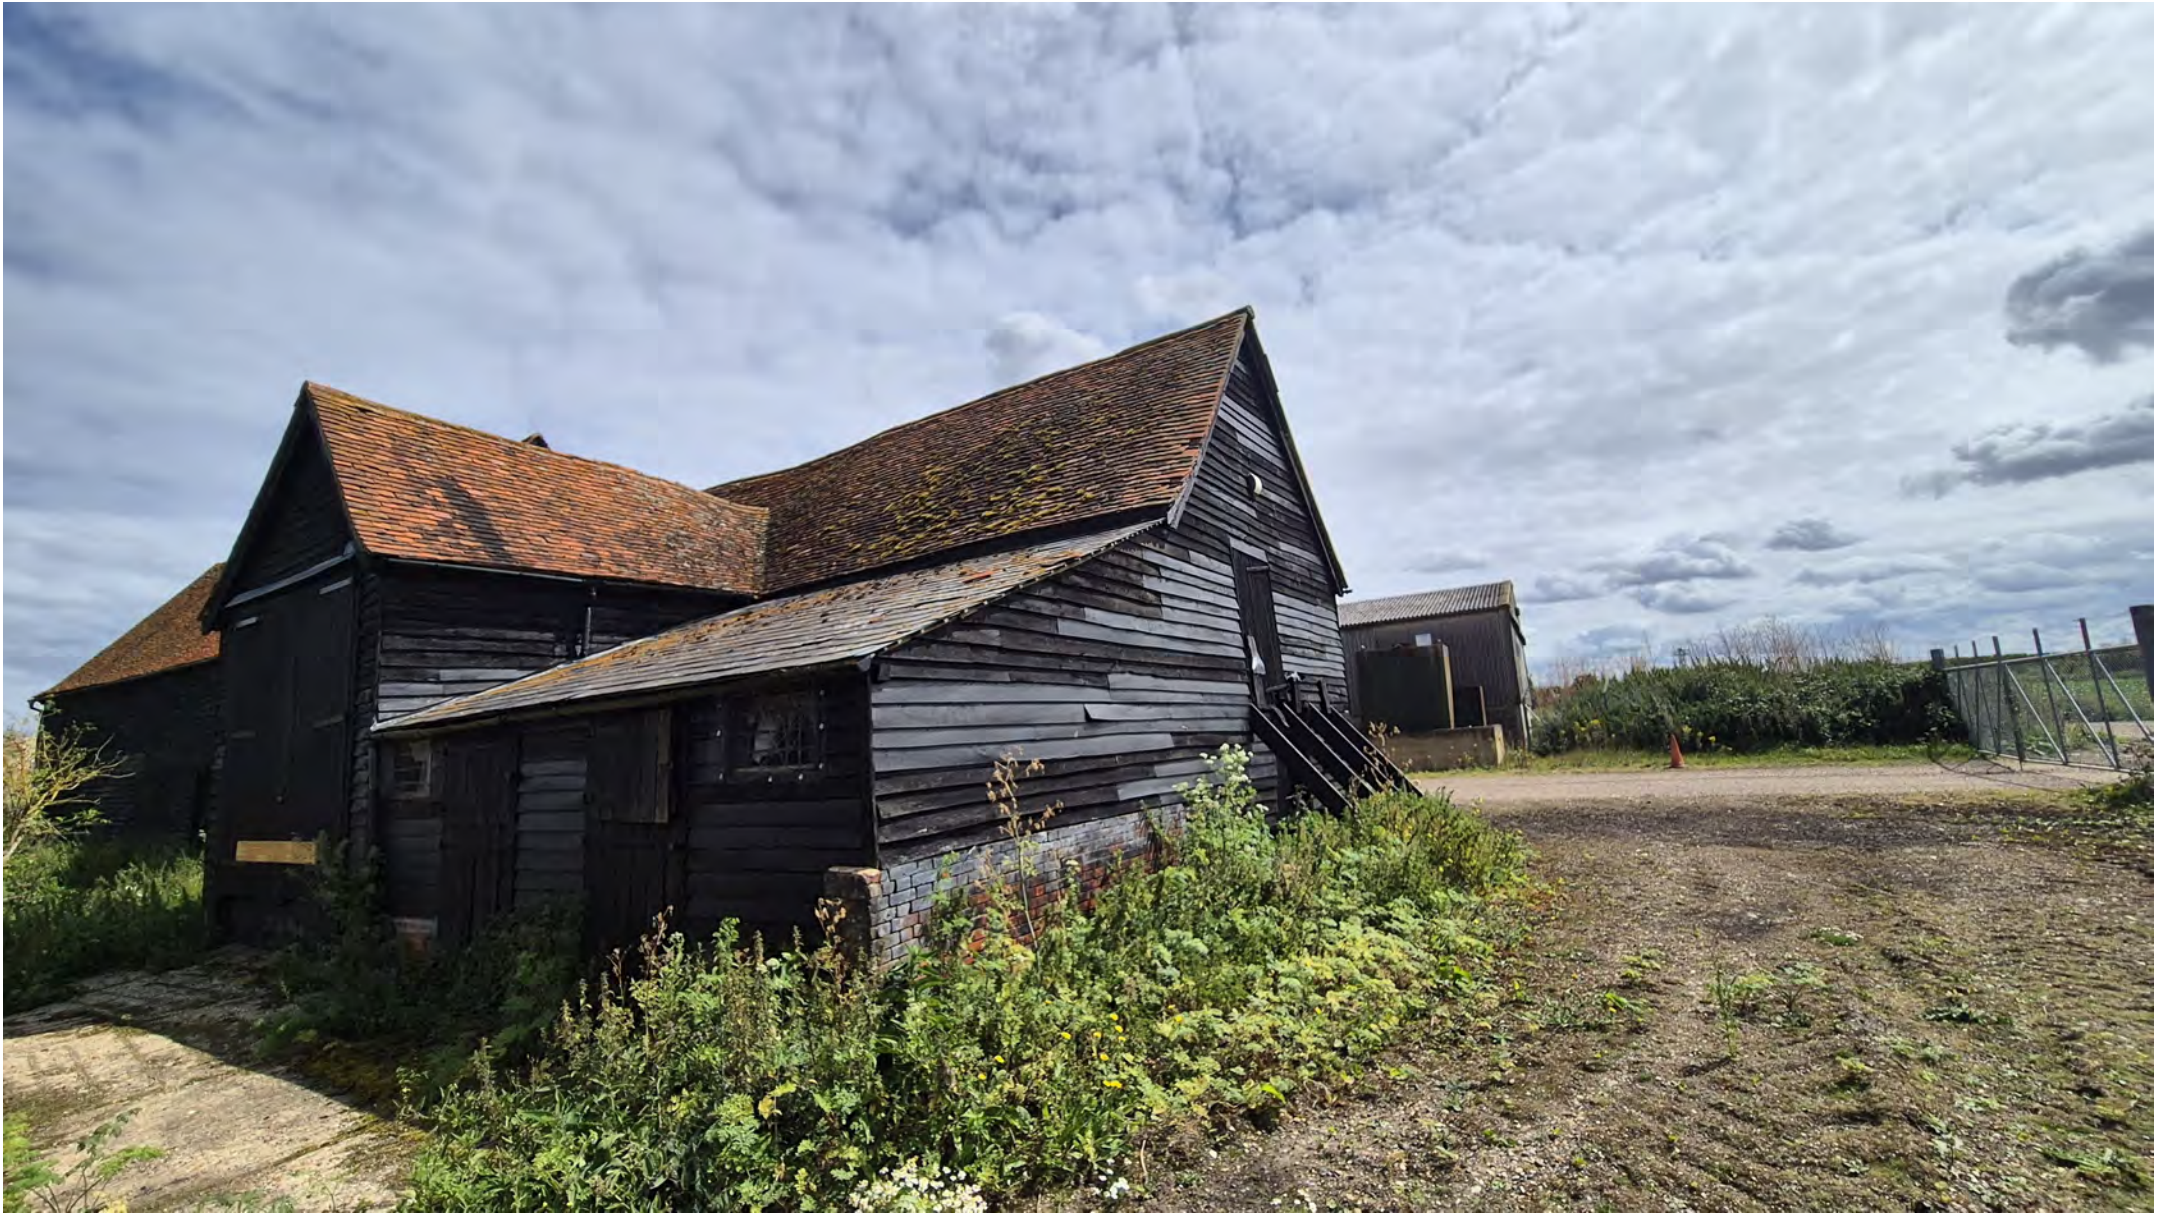
Western elevation of Big Black Barn

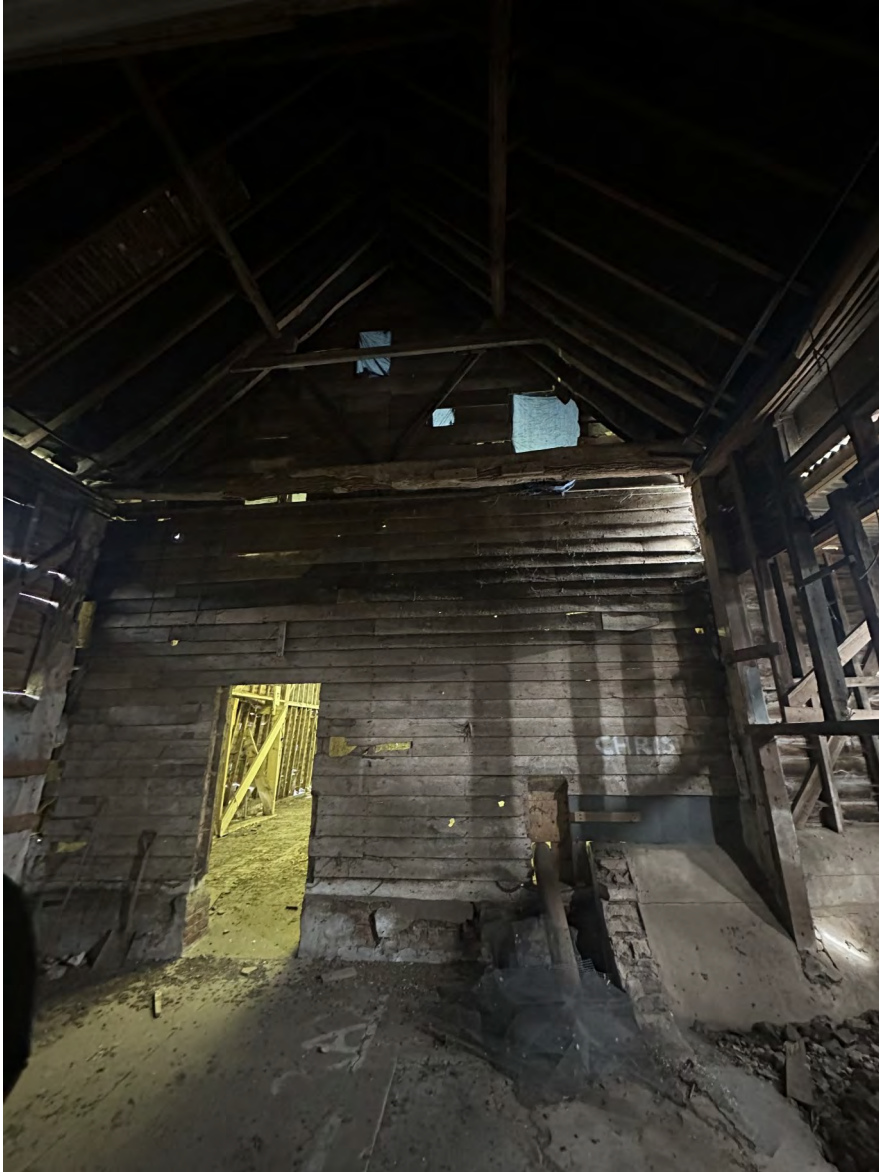
Northern gable (internal)

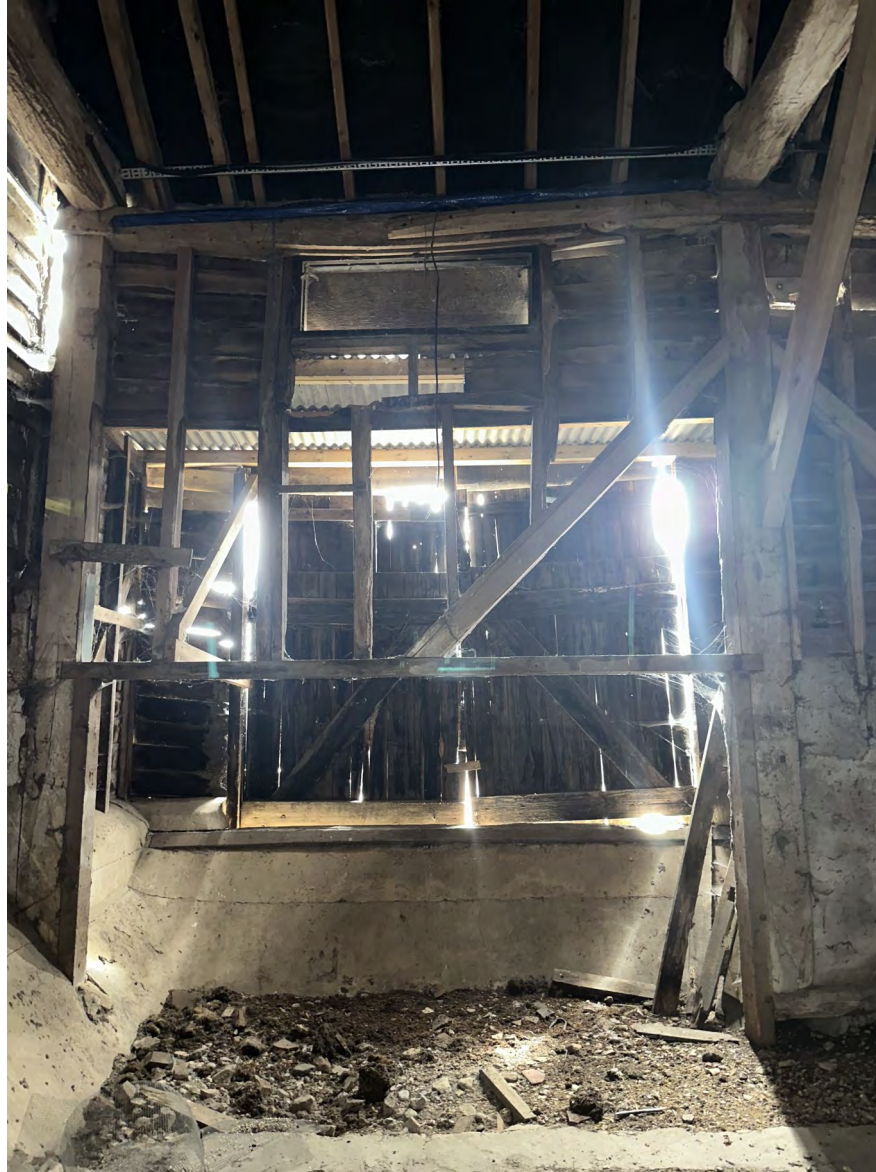
Eastern porch detail / feeding area (?)
