## *Hunsdon Airfield Heritage Assets Feasibility Study*

# Gilston Park Estate Strategic Landscape Masterplan (SLMP)

## Hunsdon Airfield Feasibility Study

March 2025

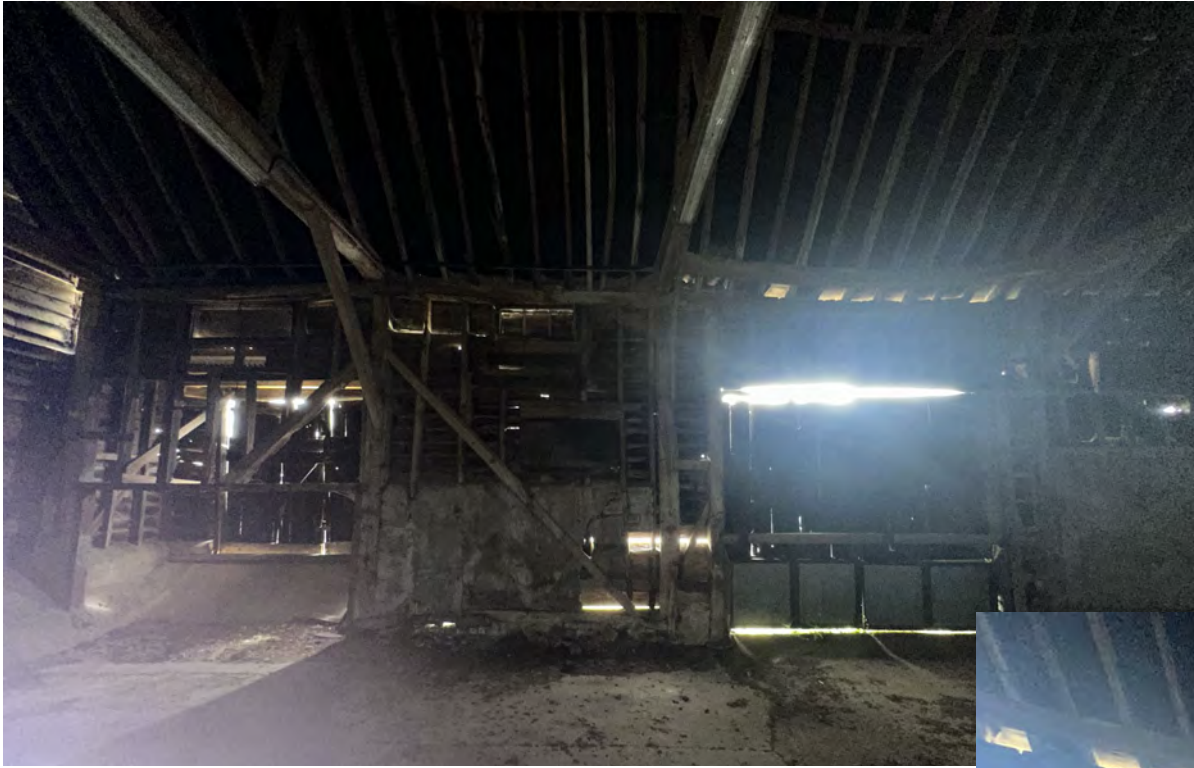
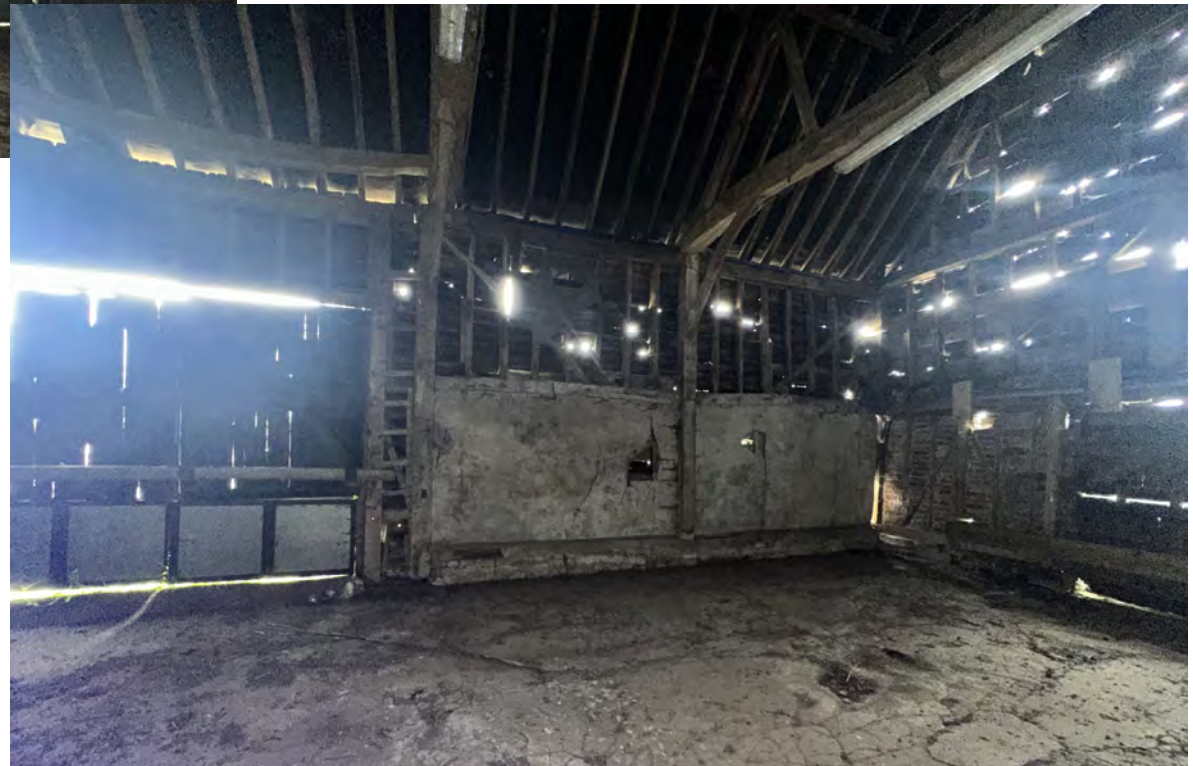
Above: Eastern Elevation internally (northern portion)

Below: Eastern Elevation internally (southern portion)

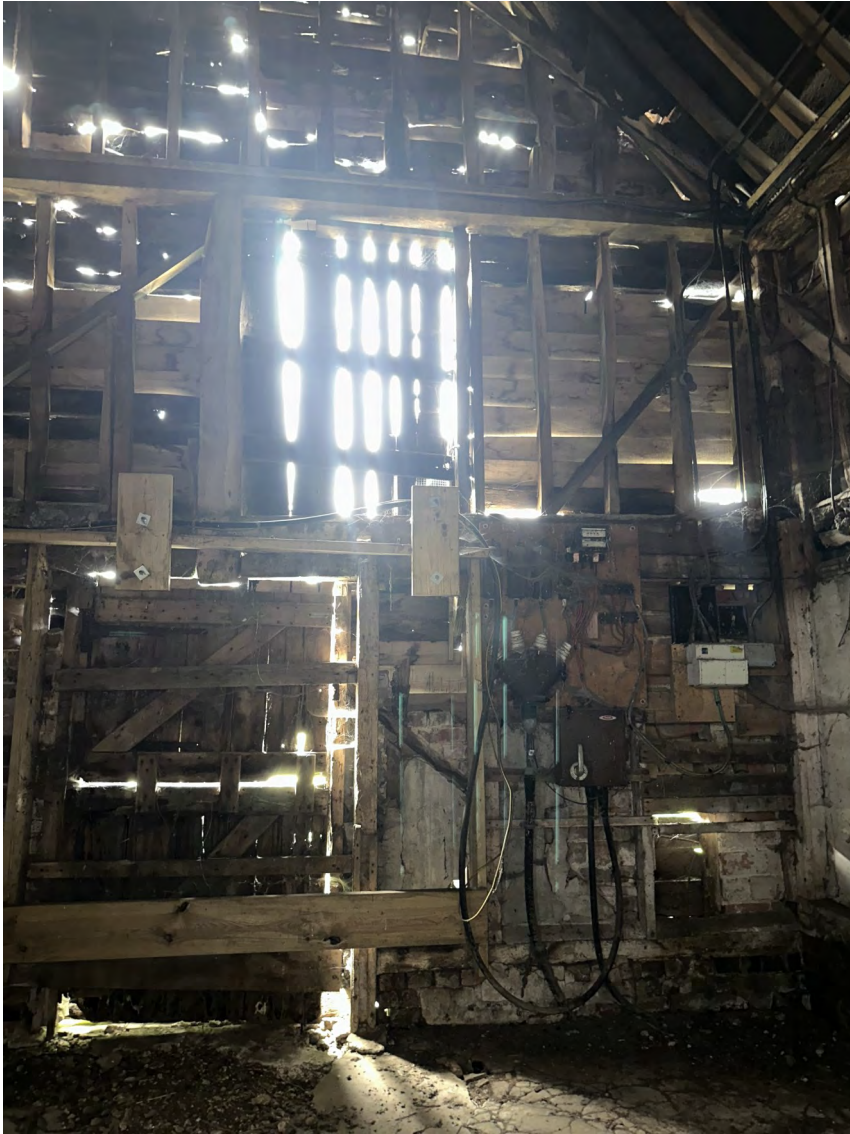
Southern gable (internal)

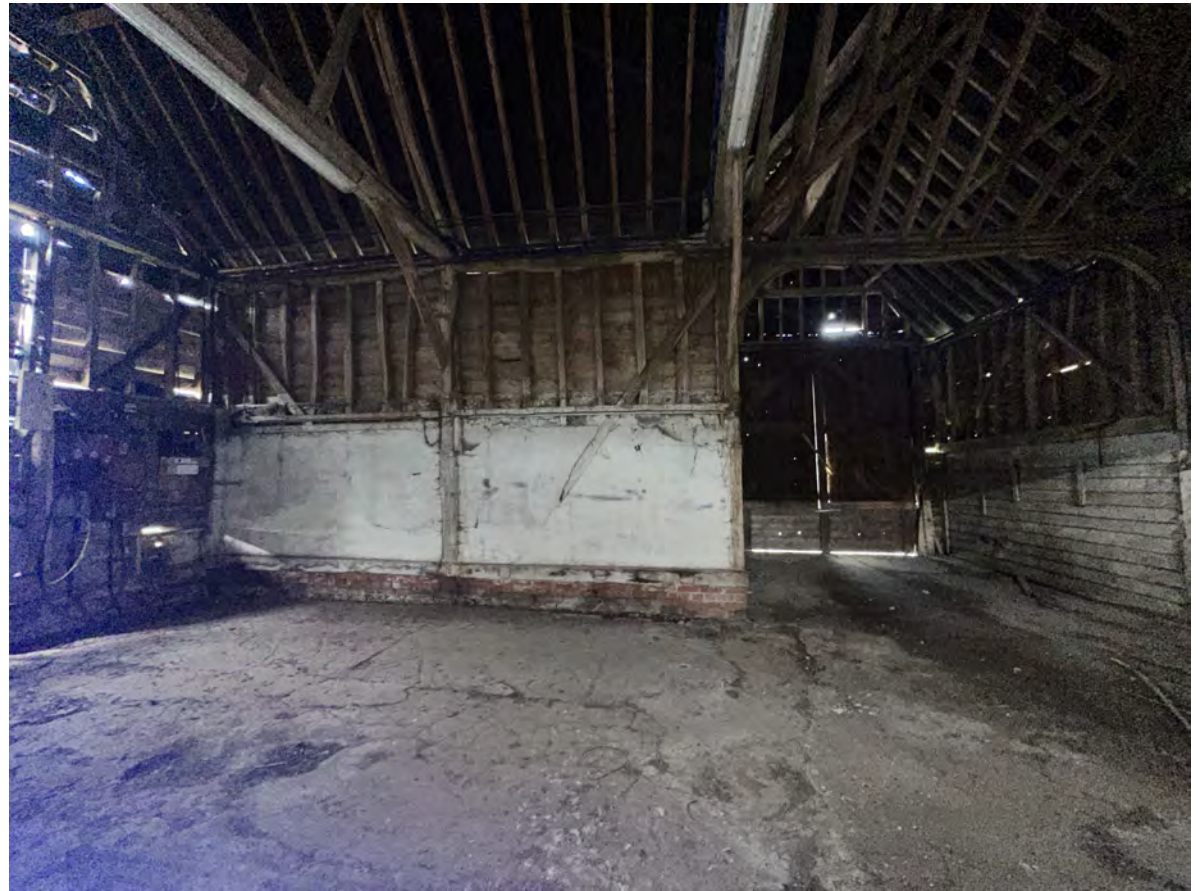
Western Elevation (southern portion)

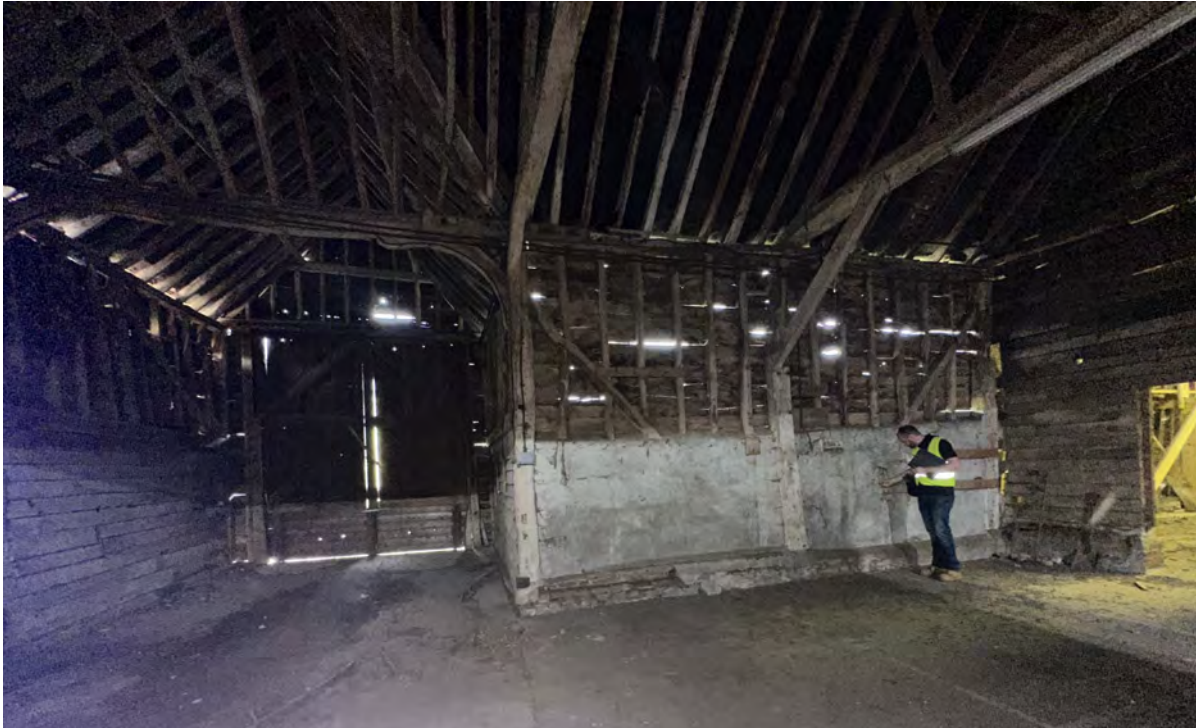
Western Elevation (northern portion)

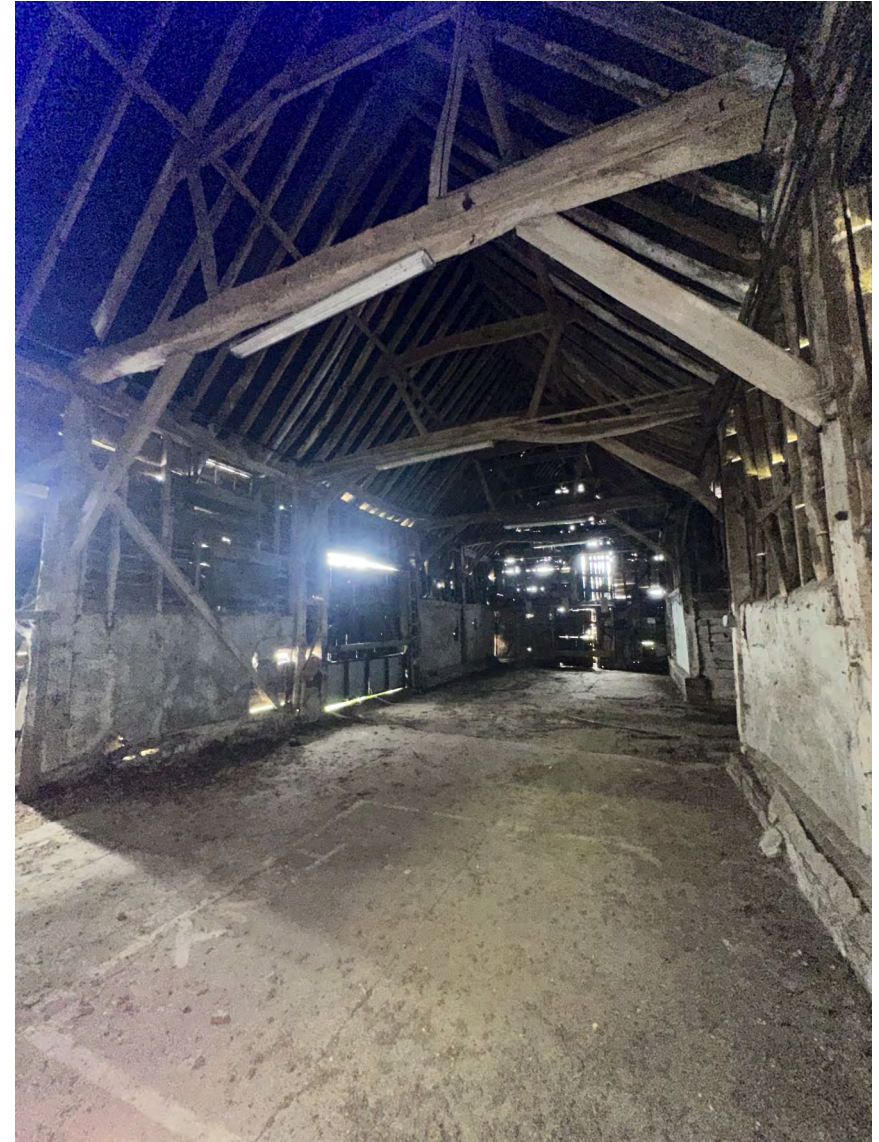
Interior looking south

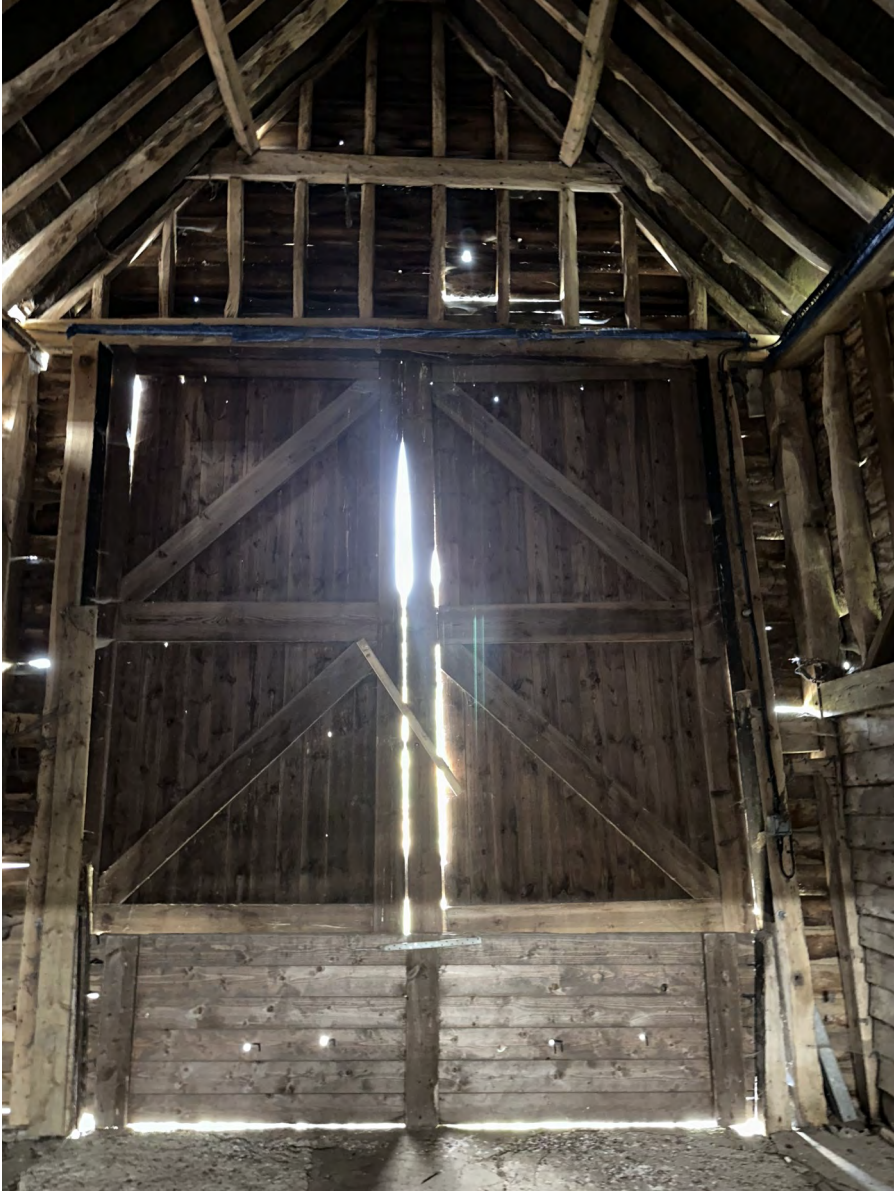
Western Gabled Porch doors

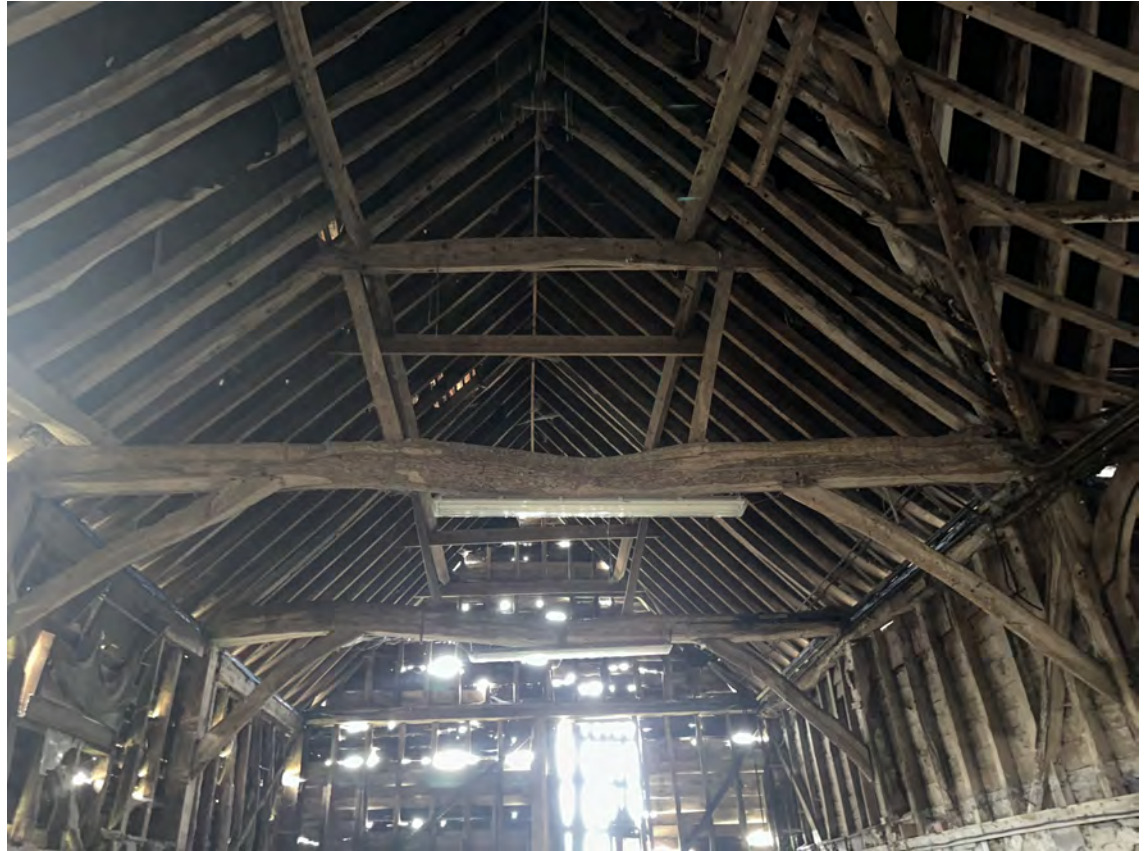
Roof structure (main barn)

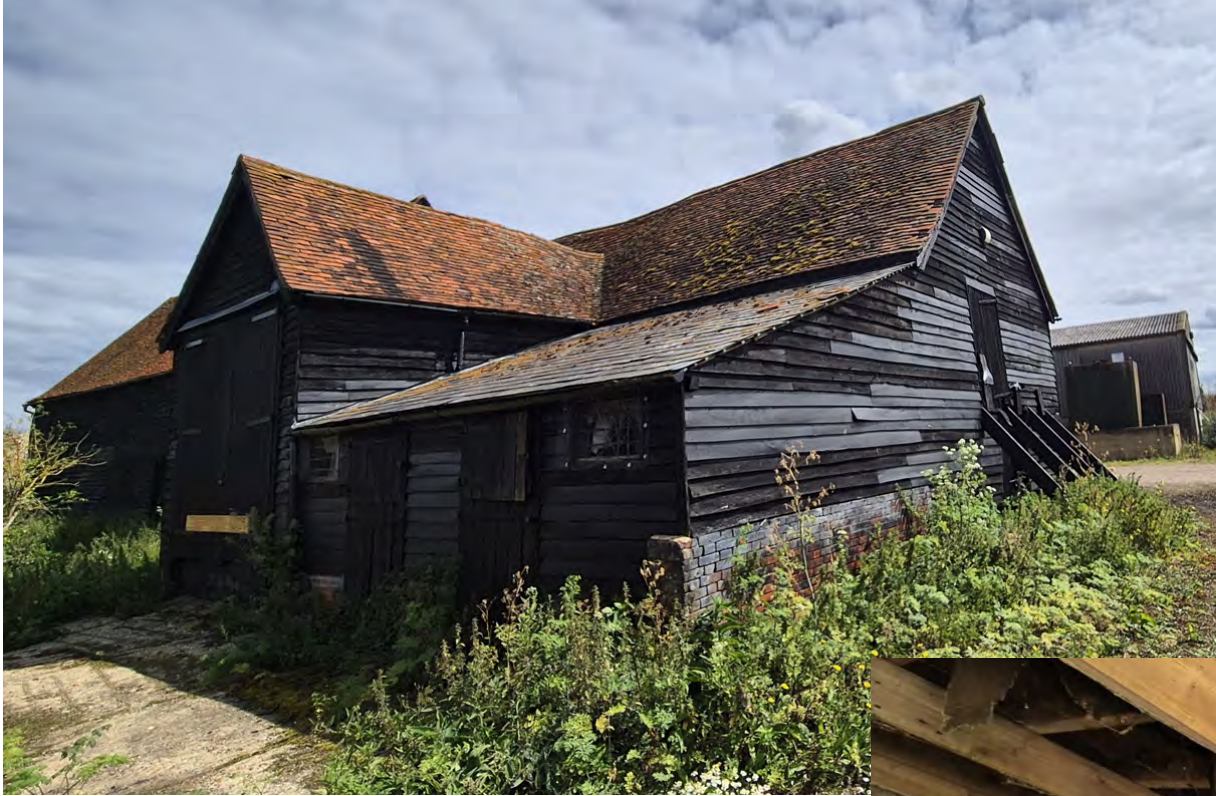
Exterior - lean-to stables to SW elevation

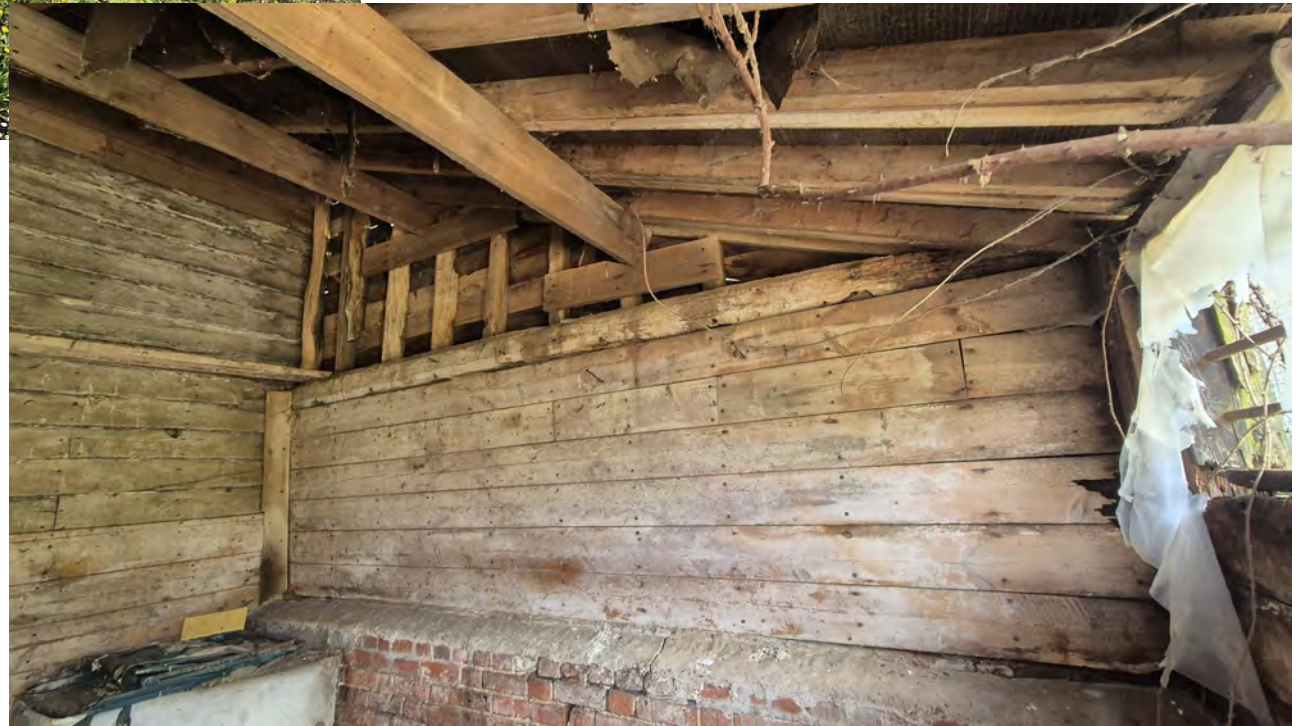
Indicative Stable Interior

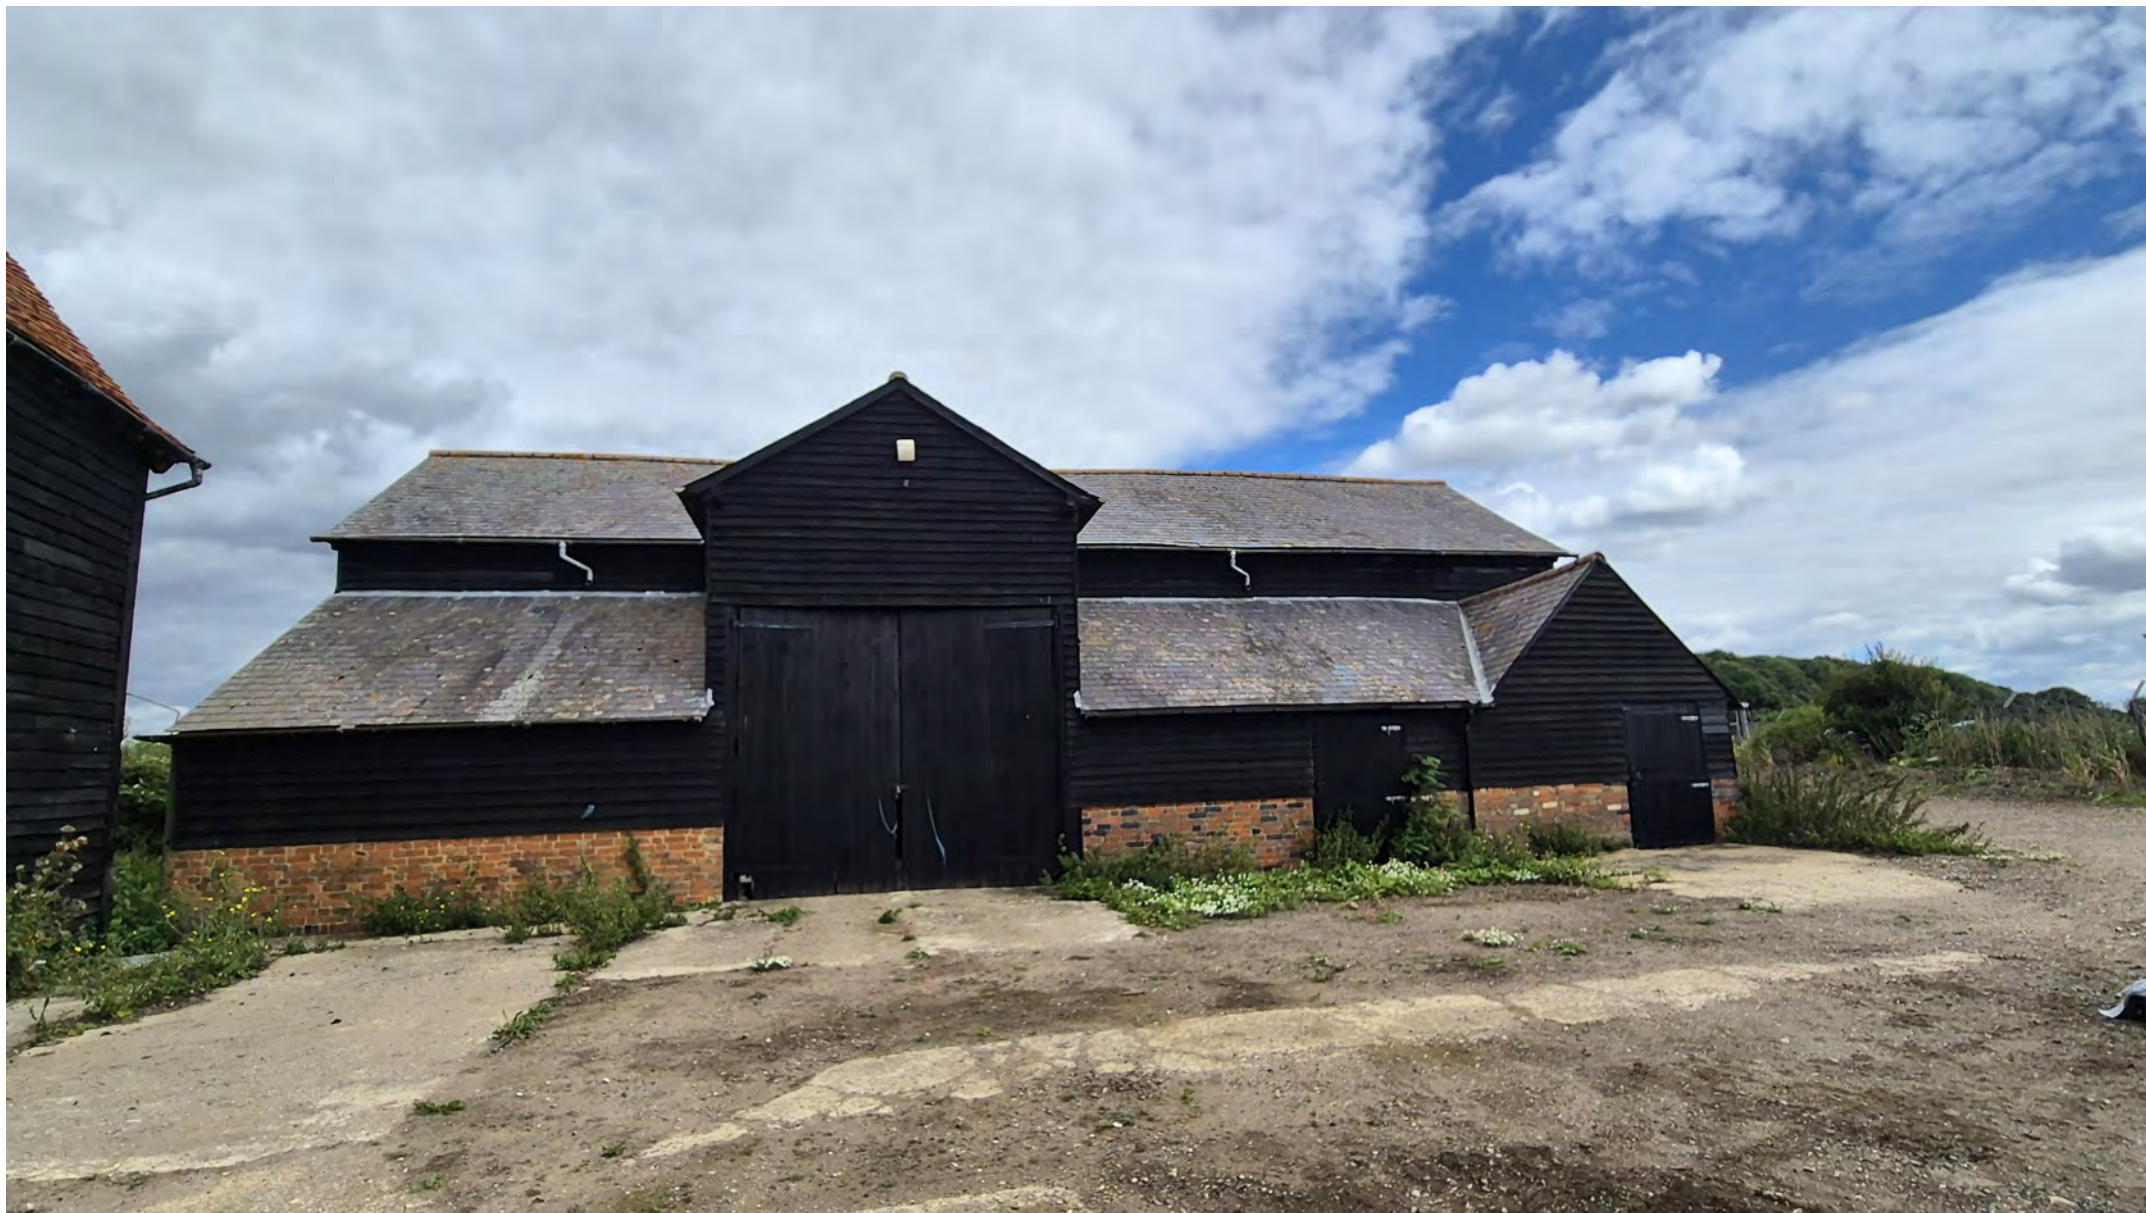
The barn is of six-bays and has an off-centre gabled porch with a lean-to to the east. The roof was reconstructed in the 19<sup>th</sup> century. Of all the barns, the Essex Barn appears to be in the best state of repair, hence its use for storing aviation equipment.

Southern elevation of Essex Barn

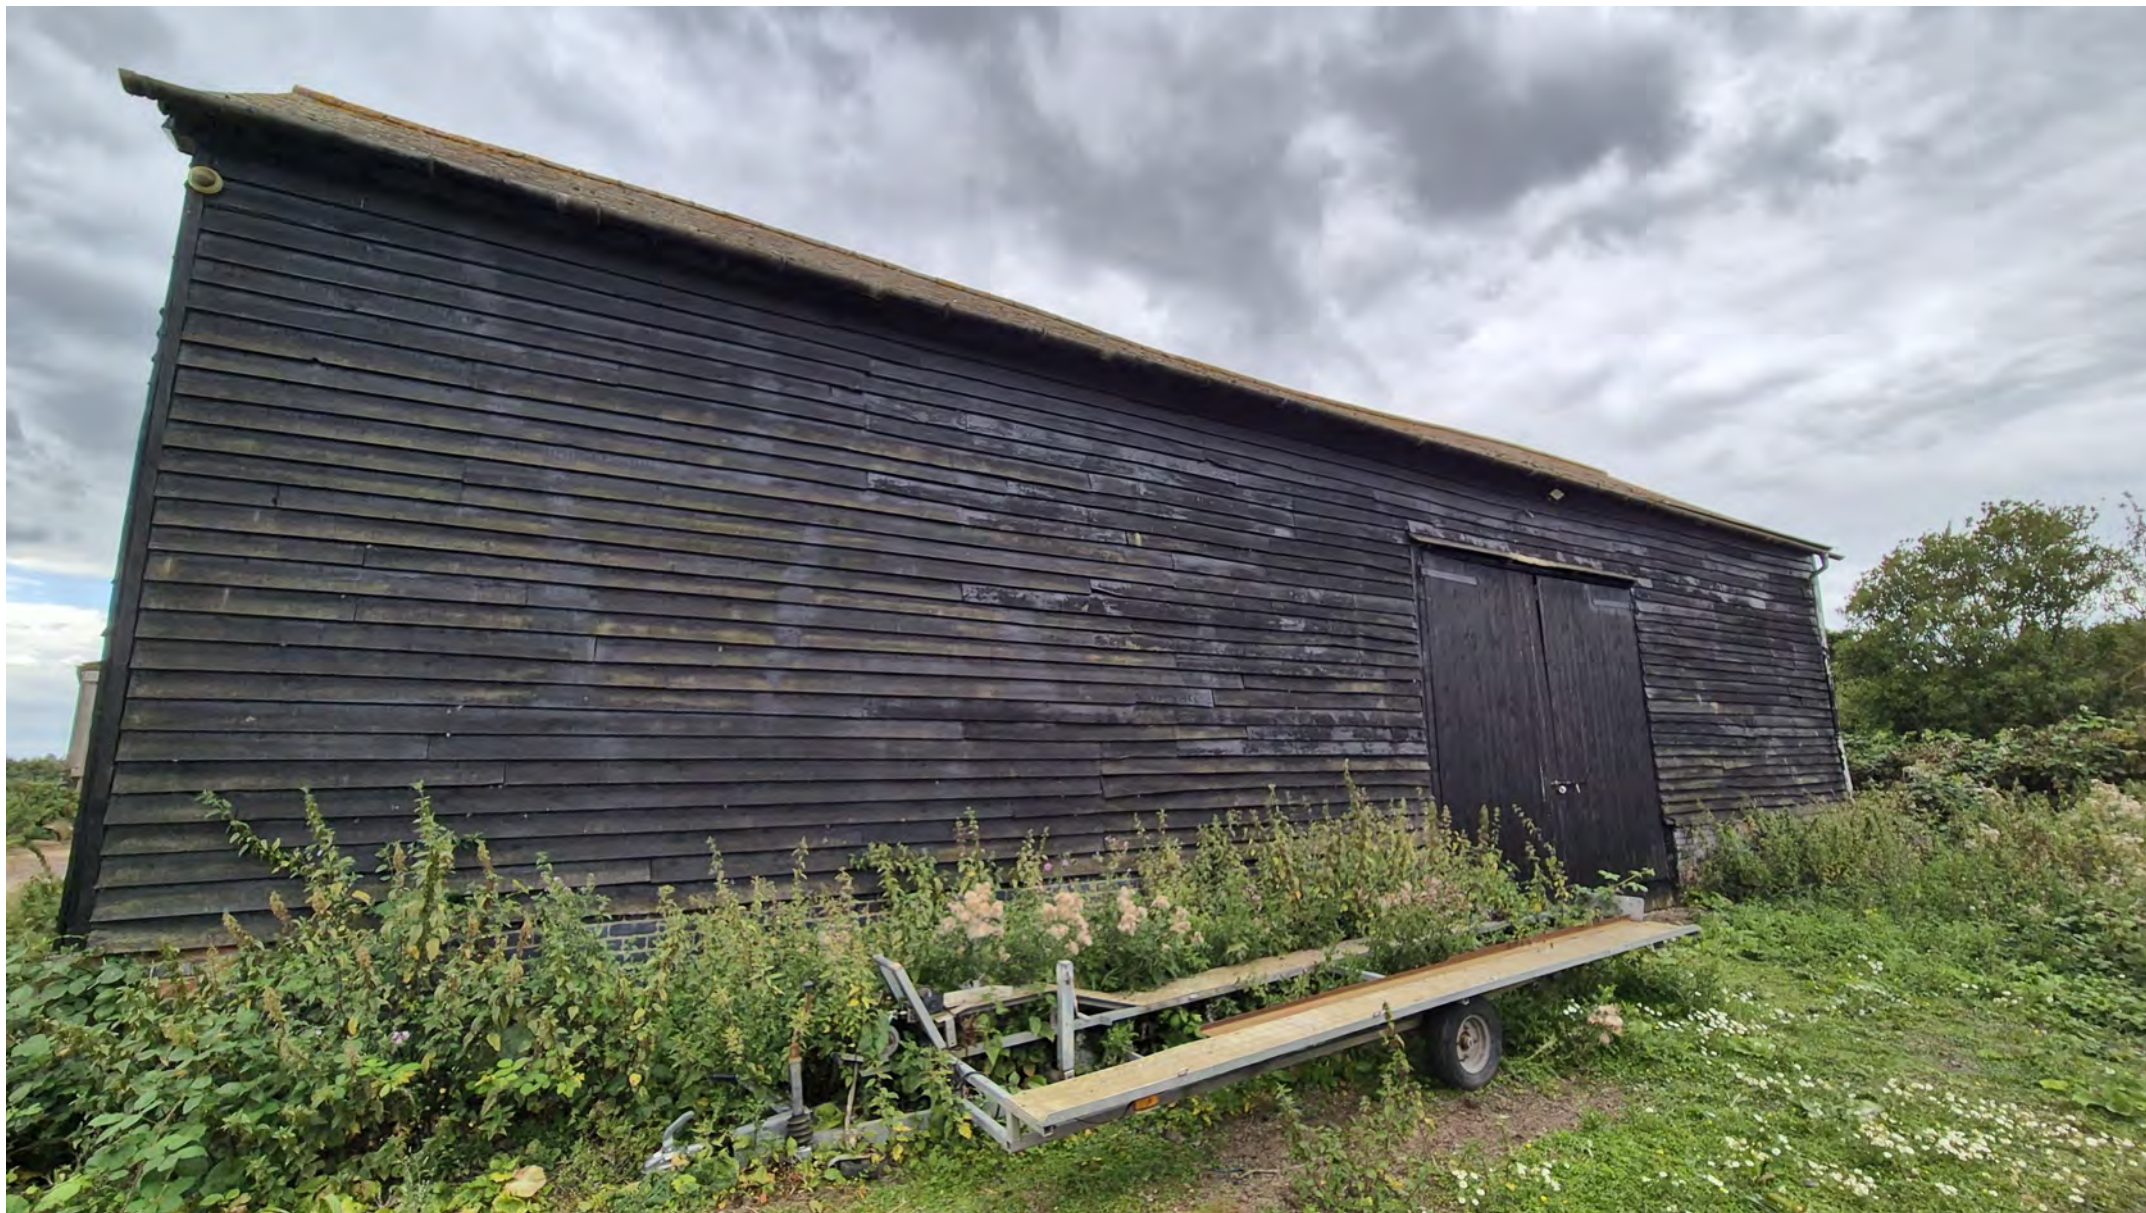
Northern elevation of Essex Barn

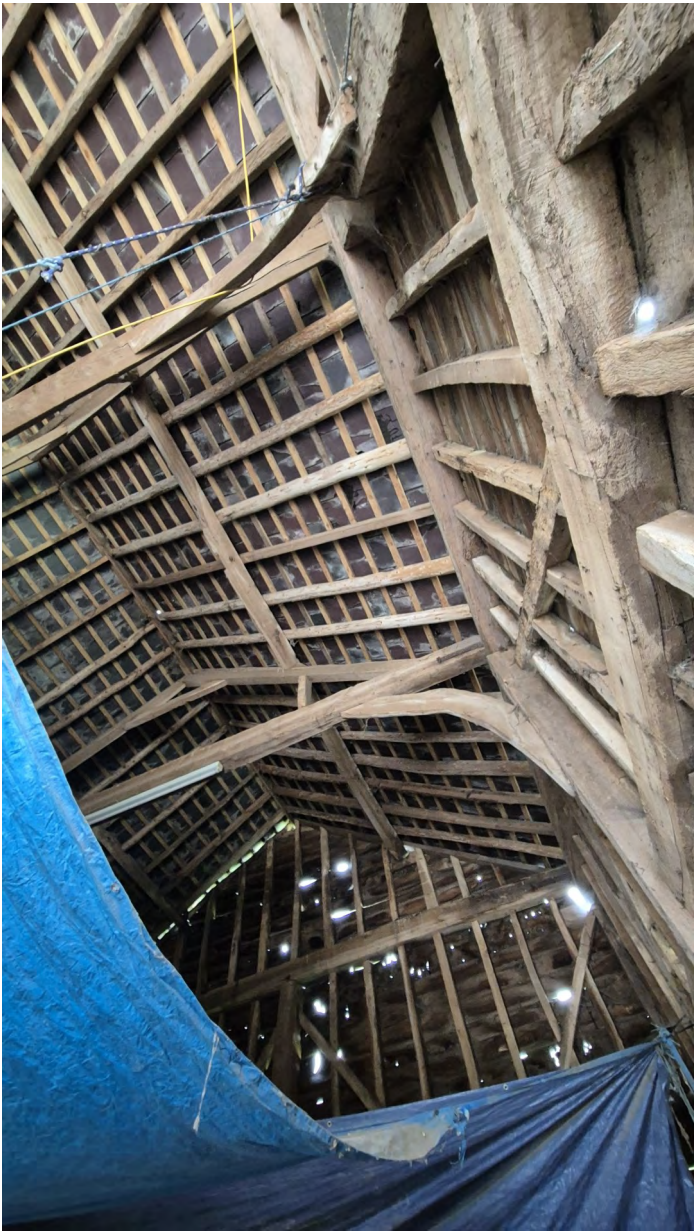
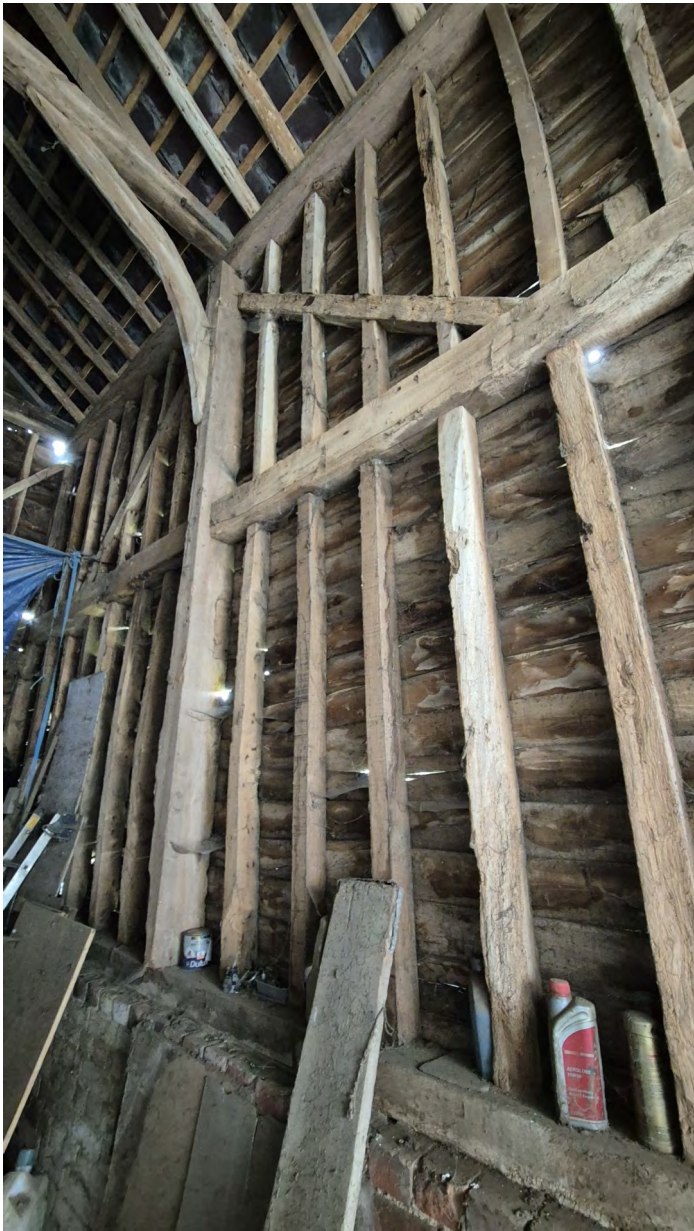
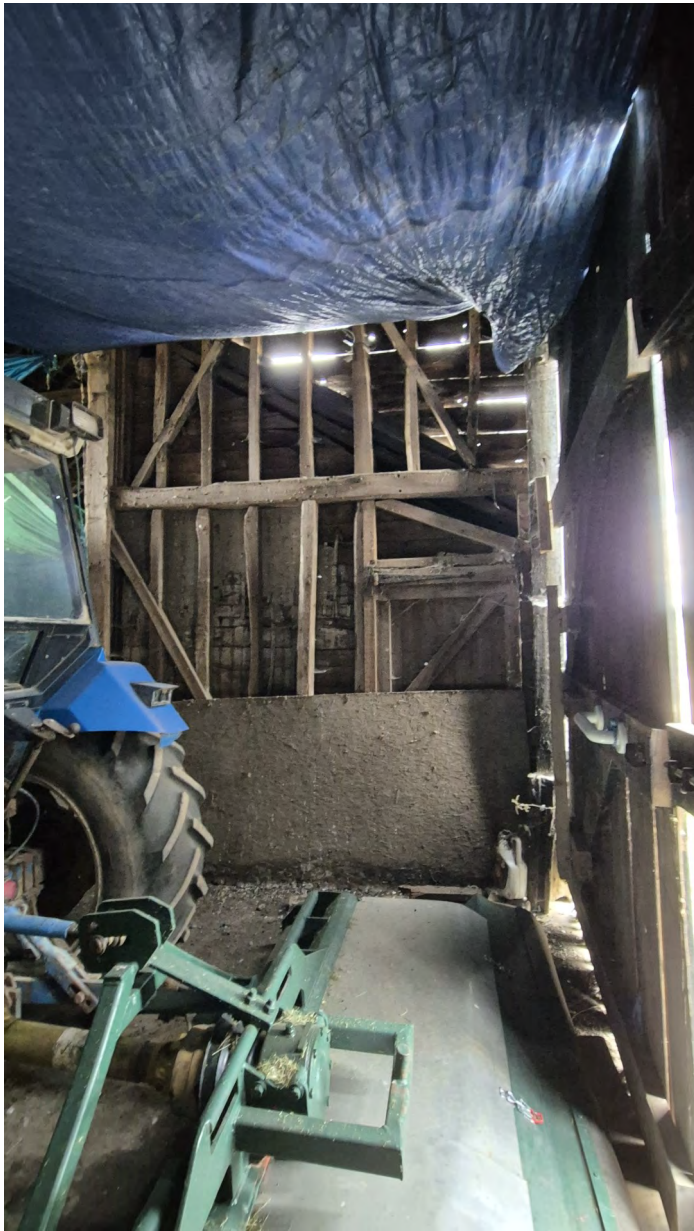
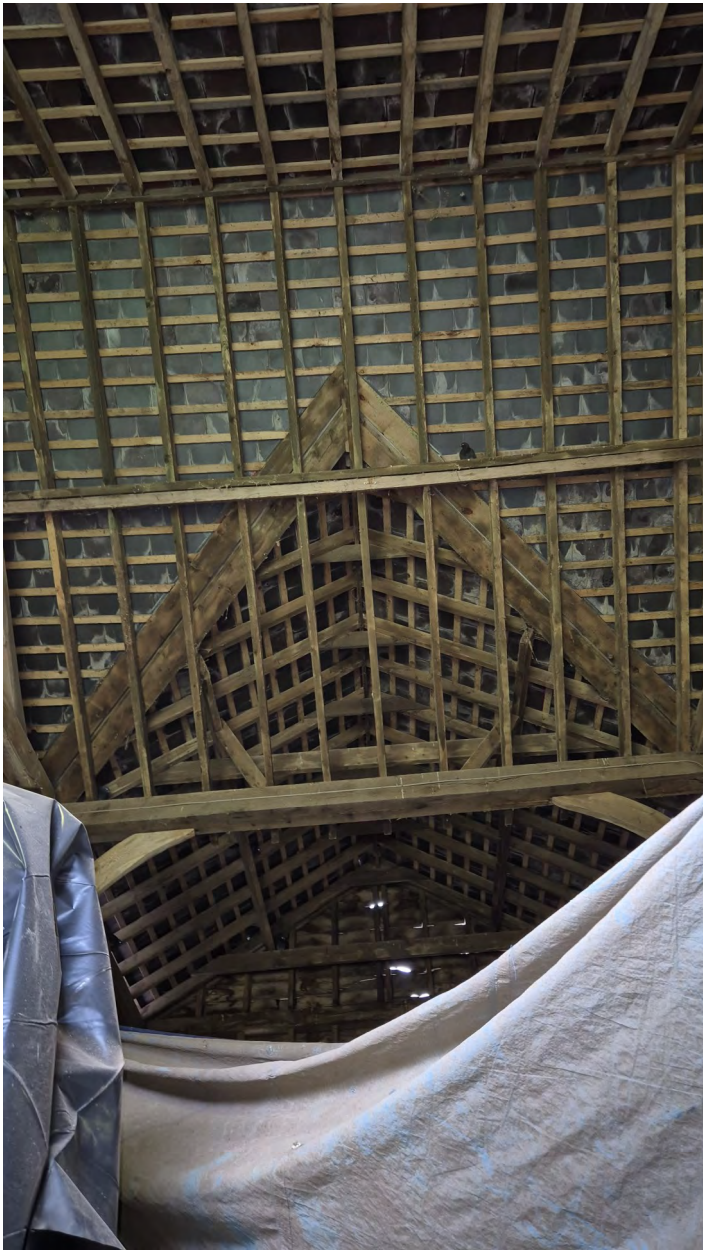
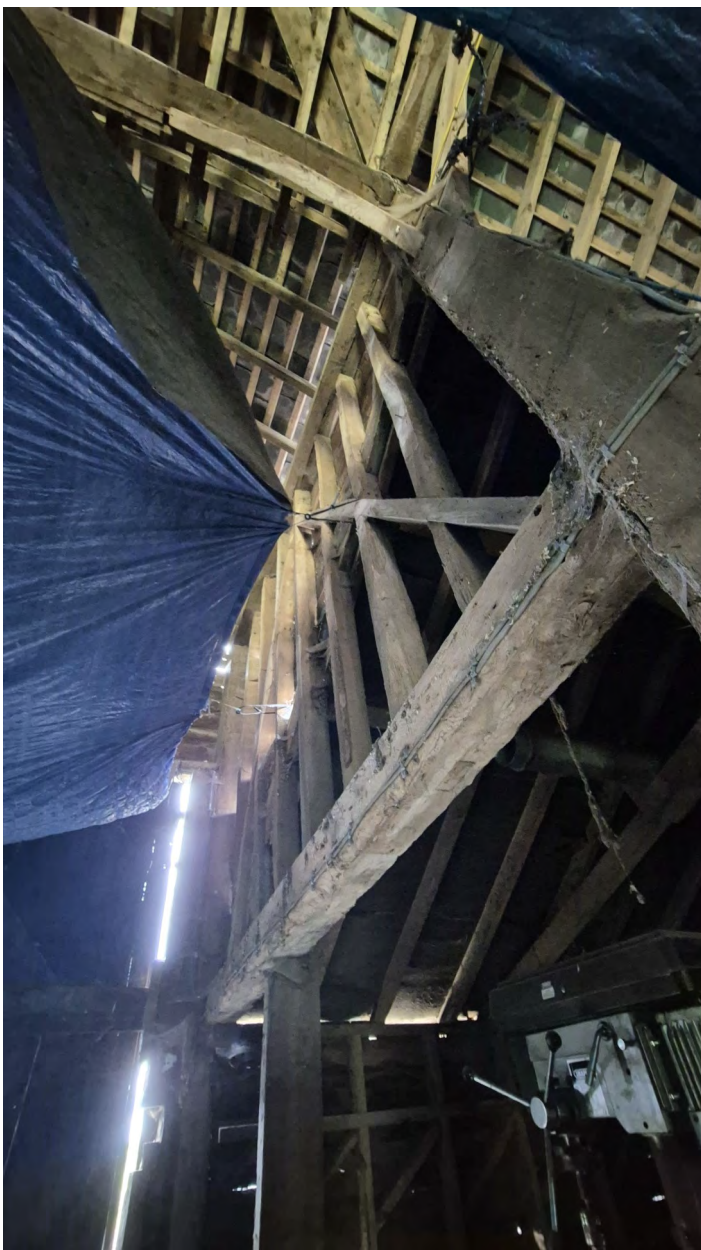
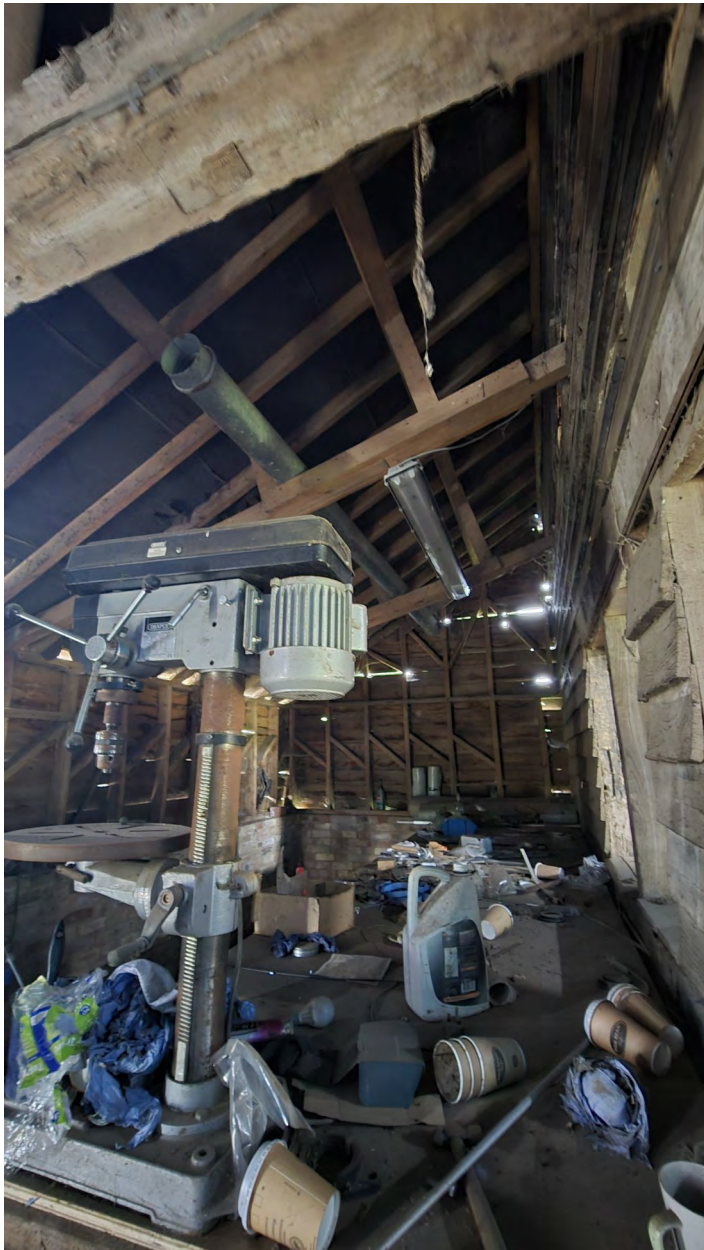
Essex Barn—Indicative interior photographs (much of the interior was screened by tarpaulin and machinery)

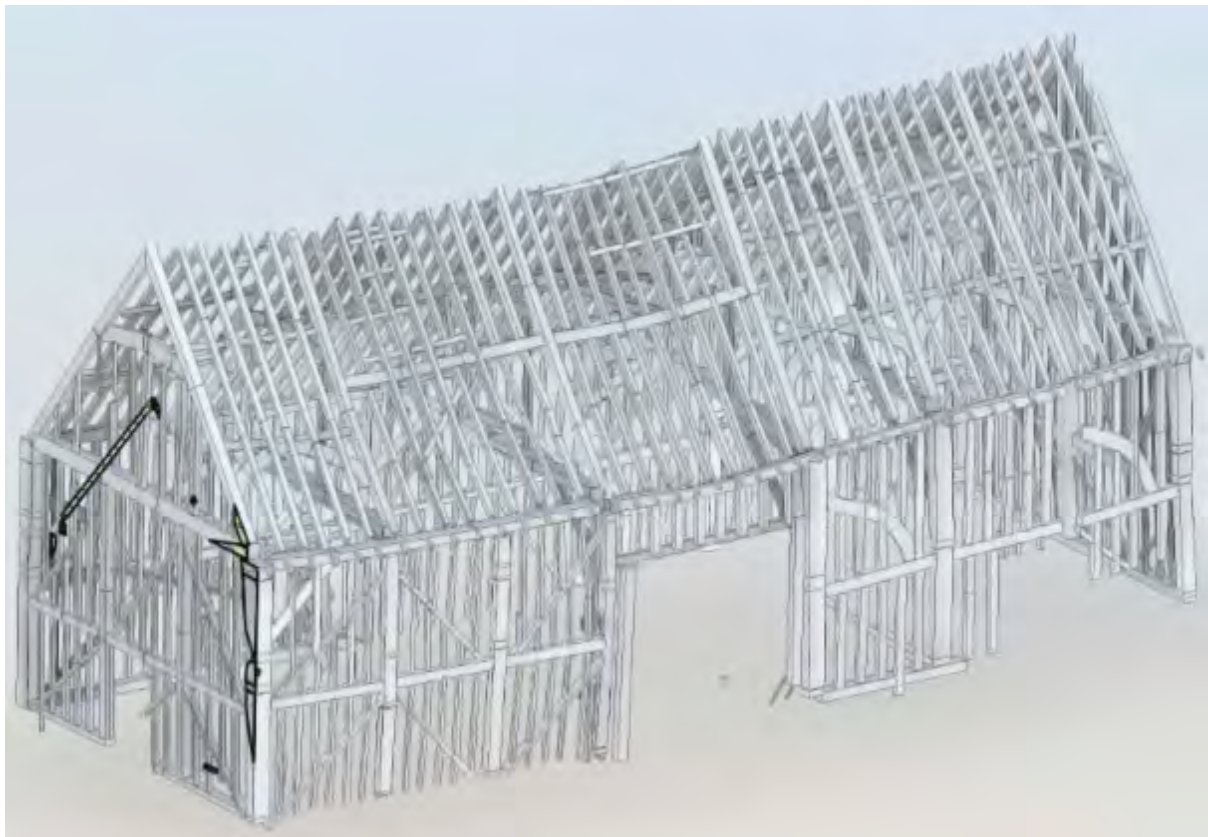
*Figure 1: Black Barn Survey Data*

The structure was that of a traditional timber framed barn with a trussed roof supported on large posts with stud panels between. The sill plate sat on a low brick plinth of only a few courses, although this was missing on the northwestern elevation where the original door had been filled in. A digital survey of the Black Barn was provided by the project team (**Figure 1**).

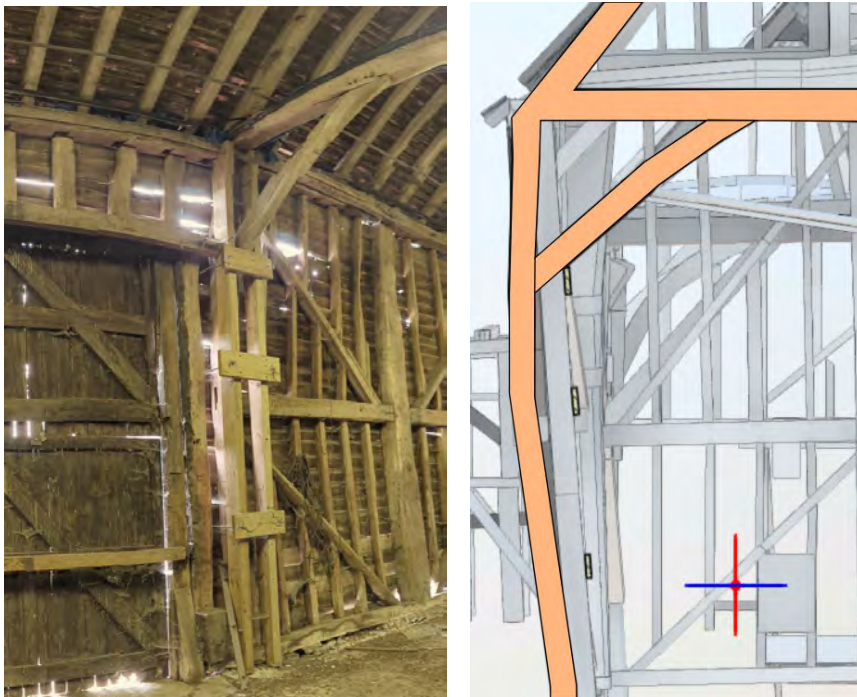
*Figure 4: Black Barn post strengthening*

On the southeastern side, where the braces would be in compression, they have applied a bending movement to the main posts, some of which have bowed significantly under this load, to the extent that temporary strengthening has been installed (Figure 4).

**Recommended Works:** The failure of the additional diagonal bracing joints suggests the racking of the frame is ongoing, although it is not known over what timeframe this movement has occurred. Neither the original arch bracing nor the newer diagonal bracing is likely to be significantly contributing to stability of the frames and therefore further movement has little resistance. Timber frames can accommodate significant movement, but this frame may be reaching the limit of what it can reasonably be expected to sustain. It is recommended in the first instance that the movement be monitored to gather more data and, if justifiable, works to arrest the movement may be required. These works could range from providing discrete horizontal bracing to replacing or strengthening individual members.

Generally, the condition of the fabric does not warrant immediate works, but in the medium-term repairs to the plinth walls, sill beam, main post bases, girding, wall plates and weatherboarding may all need to be carried out. This work must form part of a considered package of works and not be carried out piecemeal as several of these elements affect the issues around stability of the frame.
