## *Hunsdon Airfield Heritage Assets Feasibility Study*

# Gilston Park Estate Strategic Landscape Masterplan (SLMP)

## Hunsdon Airfield Feasibility Study

March 2025

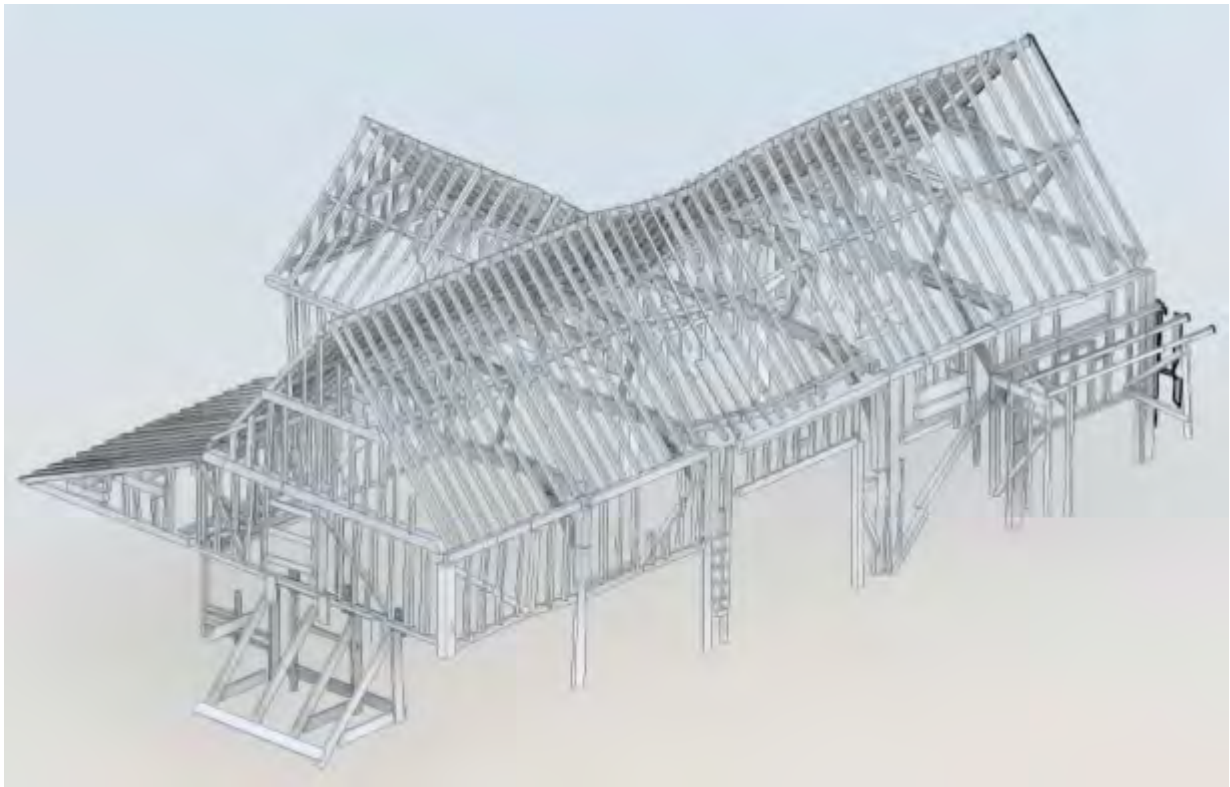
*Figure 7: South barn survey data*

The structure was that of a traditional timber framed barn with a trussed roof supported on posts with stud panels between, some with brick infill. The sill plate sat on a low brick plinth, missing from the porch. The digital model of the structure is shown at **Figure 7**.

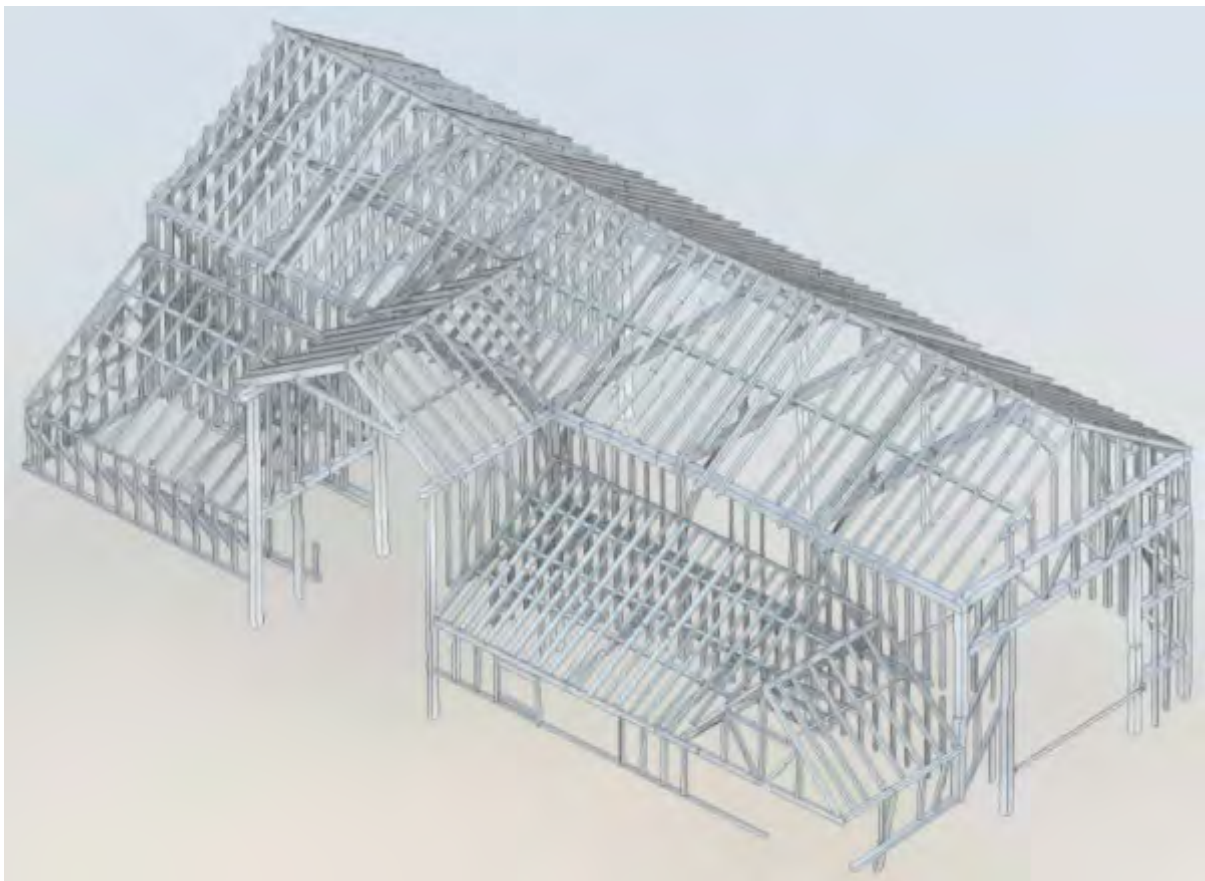
*Figure 11: Essex barn survey data*

The structure was that of a traditional timber framed barn with a trussed roof supported on posts with stud panels between. The sill plate sat on relatively high brick plinth walls which support stud panels with sill beams, wall plates and cladding weatherboarding. The data model for the Essex Barn is shown at **Figure 11**.

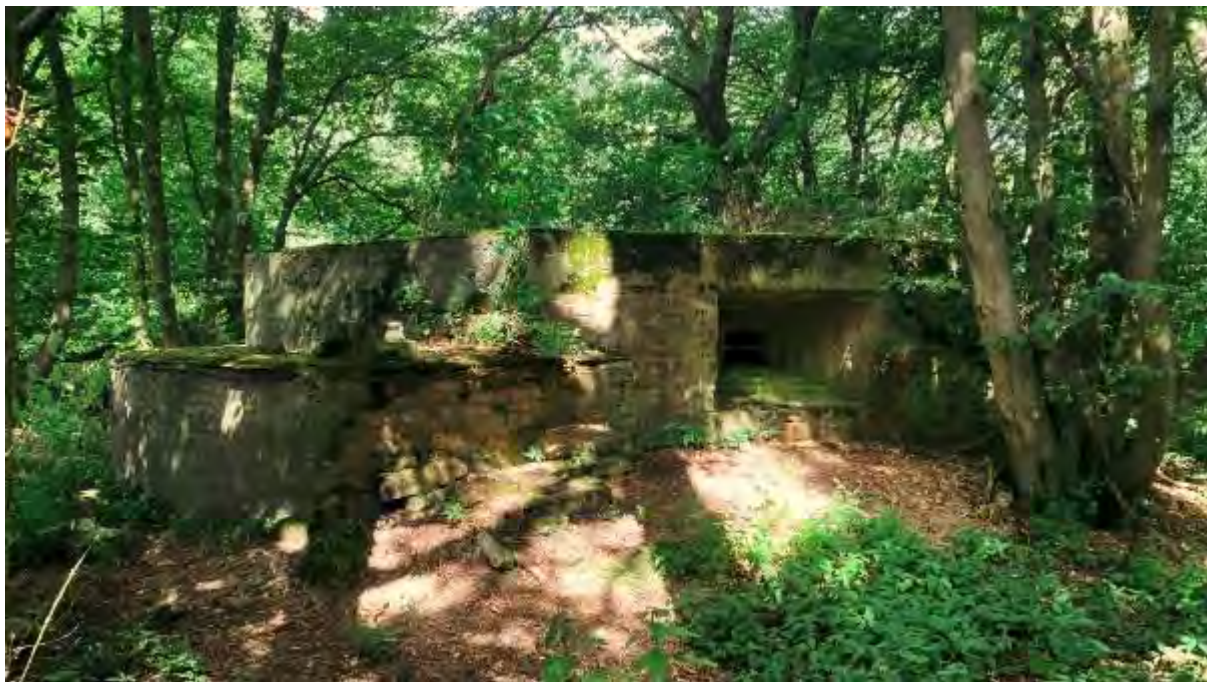
Figure 14: Typical hexagonal pillbox (No.7 – Monument ID 12)

Includes Hexagonal pillboxes 1, 3, 4, 5, 6, 7, 8 and 9 (Monument ID 14, 10, 7, 4, 11, 12, 2, and 5). The design appeared fairly uniform with a large hexagonal central space and a smaller rectangular side section currently used as the entrance (Figure 14). The structure comprised a flat reinforced concrete roof supported by thick reinforced concrete walls with a non-structural outer skin of clay brick.

The concrete elements were generally in a fair condition with only isolated and small areas of spalling observed. In the majority of cases a significant proportion of the brick facing to the wall had fallen away and there appears to be no ties back to the concrete wall behind. The primary factor generally affecting condition appeared to be vegetation. Most of the pillboxes have large quantities of vegetation around the perimeter including relatively mature trees and other woody rooted plants (Figure 15). These did not appear to have affected the primary concrete structure to date but have probably contributed to the loss of facing brickwork.

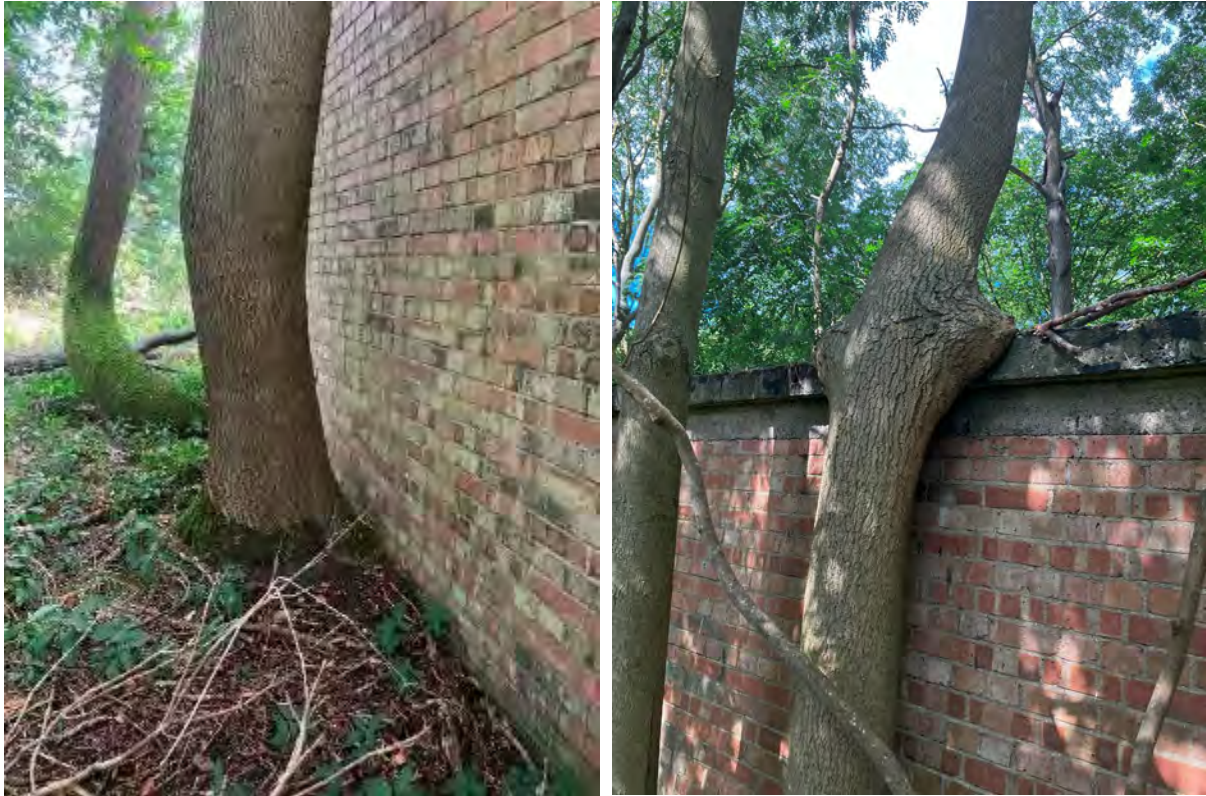
*Figure 18: Sleeping shelter trees (Monument ID 1)*

Both sleeping shelters (Recreation Hut and Flight Offices – Monument ID 1) comprised load-bearing brick external and internal walls supporting flat reinforced in-situ concrete roofs. Both are in good condition with no visible indications of structural deterioration observed. Several mature and extremely close trees were growing around each building but did not appear to be affecting the fabric (Figure 18).

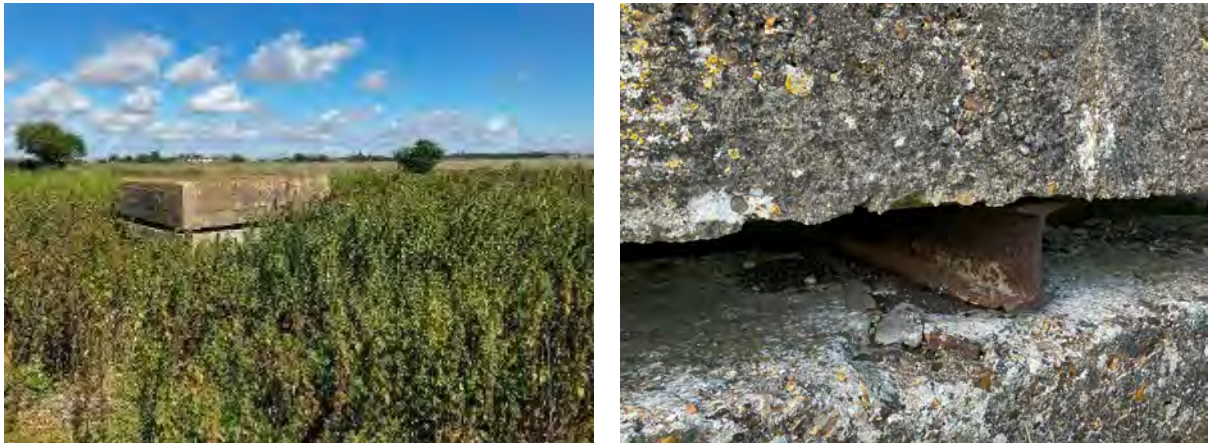
*Figure 19: Underground battle headquarters (Monument ID 3)*

The small part of the underground battle headquarters (Monument ID 3) that extended above ground comprised a concrete lid supported just above the base to create a horizontal slit. The gap is maintained by three short sections of corroded RSJ (Figure 19). The below ground portion was not accessed.

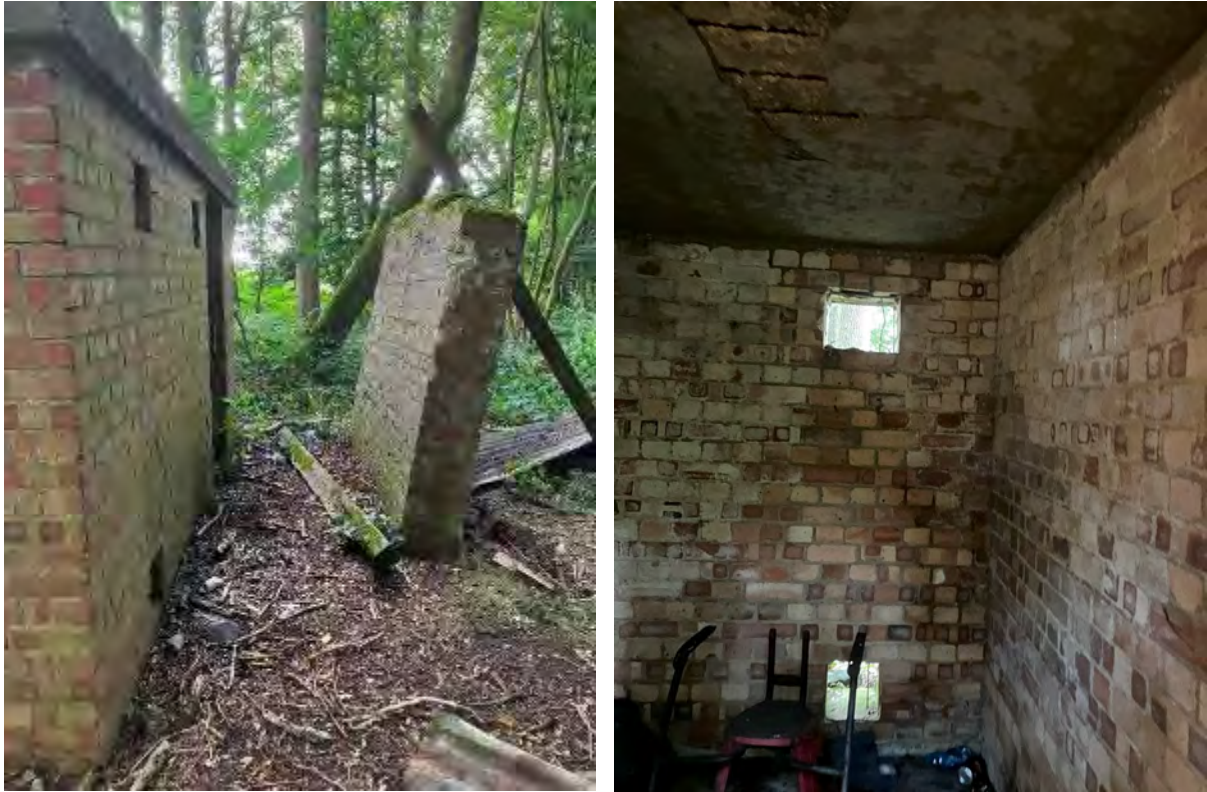
*Figure 23: Ammunition store to pillbox 7 (Monument ID 13)*

The ammunition store to pillbox 7 (Monument ID 13) comprised thick load-bearing brick walls supporting a flat reinforced concrete roof and an external brick wall (Figure 23). The building walls appeared to be in a fair condition, but the external wall was leaning significantly, likely due to foundation failure. The roof soffit had large areas of spalling, but no structural damage was observed.

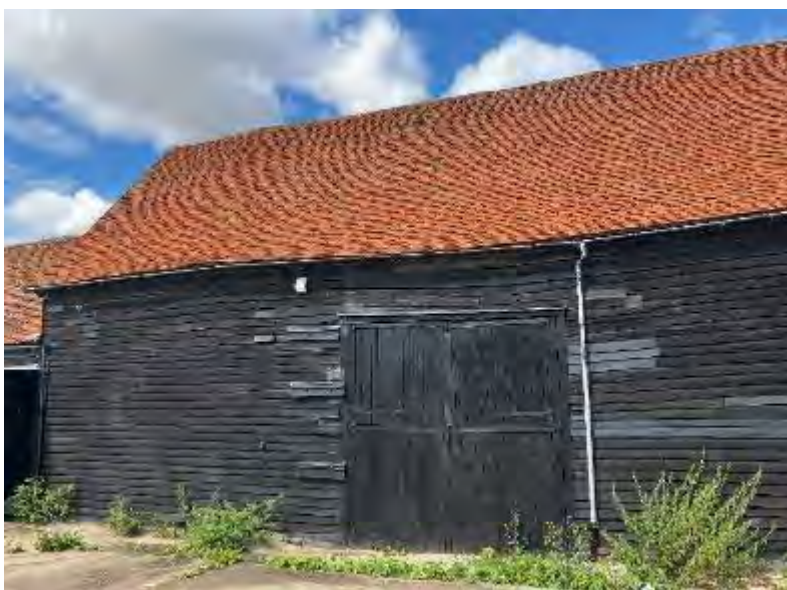
*Figure 2: Double access door on eastern elevation*

The large (8ft) double doors cut into the front elevation for vehicle access have presented issues with time, where the supporting timbers have twisted and possible overloaded the front elevation has become bowed in this area.

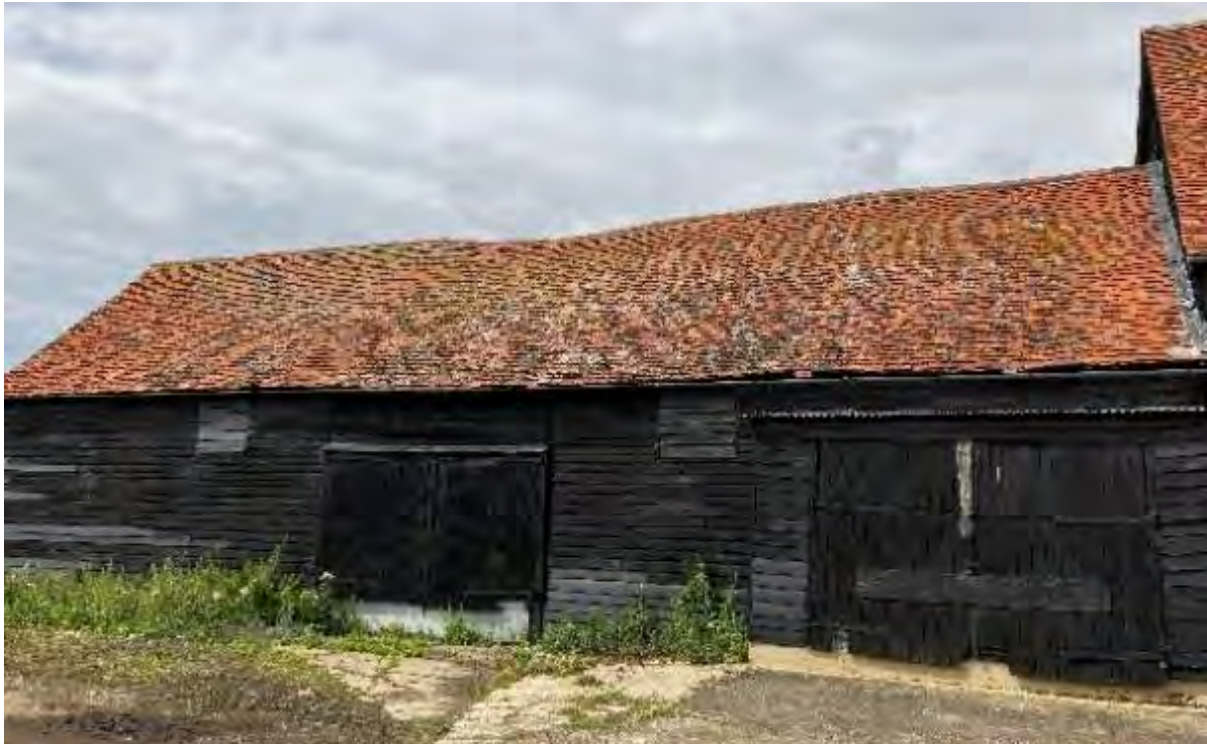
*Figure 7: Exterior of Barn attached to south of Big Black Barn*

The roof is constructed from red clay tiles with lead flashing where it joins the original barn the roof line has dipped considerable halfway along in line where the large ban door has been located, most of the roof looks intact and mostly watertight.

The flat roof on the extension which can be seen in this picture (Fig 7) does have presumed asbestos in the corrugated concrete sheets.

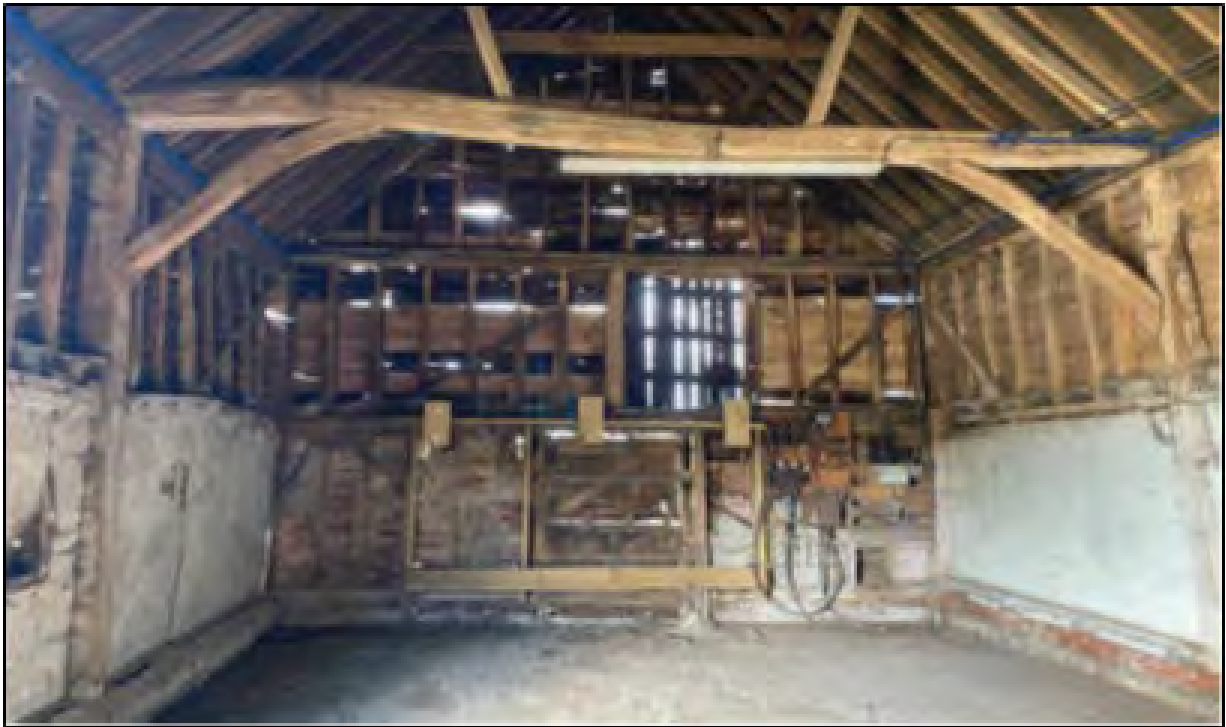
Figure 8: Alternative wall finishes in Barn attached to south of Big Black Barn

There are several areas in the barn with a half-height rendered wall finish as in Fig 8. Many of these are damaged and flaking. This picture also shows the electrical system and the gable end wall which has shoring.

**The overall condition of Barn no.2 is considered as Grade D - Inoperable or serious risk of major failure or breakdown**

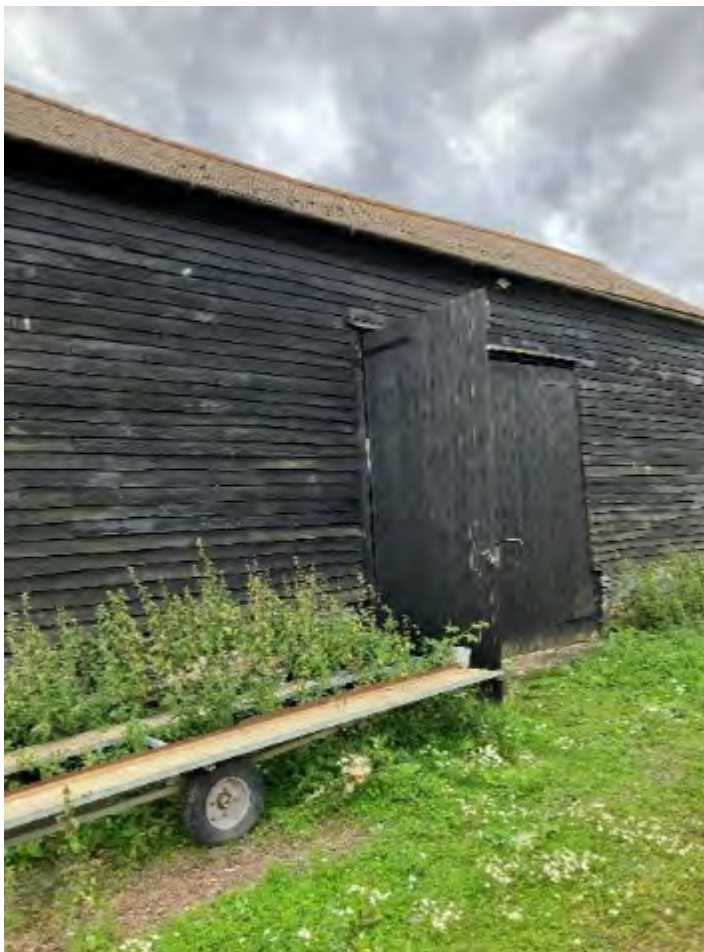
*Figure 9: North elevation of Essex Barn*

The roof is tiled in slate with ridge coping tiles, there is some deviation in the main roof line with some sagging. The front elevation has an intersecting pitched roof which again is slate tiles and lead flashing there is guttering all around which is functional and is in general good condition.

The front face of the building adjacent to the large wooden double doors is brick whilst the remainder of the property apart from a brick plinth is covered in weather boarding which have been patched at various times.

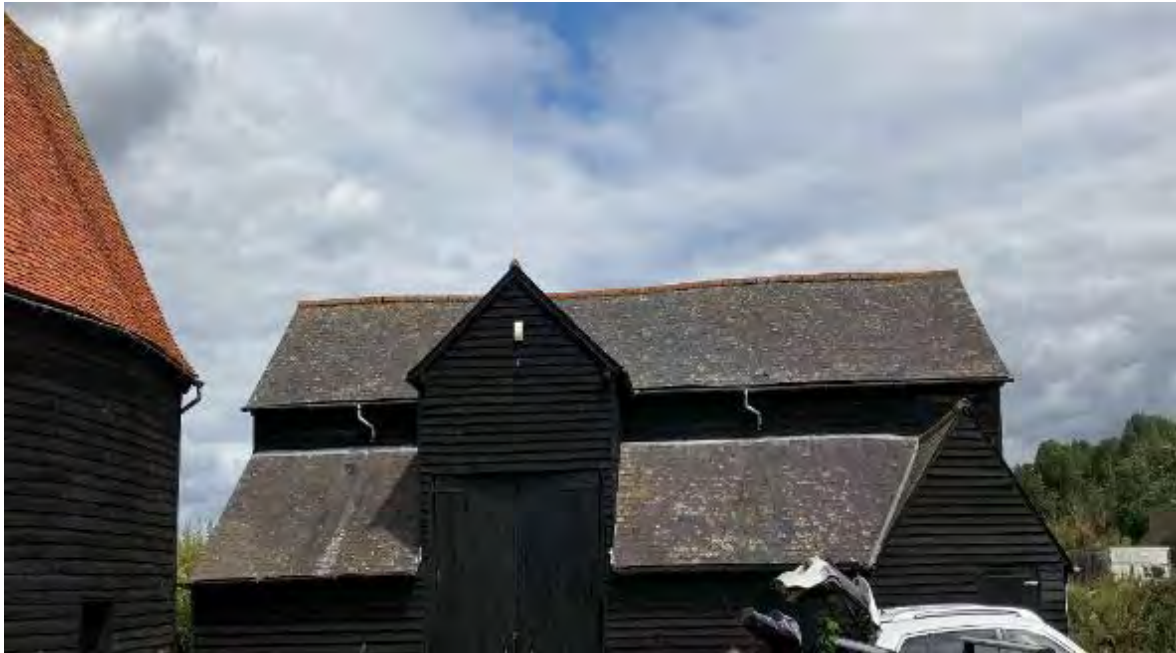
*Figure 10 South elevation of Essex Barn:*

The Barn is being utilised for storage of machinery which restricts the vision for an internal inspection. There are vermin (pigeons) within the property and there are coverings on the machines to keep them clean however this does restrict being able to see where the vermin are entering the property from.

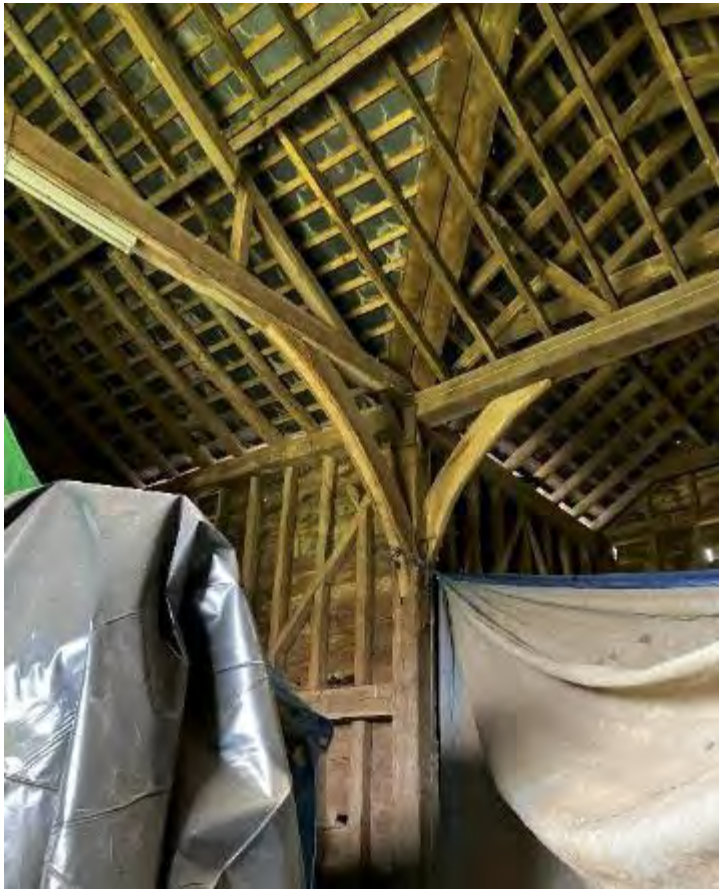
*Figure 11: Internal roof detail - Essex Barn*

The asbestos register provided does not appear to cover Barn no 3, The Essex Barn, but it cannot be assumed that there is no asbestos present.

**The overall condition of Barn no.3 is considered as Grade C - Operational but major repair or replacement needed in the short to medium-term (generally 3 years)**

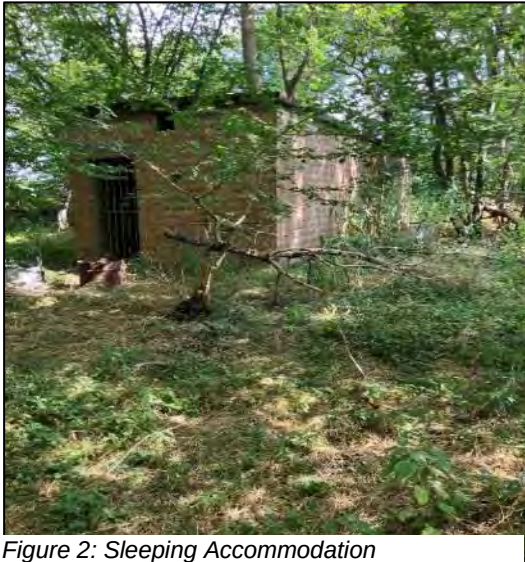
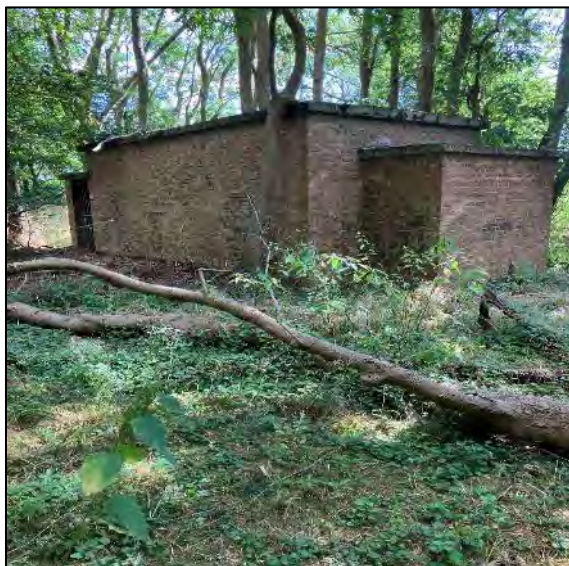
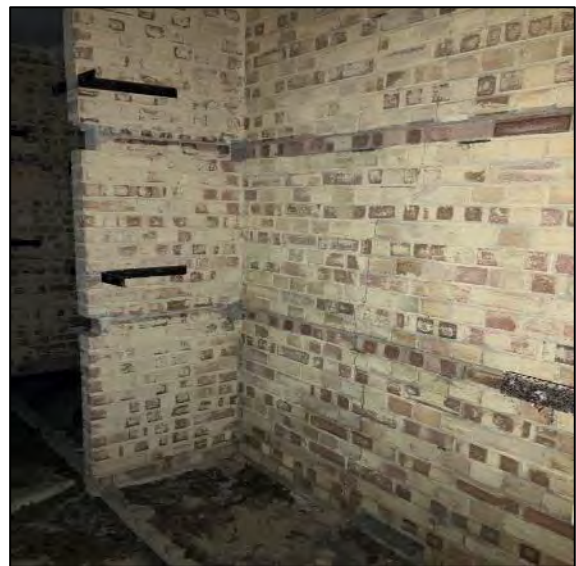
This consists of two brick structures with concrete slab roofs designed for emergency sleeping accommodation, blast entrances and an internal vent system (as there are no windows). Original electrical fittings are in place. There is currently open access to these structures and evidence of vagrant use (low level). They are in a relatively good condition although now surrounded by trees and undergrowth.

Current condition is considered as **Grade C** - Operational but major repair or replacement needed in the short to medium-term.

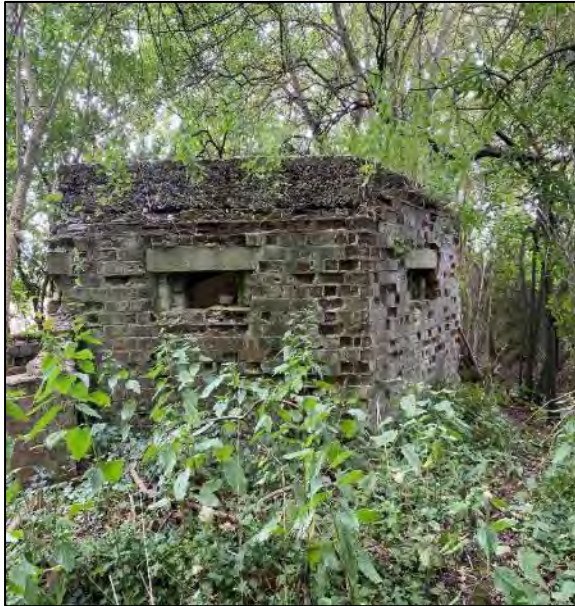
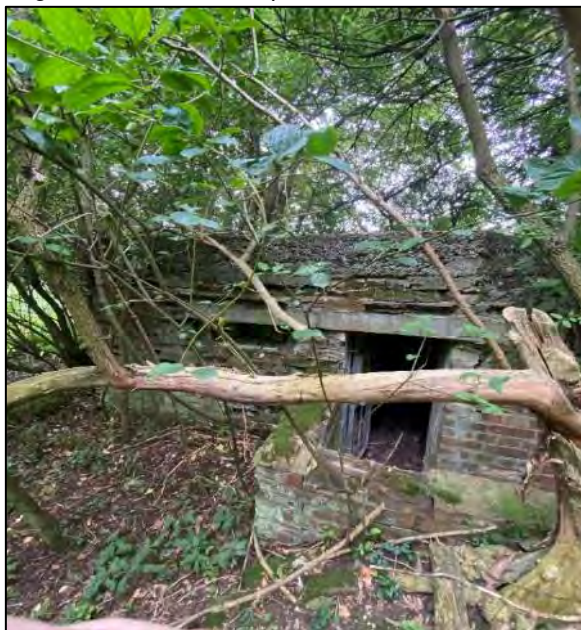
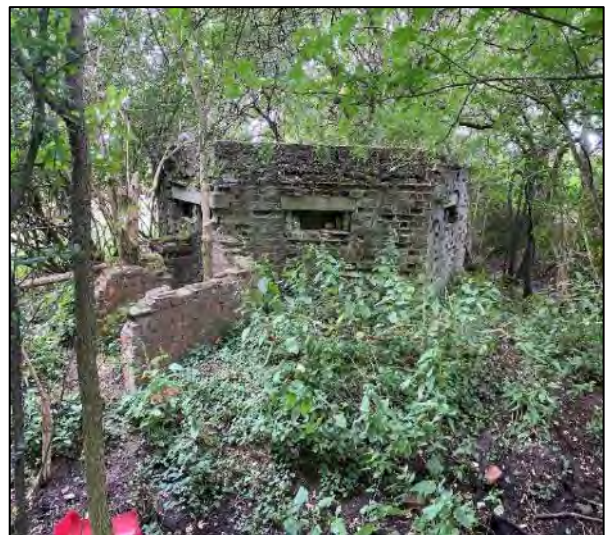
Hexagonal brick built with a concrete slab roof gun positions on each face, entrance via a tunnel, The brick facing has deteriorated considerably and the building is heavily covered in vegetation and forest debris, steel gate on entrance is open.

Current condition is considered as **Grade D** - Inoperable or serious risk of major failure or breakdown.

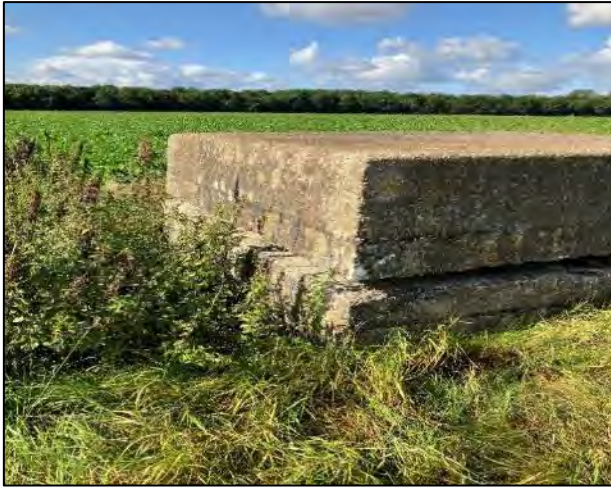
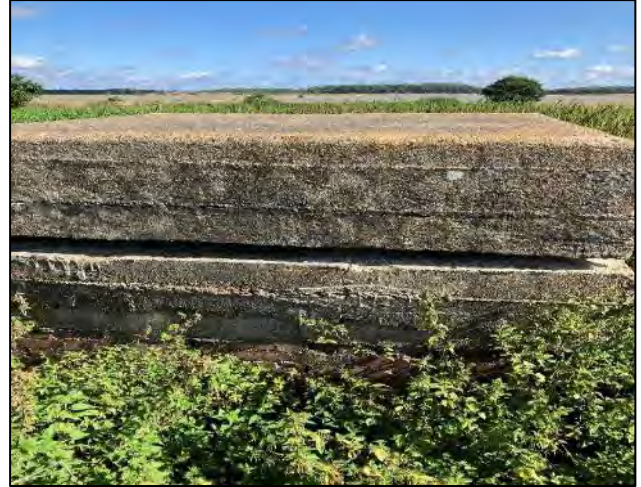
This structure is of Concrete construction which is above and below ground with the visible portion being approximately 2m x 2m. This construction is believed to be the former battle headquarters with the majority of the building below ground. Underground is accessible via a hatch and vertical ladder with additional steps to the side approximately 3m away. It is unknown how much of the underground structure is visible. The ground surrounding the area would have to be excavated in order to assess the integrity of the whole area.

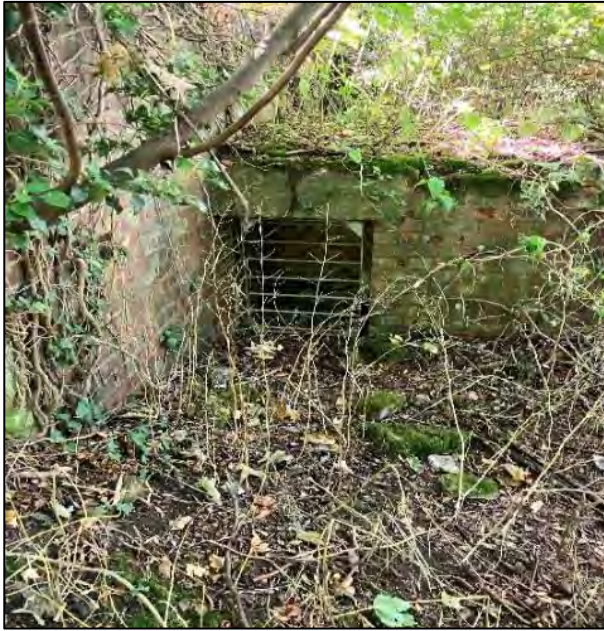
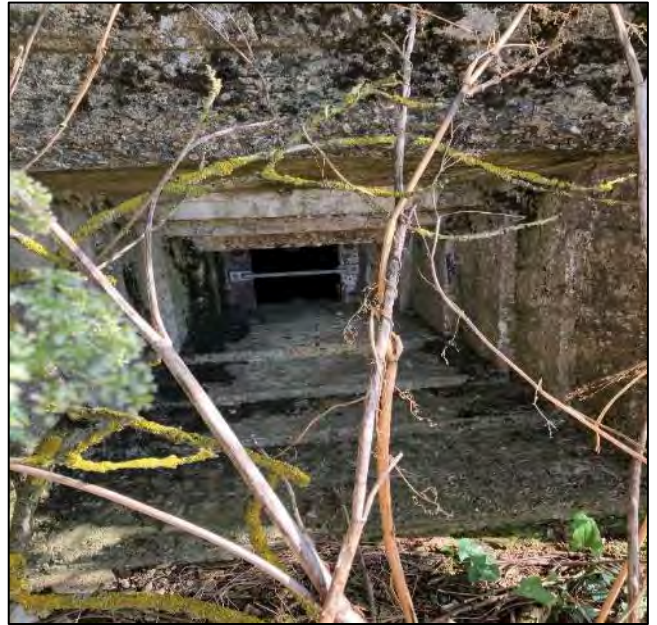
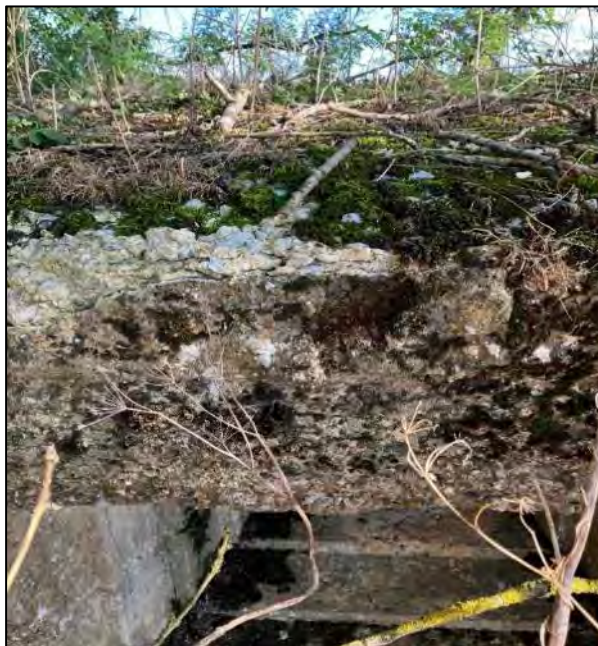
This is a hexagonal concrete pillbox structure with walls over 1 meter in depth, originally with brick facing which have mostly now collapsed. The entrance is via a rear square aperture to one side, which has a steel mesh gate for security. Headroom is severely restricted due to build up of debris, with the inside not visible. This will require extensive work to make accessible, however the structure appears intact.

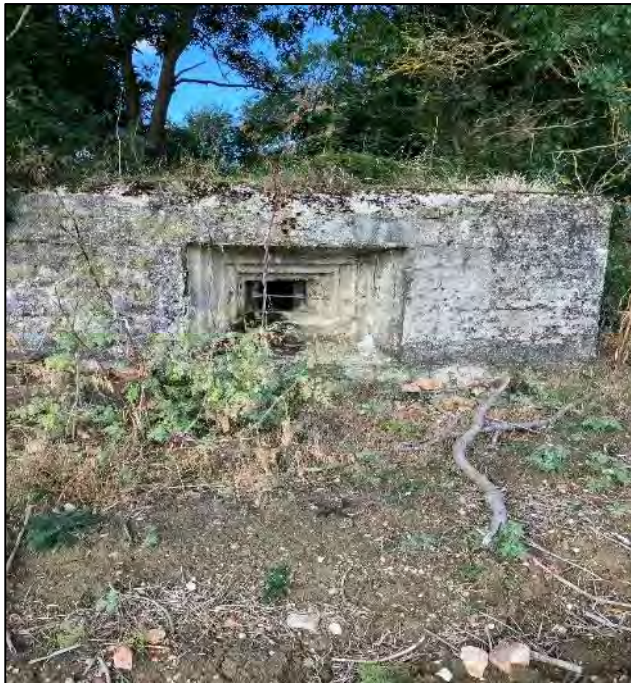
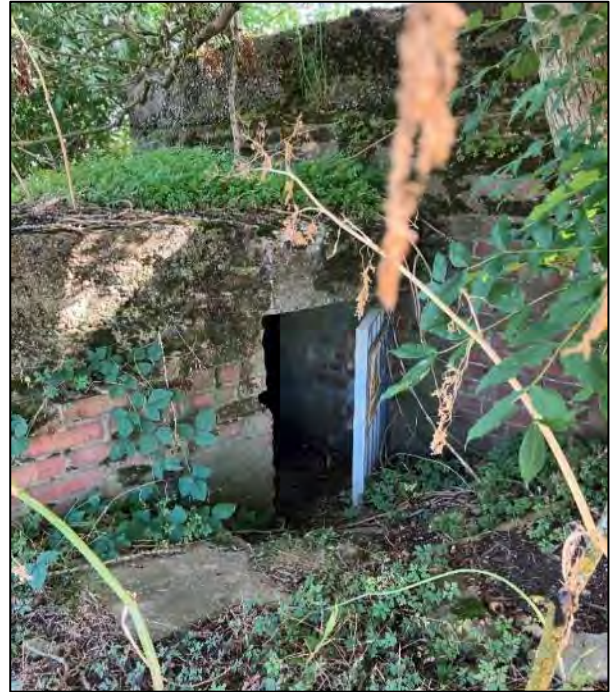
This is a hexagonal concrete pillbox structure with walls over 1 meter in depth, originally with brick facing which have mostly collapsed. The entrance is via a brick square addition to one side. There is a steel gate for security but has been left open, restricted headroom due to build up of debris in the entrance. The structure is covered with vegetation and self-seeded trees, with the inside not visible. This will require extensive work to make the structure accessible, however the structure appears intact.

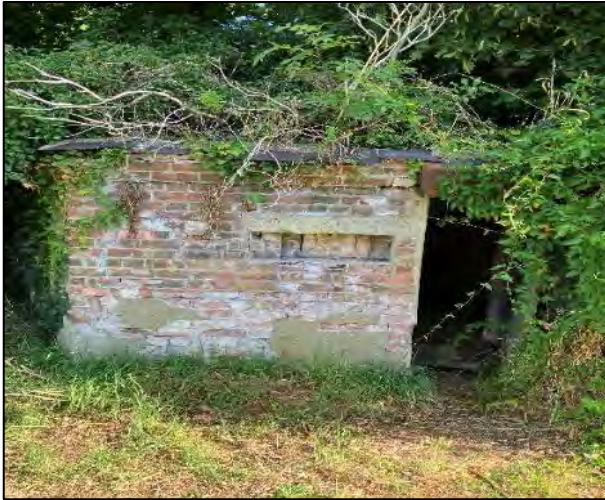
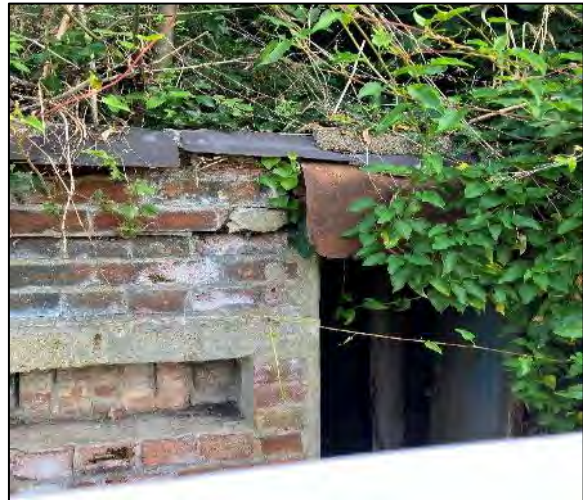
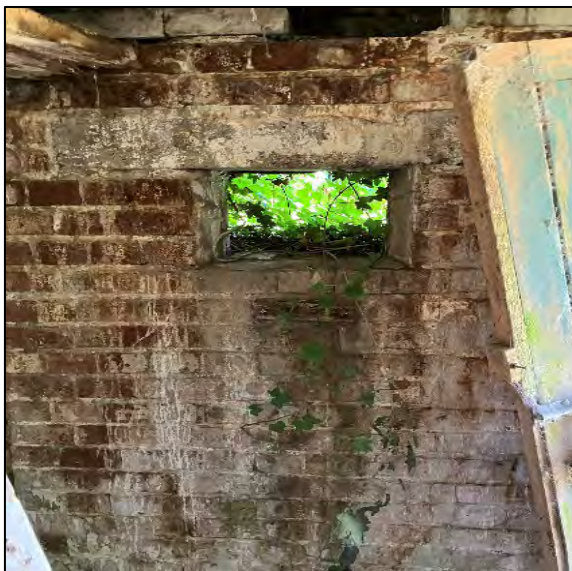
This is a square brick structure with none of the original roof present, which now appears to be corrugated iron. A wooden door which had been added for security has now been forced open allowing access. The slit windows have been mostly bricked up. The building has also been engulfed by trees and shrubs and bricks are decaying in many areas. Once uncovered a more accurate assessment could be made, condition is poor.

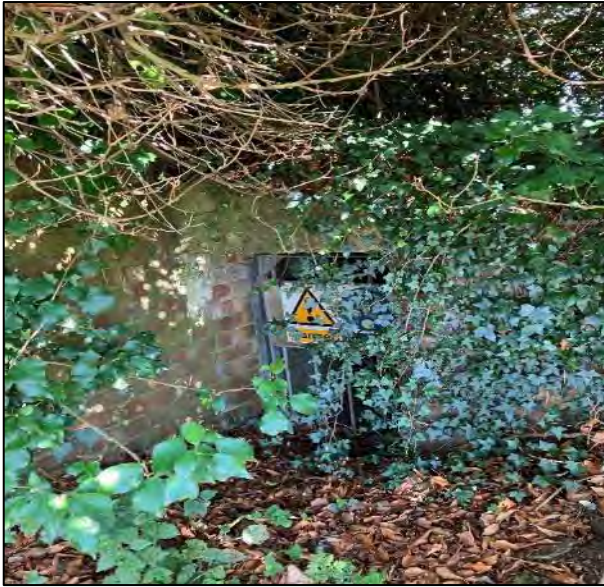
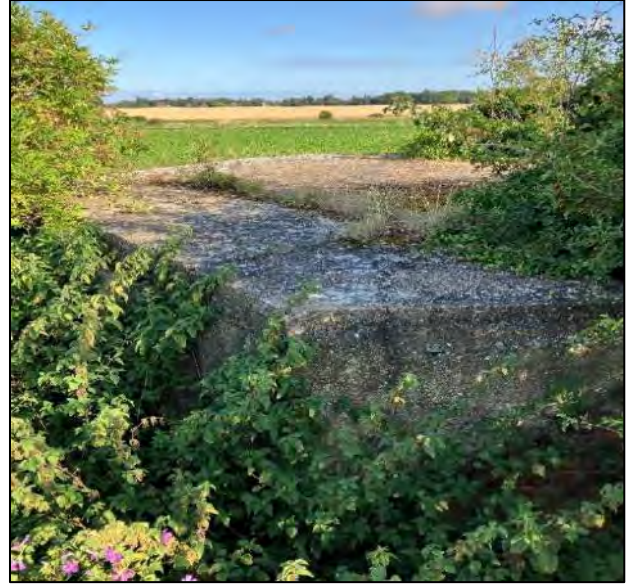
This is a hexagonal concrete pill box, heavily covered with trees and vegetation. It has a concrete structure, faced with bricks where it is visible that there is some collapse to the brick facing walls. The entrance to the defence is closed with a steel structure - due to the vegetation it was not possible to get an accurate assessment but once the area is opened the structure could be further examined in more detail.

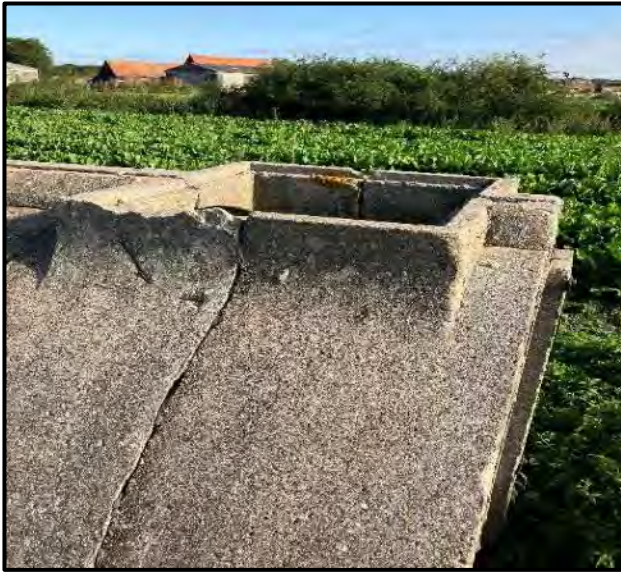
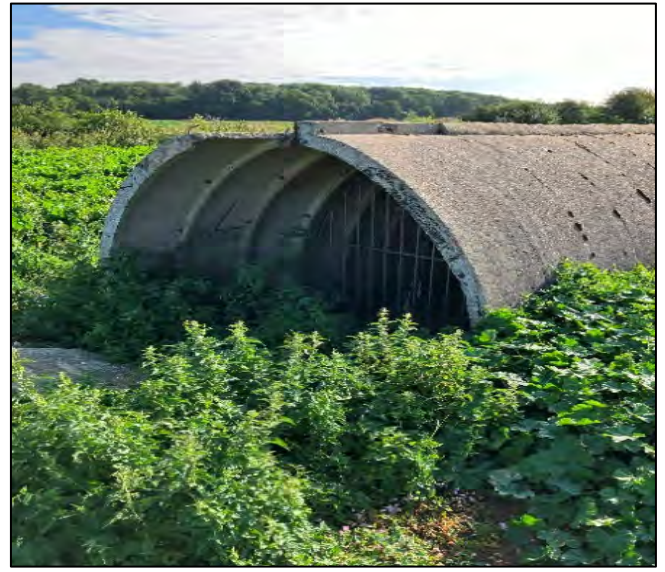
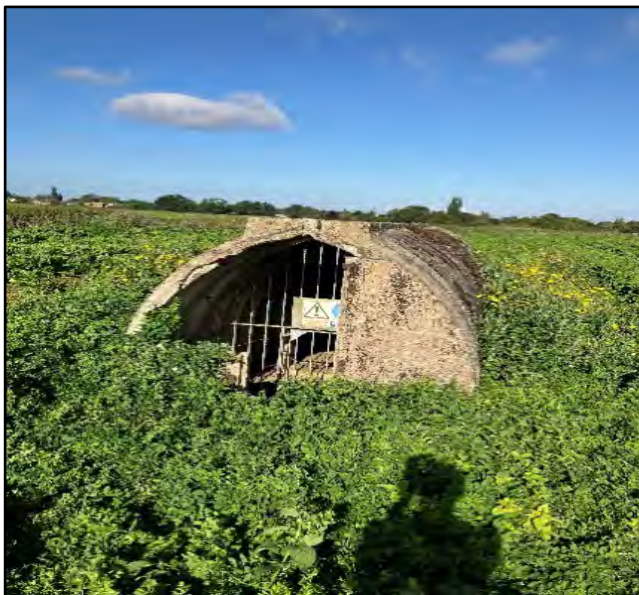
The air raid shelter (Monument ID 8) comprised precast concrete segments bolted together to form a single tunnel form (Figure 20). Given the exposed location the condition was relatively good but metal fixings between segments had corroded and there were some small areas of concrete spalling internally. One of the northern segments appeared to have collapsed along with what could have been end walls.

This former air raid shelter is made from 18 pre-cast concrete sections bolted together with open ends and an escape hatch this would during operations have been covered in earth. Currently both ends are fenced off preventing entry, there is some mechanical damage to the structure but is in a reasonable sound condition.

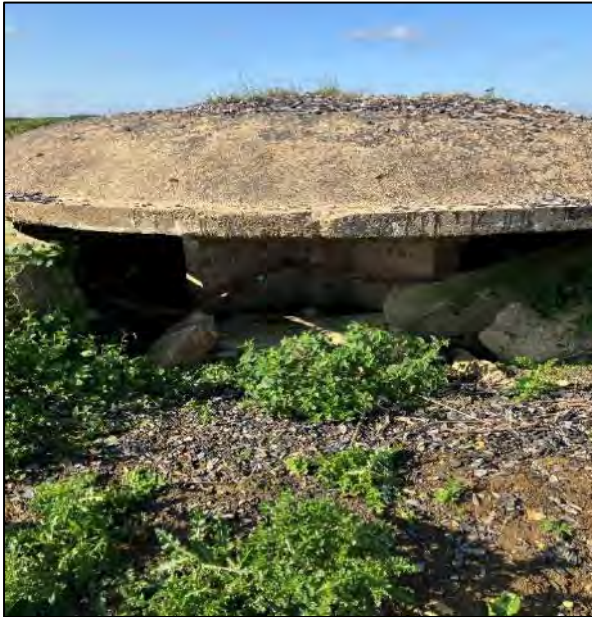
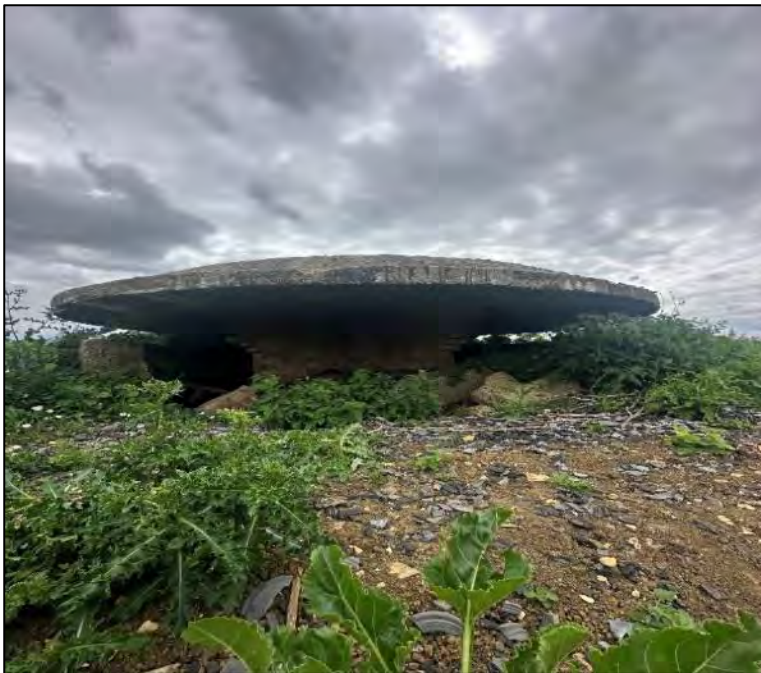
The cantilever pillbox (Monument ID 9) is an interesting arrangement comprising a reinforced concrete shallow domed cantilever roof supported on a central cruciform of brickwork, with a masonry and concrete wall around the perimeter (Figure 21). The condition of the roof is fair, and the central brick support appears to be in good condition. The perimeter wall had in sections collapsed into the centre. This is likely either due to an agricultural accident and/or failure of the wall's foundations over time. There was a significant amount of water in the base of the pillbox.

This structure is a concrete cantilever top sitting on a brick pedestal and a brick surround wall (mushroom). A considerable amount of damage is evident, which is mostly mechanical to the brick wall that has collapsed inwards in places. The internal base is not accessible but looks to be full of water and debris - this is in poor condition and requires some brick work restoration to make it safe.

Current condition is considered as **Grade D** - Inoperable or serious risk of major failure or breakdown.

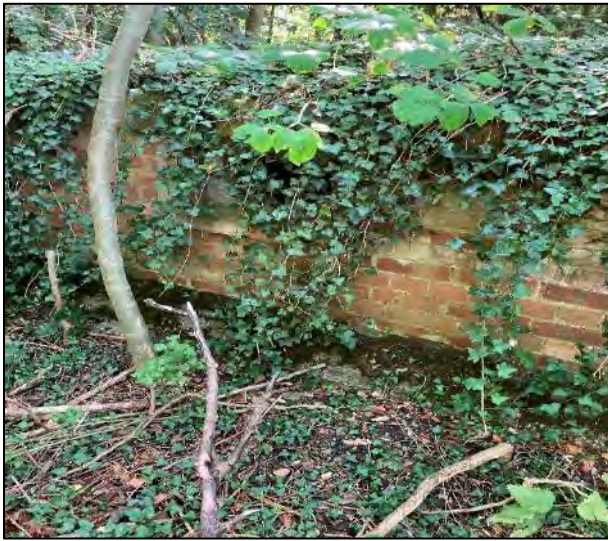
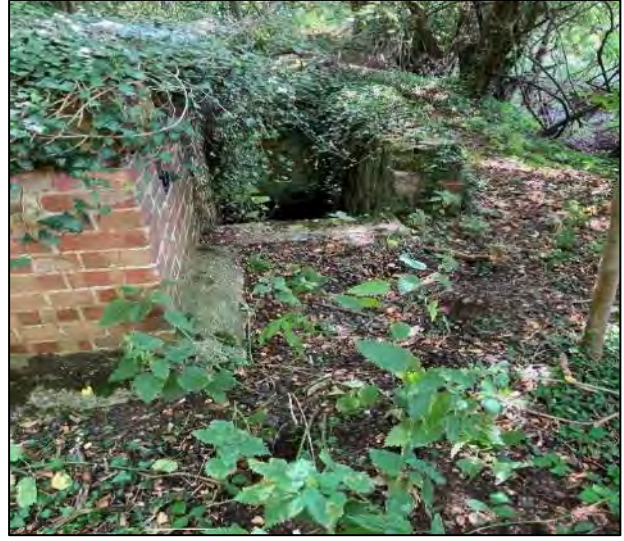
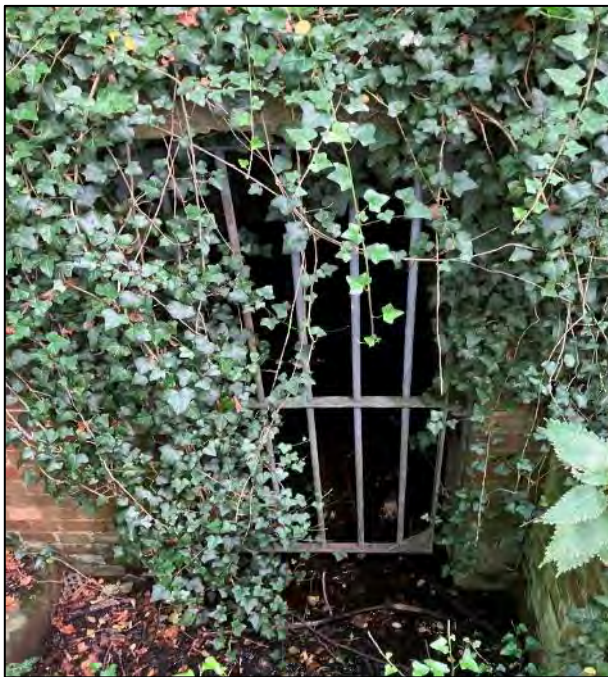
The ammunition store to pillbox 6 (Monument ID 11) comprised thick masonry load bearing walls set into the ground to create a semi-basement and supporting a flat concrete roof. The structure appeared to be in reasonable condition given its exposure but with some deterioration to the external walls, primarily from vegetation (Figure 22).

This is a brick-built structure with concrete slab roof, semi submerged originally thought to be an ammunition store now covered in vegetation and debris.
