## *Hunsdon Airfield Heritage Assets Feasibility Study*

# Gilston Park Estate Strategic Landscape Masterplan (SLMP)

## Hunsdon Airfield Feasibility Study

March 2025

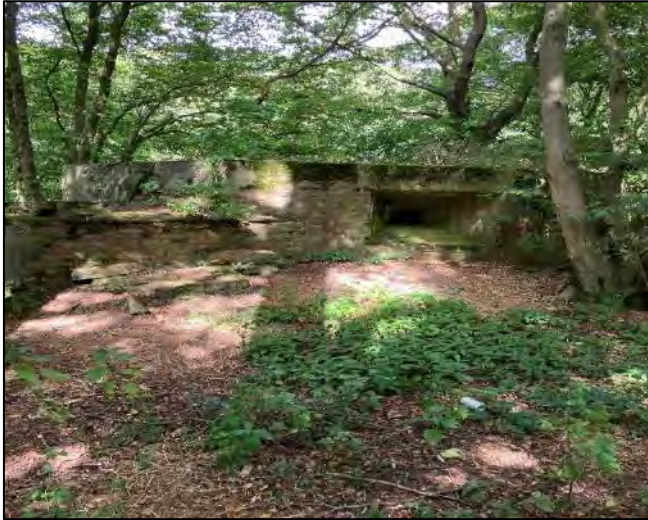
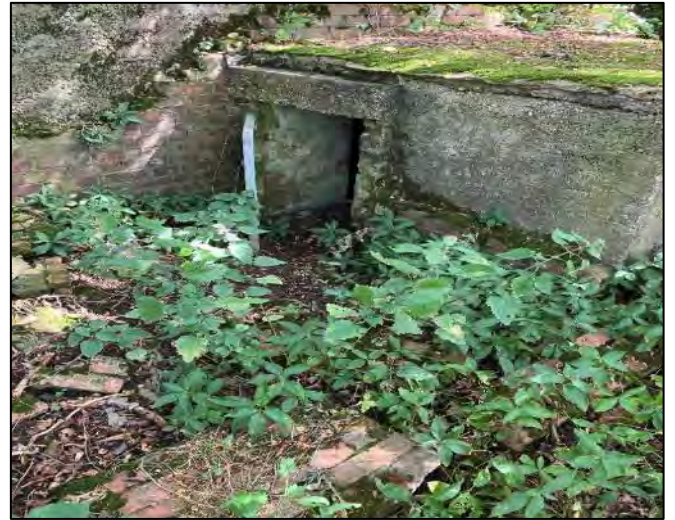
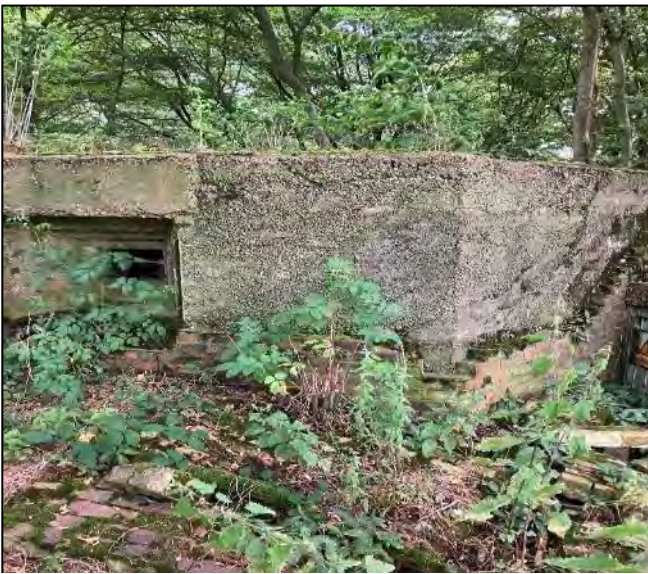
This is a hexagonal concrete pillbox structure, with walls over 1 meter in depth, originally with brick facing which have mostly now collapsed. The entrance is to the left of the structure. Undergrowth and debris now prevents entry, although entrances have been closed off with steel bars. Structure appears to be in good condition.

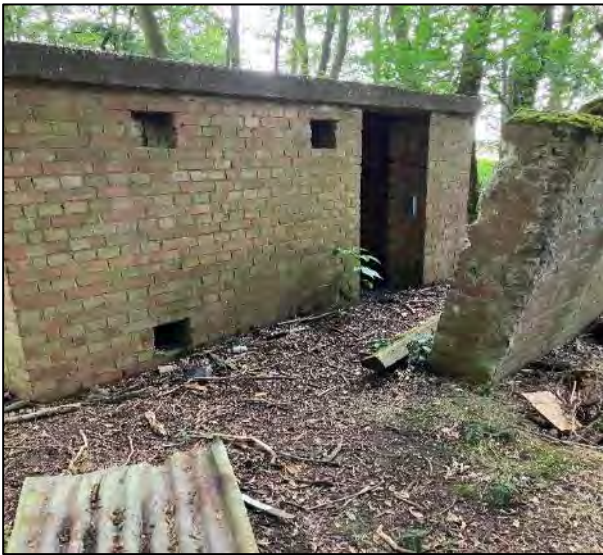
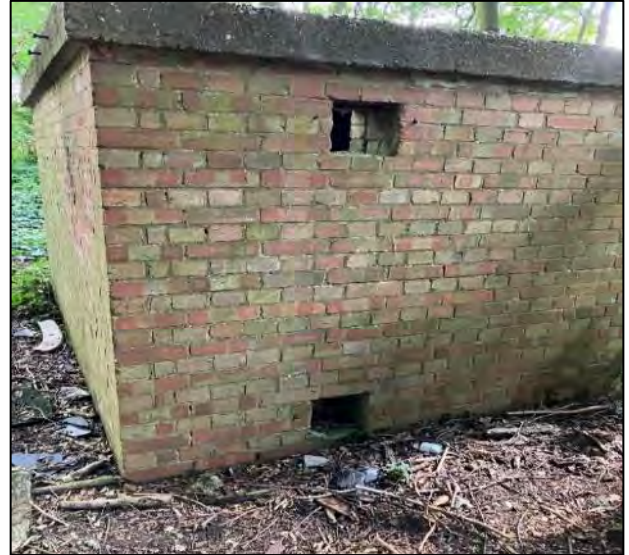
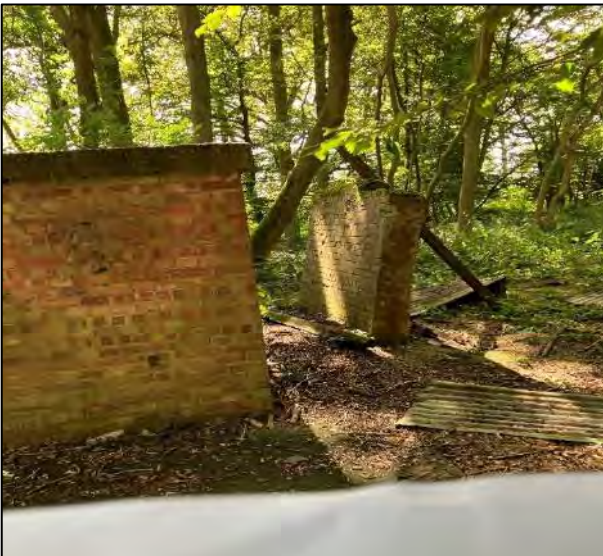
The ammunition store to pillbox 7 (Monument ID 13) comprised thick load-bearing brick walls supporting a flat reinforced concrete roof and an external brick wall (Figure 23). The building walls appeared to be in a fair condition, but the external wall was leaning significantly, likely due to foundation failure. The roof soffit had large areas of spalling, but no structural damage was observed.

This is an above ground ammunition store, of brick construction with concrete slab roof, and no windows (only small ventilation gaps). The external blast wall has slipped intact into a trench and will require correction for safety reasons. Building is in reasonable condition.
