Thorley Wedge & Northern Parkland

GREENSPACE ACTION PLAN

2024 – 2029

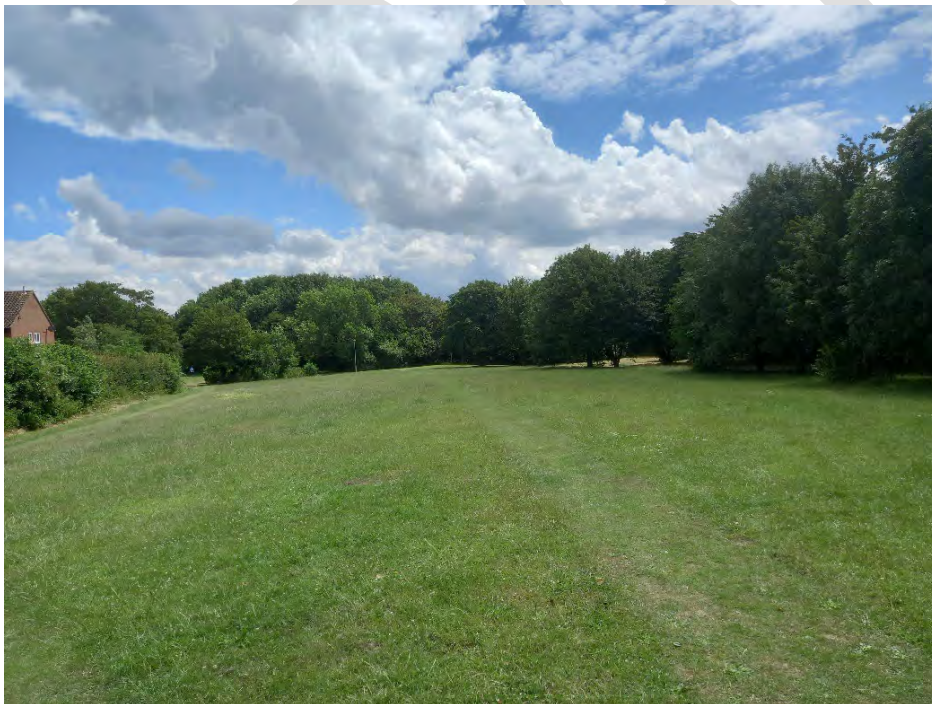
Image 1: View of Thorley Wedge showing mown paths

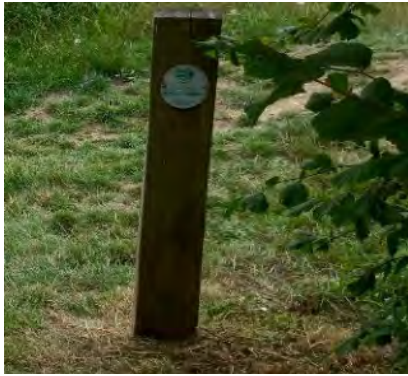
At the majority of entrances at both Thorley Wedge and Northern parkland there are marker posts as in the photo below.

Image 6: Entrance post at Northern Parkland

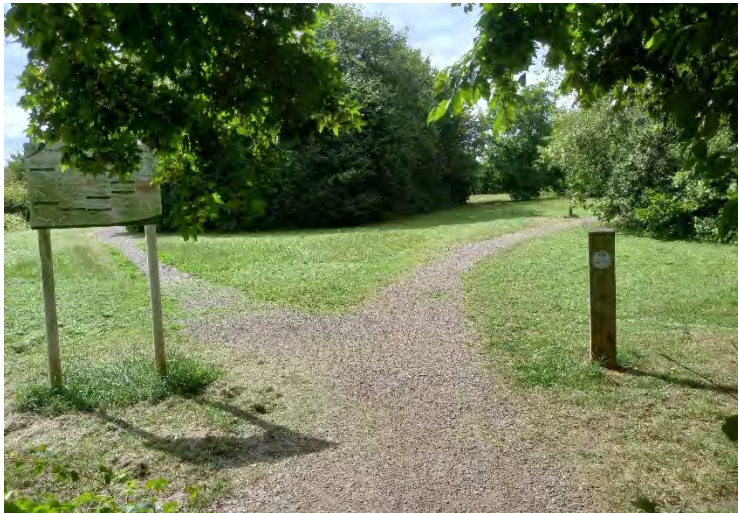
Interpretation panels and entrance signage will be improved across Thorley Wedge and Northern Parkland over the course of this GAP. Currently most entrances have a post demarcating the entrance to the site and a board showing the bylaws and shown by image 6 below. Key entrances will have an interpretation panel/notice board developed to welcome site users and inform them about the facilities.

Image 6: Existing entrance signage (entrance post and bylaws)

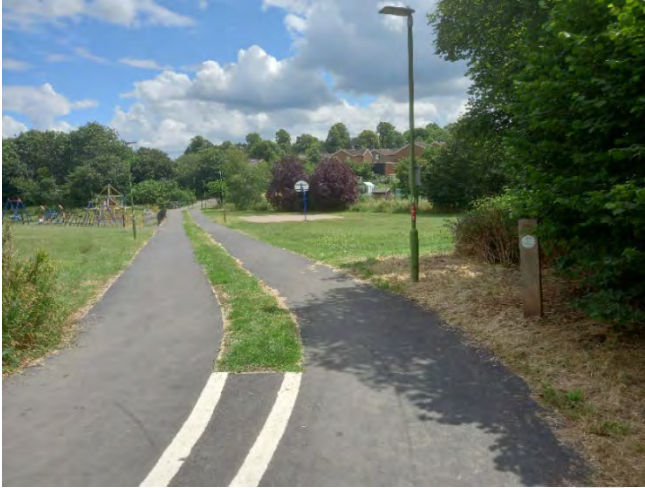
footpaths on site will be assessed to determine where repairs are needed, which includes both tarmac and loose surfaced routes. The bridges which cross the ditch close to Thornbera Road will be assessed for their condition and repair works/ replacement carried out as necessary.

Image 8: The pedestrian/cycle route Norfolk Way to Thornbera Rd

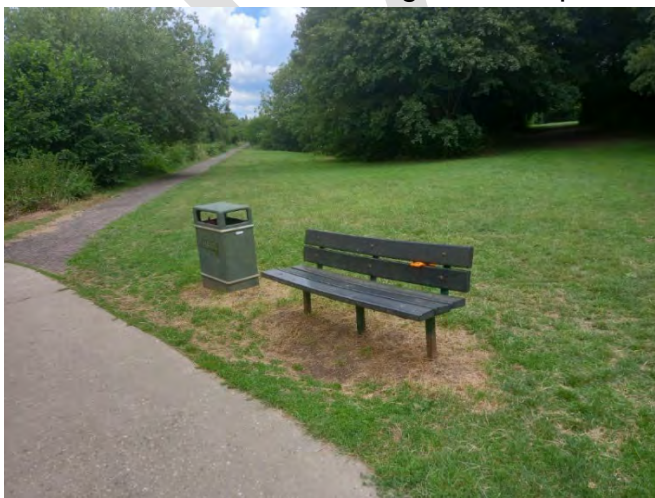
Image 9: Existing bench located near the entrance from Honeybourne

Image 9 above shows an existing bench and an example of installation alongside a path. New possible bench locations are highlighted on the action plan maps. Benches installed should be consistent with existing designs used on the site.

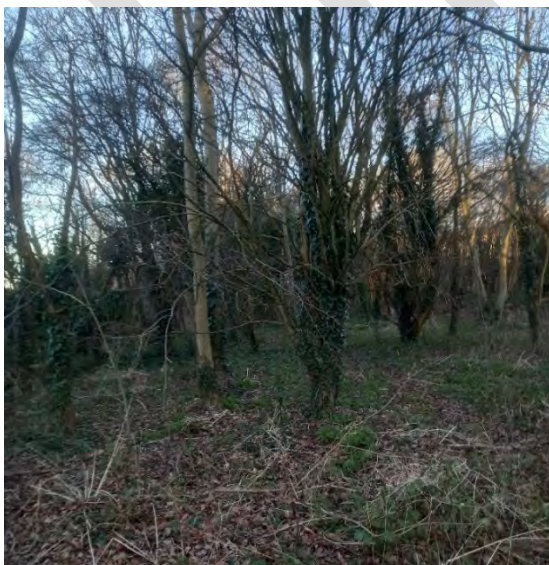
Historically the woodland at both Thorley Wedge and Northern Parkland has been managed through thinning and underplanting. This has improved the structural and species diversity of the woodland. However, some further thinning of the woodland, particularly the woodland in Thorley Wedge would be of benefit to the habitat value of the parcels of woodland. Image 10 below shows an area of woodland at Thorley Wedge that needs some thinning and underplanting to enhance the diversity of the woodland. The focus for thinning within the areas dominated by ash would be those trees which are becoming dangerous due to ash dieback.

Image 10: Woodland at Thorley Wedge lacking understory

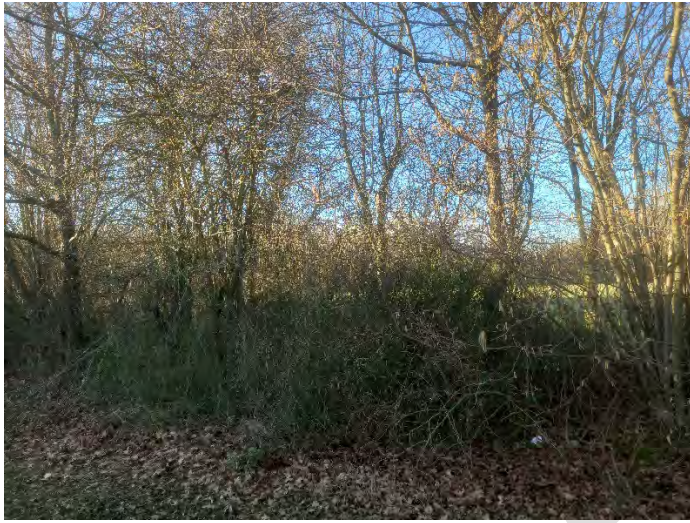
The woodland compartments in Northern Parkland have good structural diversity with evidence of previously coppiced hazel stools. It would be beneficial to re-coppice some of this hazel over the course of this Greenspace Action Plan.

Image 11: Woodland at Northern Parkland with hazel coppice stools
